# South Brighton Motor Camp – Camp Building 2

## Detailed Engineering Evaluation

### Qualitative Report

## **South Brighton Motor Camp – Camp Building 2 BU 1359-004 EQ2**

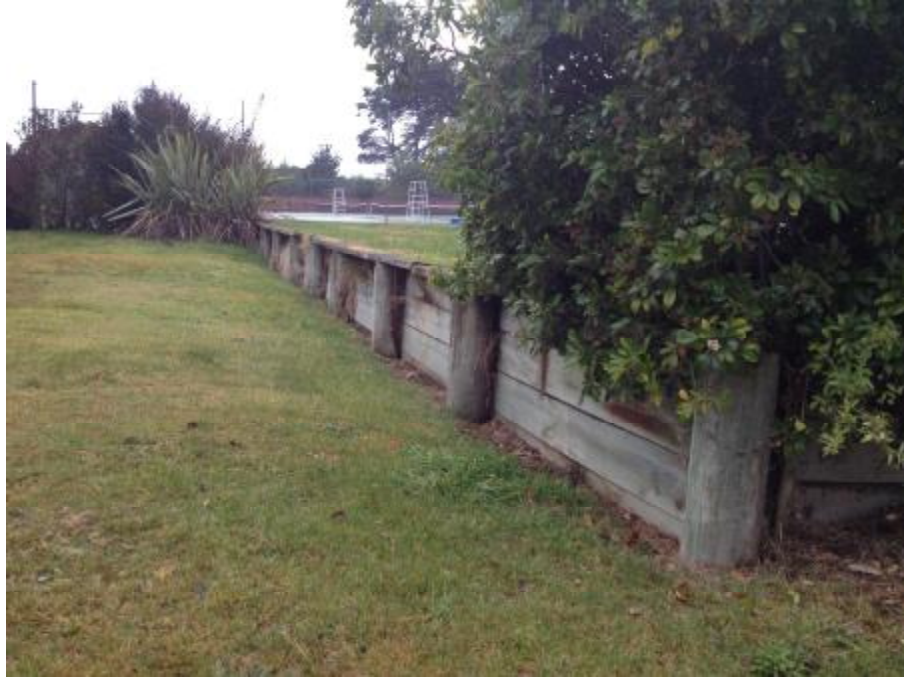
**Photo 1: Leaning retaining wall located 7m at north face of the building**

- Retaining wall located 7m at north face of the building is leaning. This is likely due to ground settlement and liquefaction during the earthquake event.

Damage description: Retaining wall located 7m at the north face of the building is leaning and tilting. This damage likely implies the external ground settlement and movement.

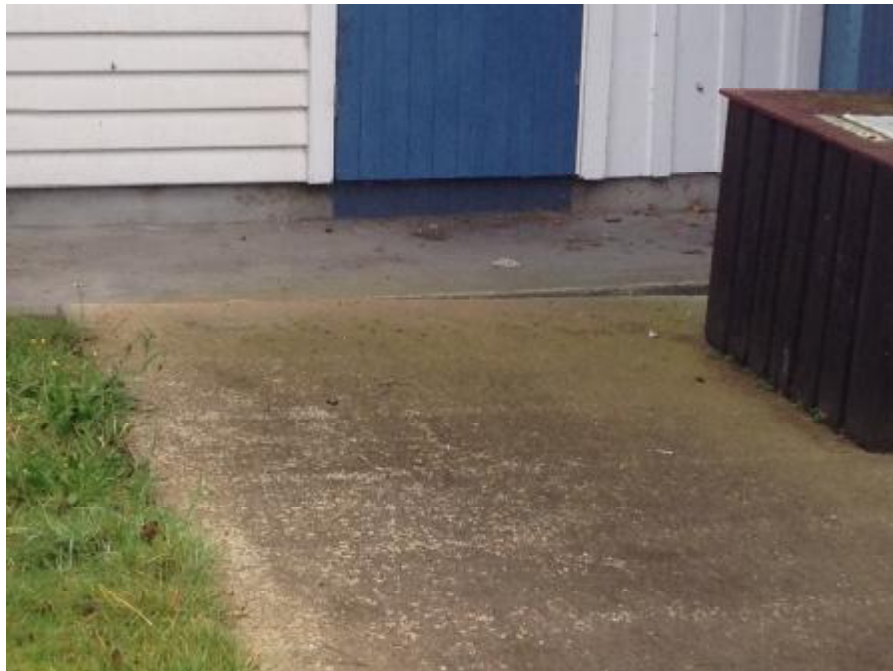
**Photo 2: Uneven external concrete pavement**

Damage description: Uneven external concrete pavement indicates the external ground settlement and movement.

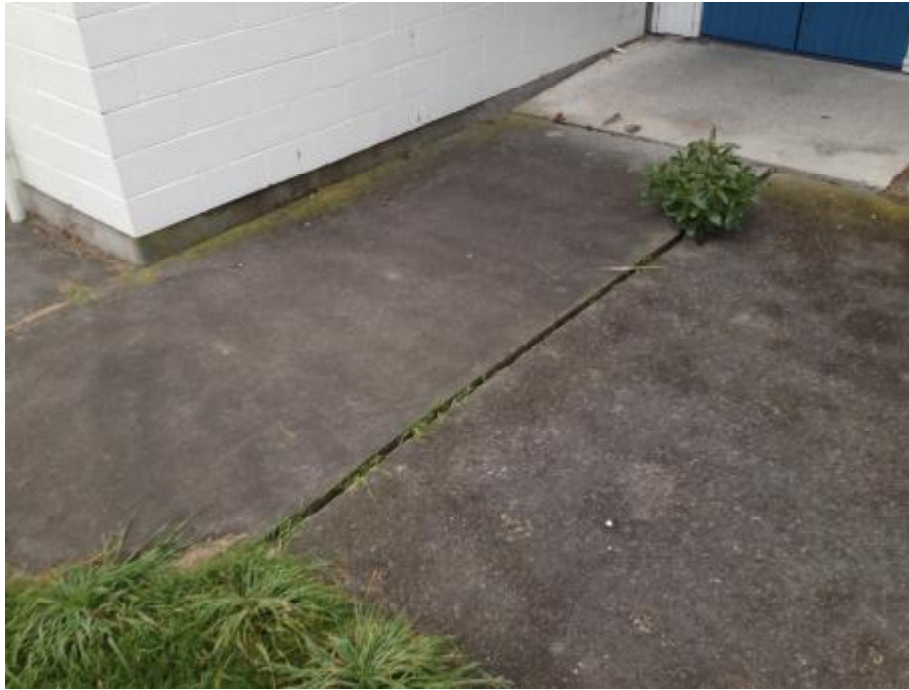
**Photo 3: Widened construction joint of external concrete pavement**

Damage description: Widened construction joint of external concrete pavement indicate there is an external ground settlement.

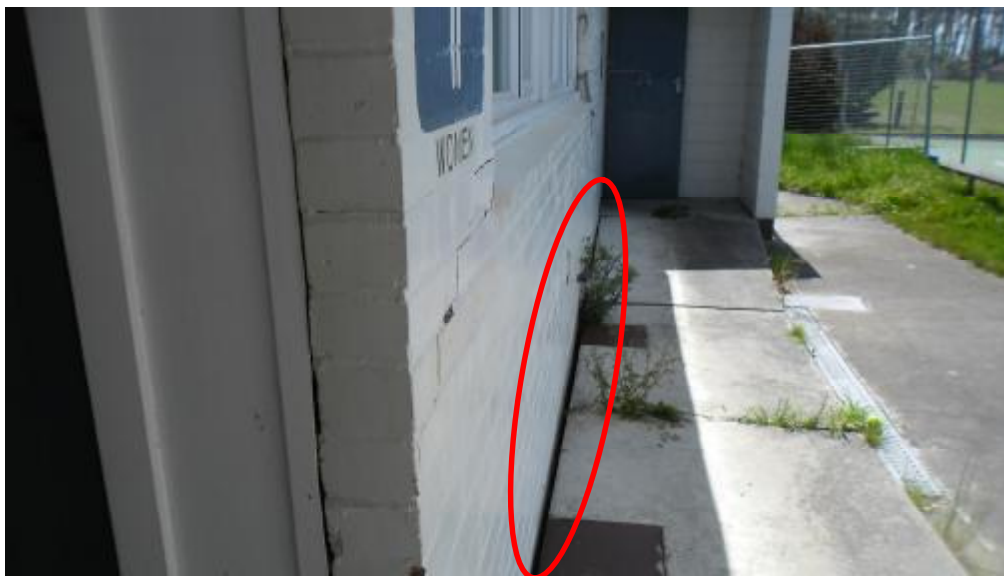
**Photo 4: Separation between external pavement and foundation wall**

Damage description: Separation between external concrete pavement and foundation wall implies the ground movement and settlement.

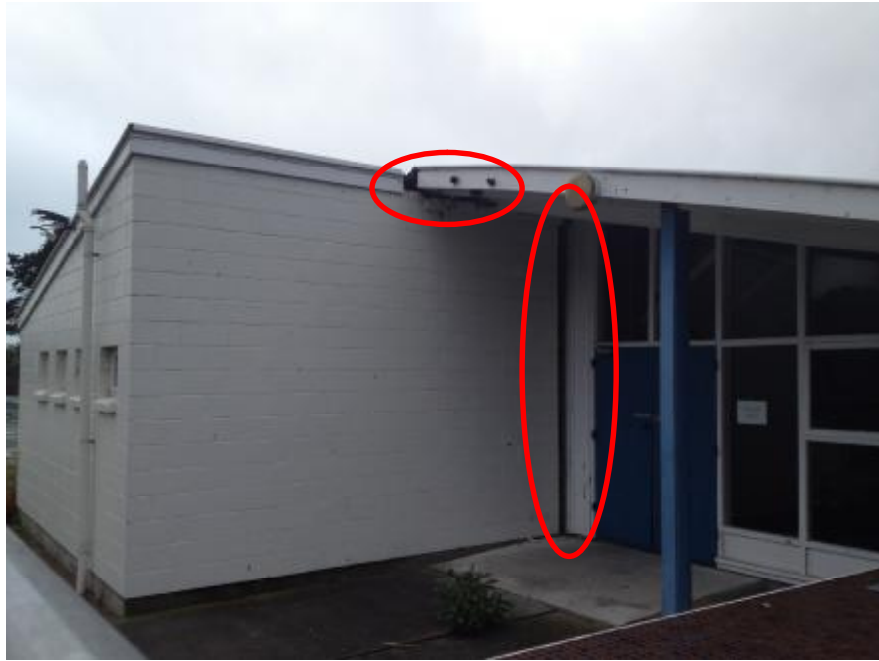
**Photo 5: Separation between original and extension area**

Damage description: Separation between original and extension area implies there has been lateral spread of the foundation.

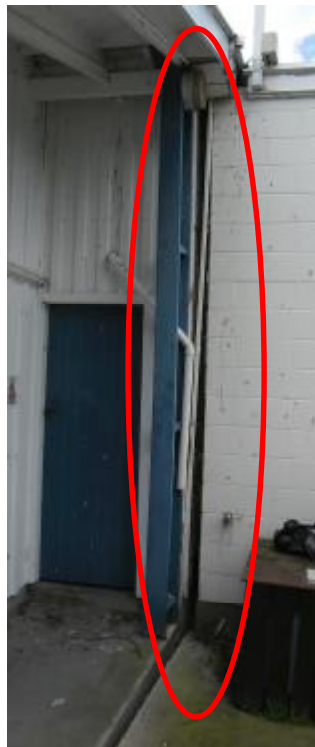
**Photo 6: Separation between original and extension area**

Damage description: Separation with approximately 110mm between original and extension area implies there has been lateral spread of the foundation.

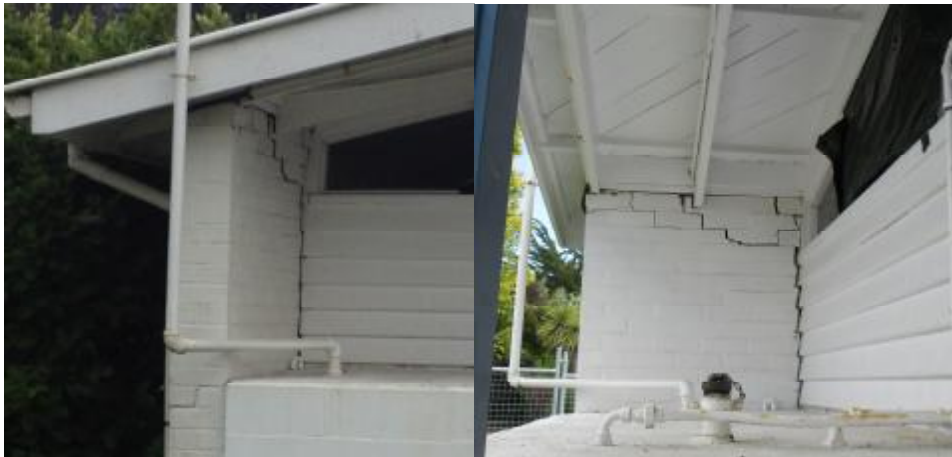
**Photo 8: Typical cracking to unreinforced masonry wall**

Damage description: Cracking to unreinforced masonry is potentially due to in-plane and out-plane lateral load overstressing the wall.

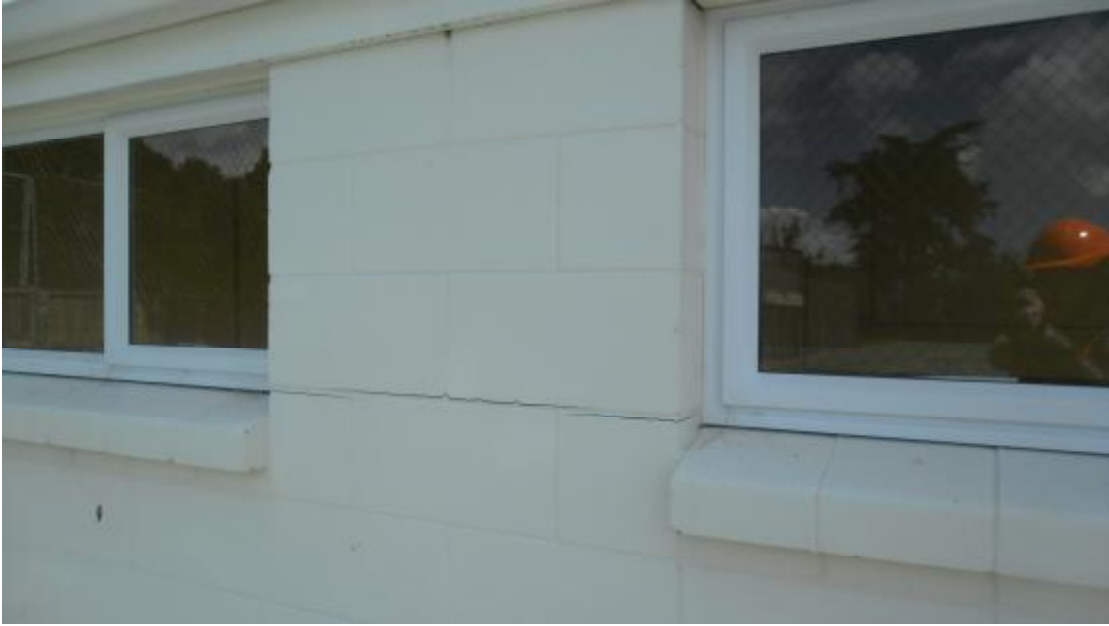
**Photo 9: Cracking to reinforced masonry wall at extension area**

Damage description: Cracking to reinforced masonry wall at extension area is potentially due to in-place lateral load overstressing the wall.

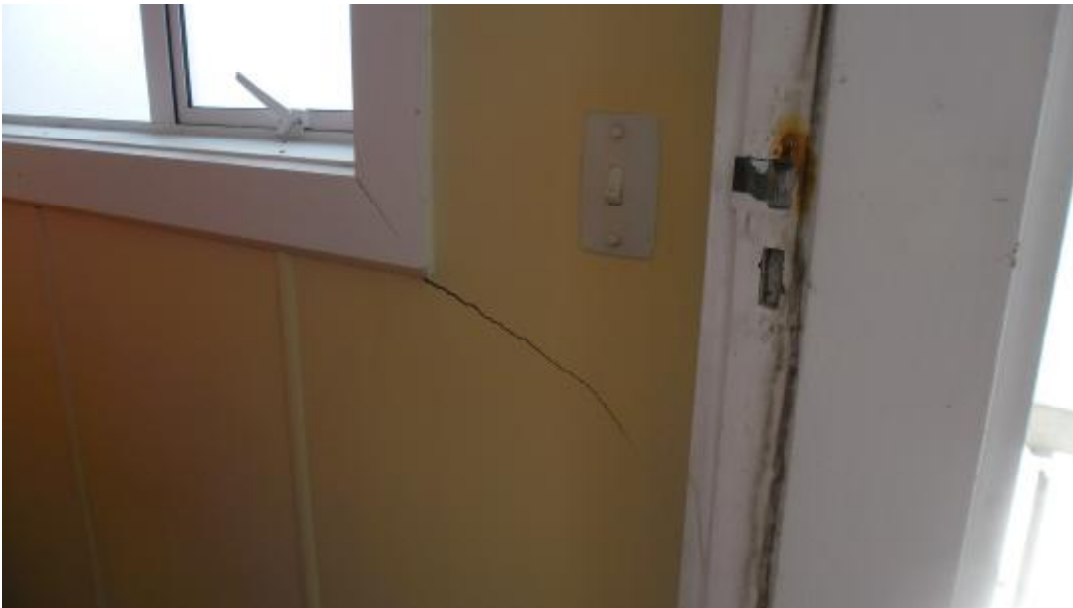
**Photo 10: Cracking to non-structural wall lining**

Damage description: Cracking to non-structural wall lining is due to the building movement during the earthquake.

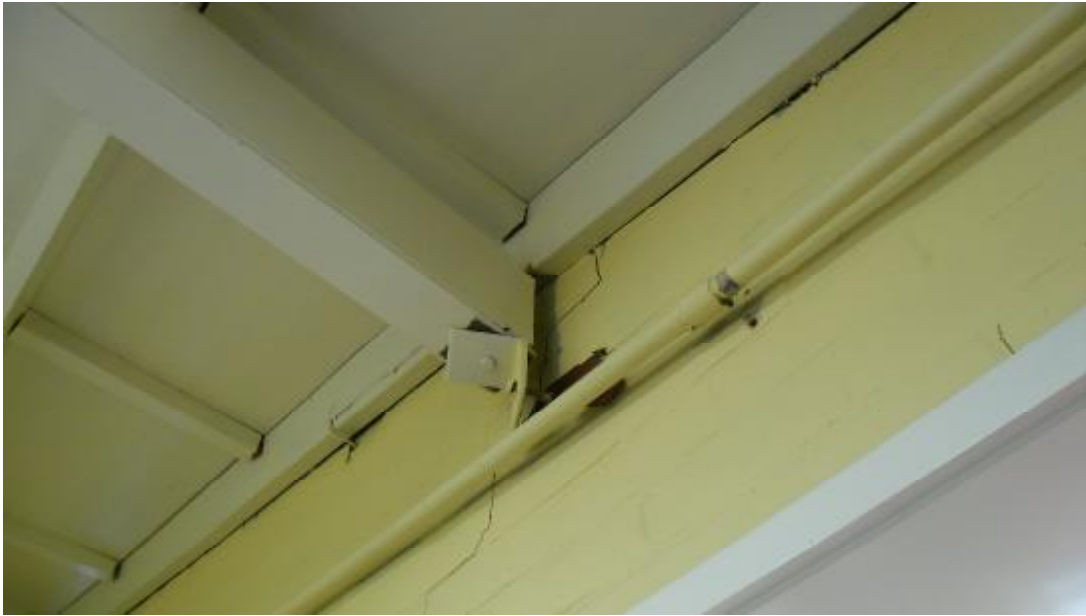
**Photo 11: Roof timber connection damage**

Damage description: Roof connection between original and extension area has been pulled out. This is potentially due to the lateral spread of foundation along the joint between original and extension area.

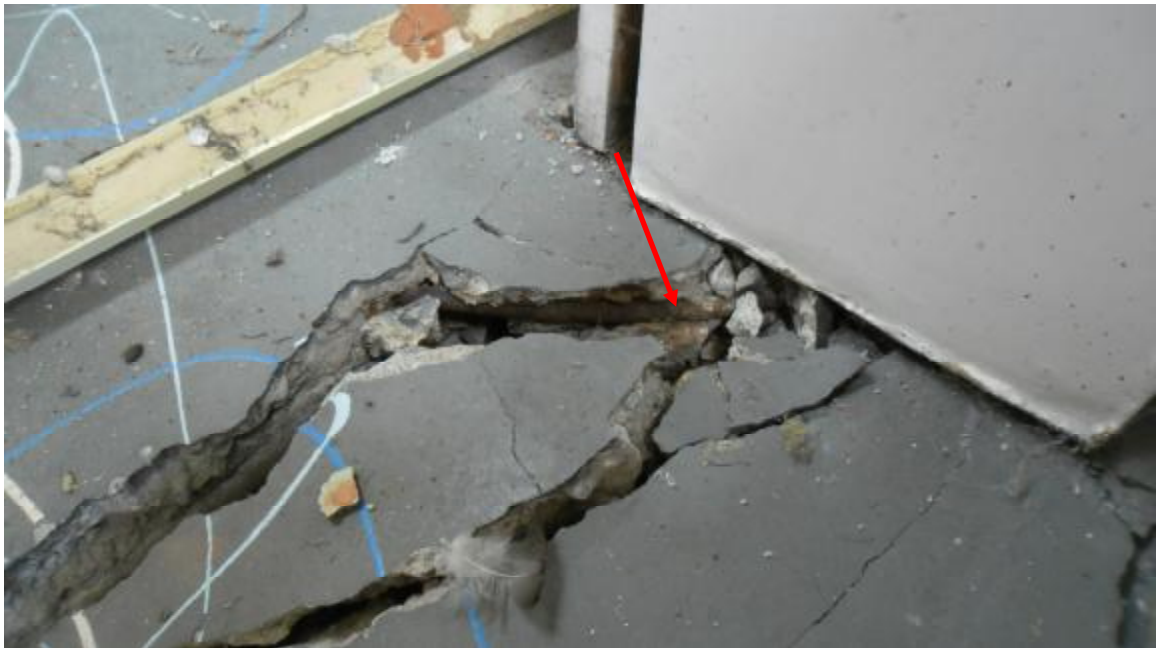
**Photo 12: Cracking to concrete floor with exposed reinforcement**

Damage description: Cracking to concrete floor along the joint between original and extension area with exposed reinforcement.
