South New Brighton Beach Changing Shed

PRK 1351 BLDG 001

Detailed Engineering Evaluation

Quantitative Assessment Report

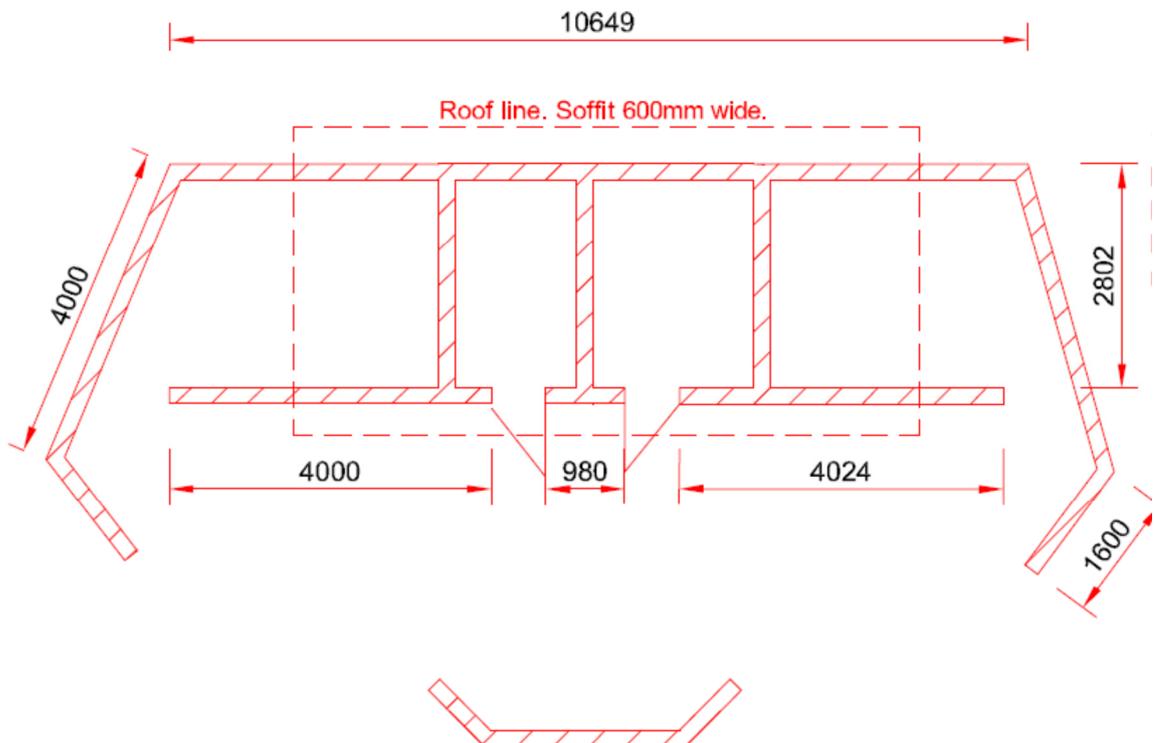
Figure 2: Wall plan of the toilets.

Lateral restraint of the building is provided by the shear capacity of the reinforced concrete masonry walls. According to the structural drawings found the walls are fully grouted and reinforced with D12 bars at 600mm centres each way. A cover meter survey conducted has confirmed these details.

There is no ceiling diaphragm and the roof is supported by 10 CHS sections bolted to the bond beam of the front and back walls (5 supports each side).

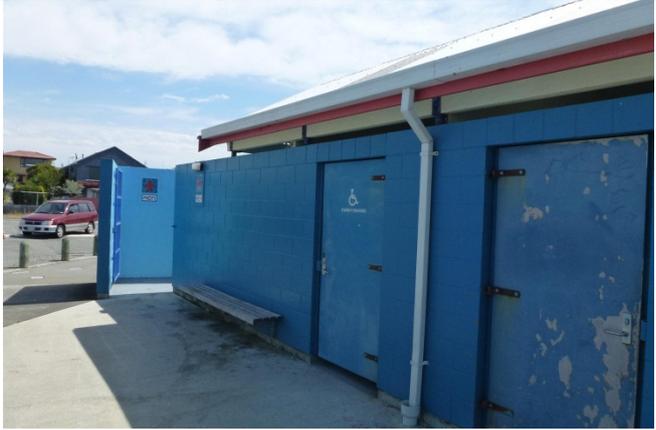
South New Brighton Beach Changing Shed		
No.	Item description	Photo
General		
1.	View of the male toilets

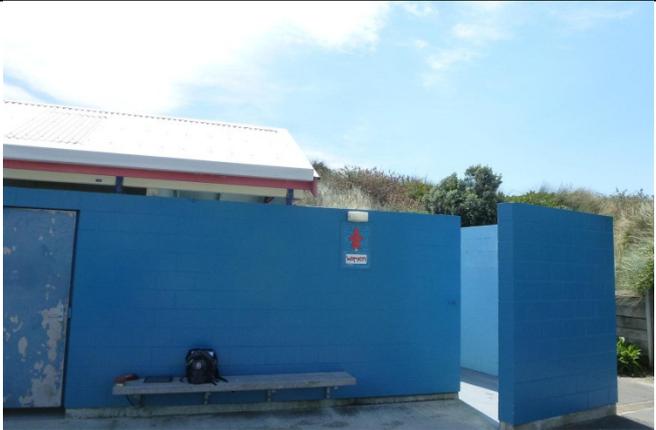
2.	View of the female toilets

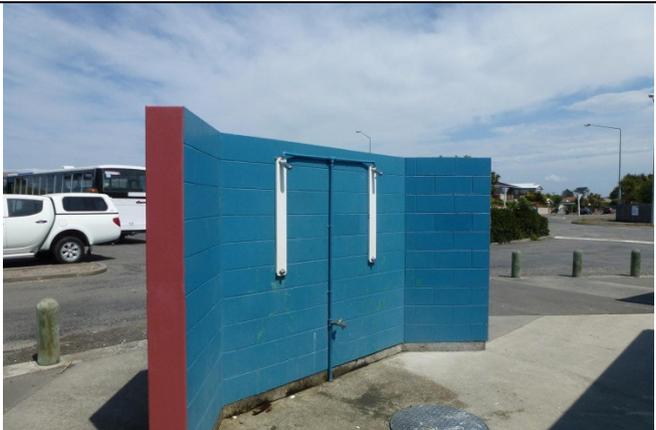
3.	View of the standalone shower wall

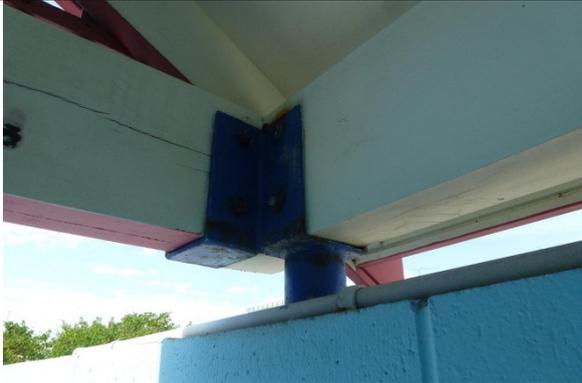
4.	Cracking of timber beam

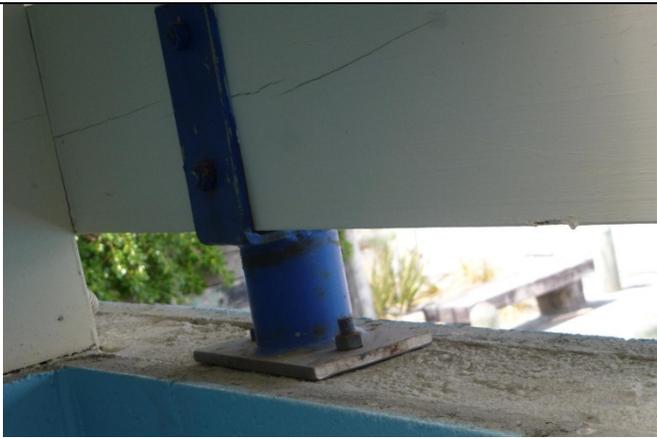
Impact damage to the masonry walls and rusting of steel connections was noted however this is not earthquake related damage.

5.	View of the roof connection to the walls

- The non-structural earthquake and impact damage be repaired.
- The maintenance issue of the rusted steel connections is considered by CCC in the future.

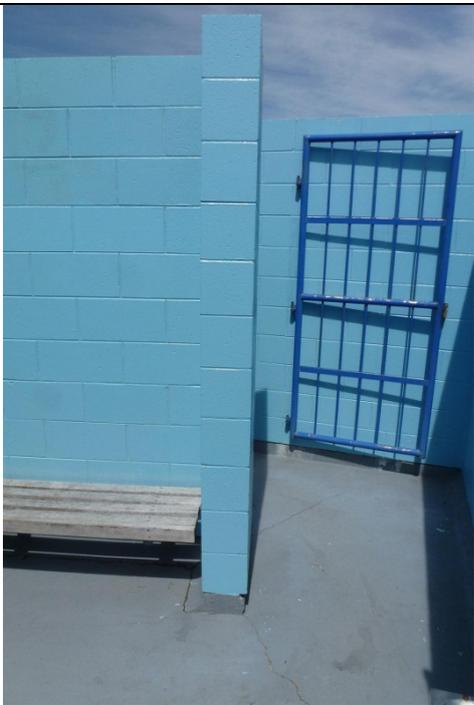
6.	Cracking at entrance

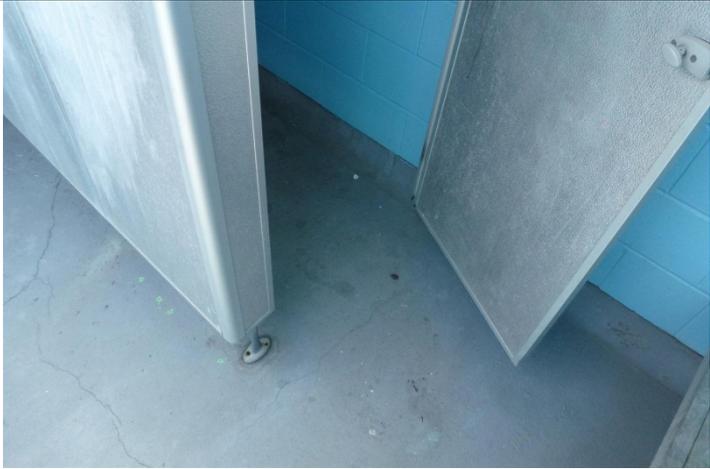
Cracking along mortar joints between internal walls in the changing area has been noted. There has been cracking of the concrete ground slab throughout the changing shed as well as separation between the masonry wall and concrete strip footing. This damage does not affect the structural capacity of the building.

7.	Cracking of concrete ground slab
