CHRISTCHURCH CITY COUNCIL
PRK_1360_BLDG_001 EQ2
Spit Reserve Toilet
217 Rocking Horse Road, Southshore

QUALITATIVE ASSESSMENT REPORT
FINAL

- Rev B
- 23 May 2013

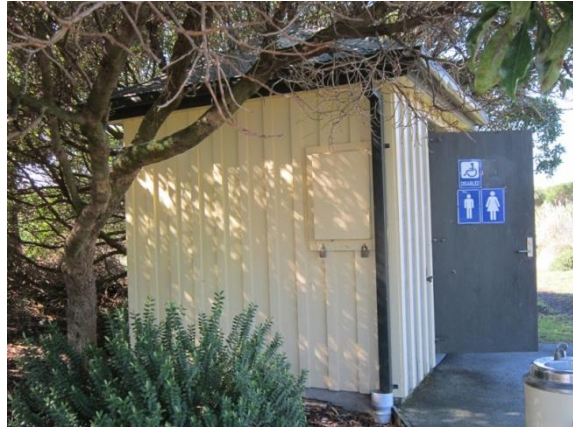
Photo 1: North elevation

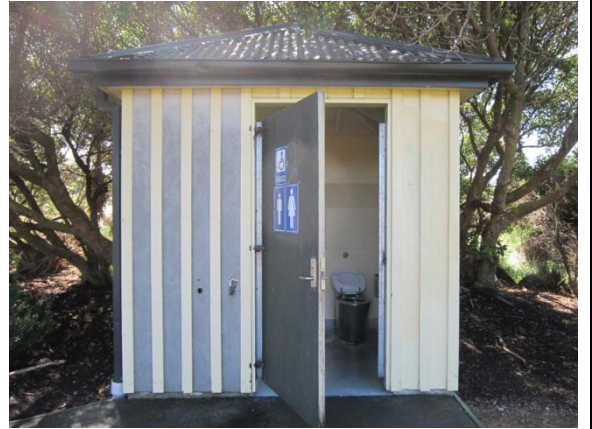
Photo 2: West elevation

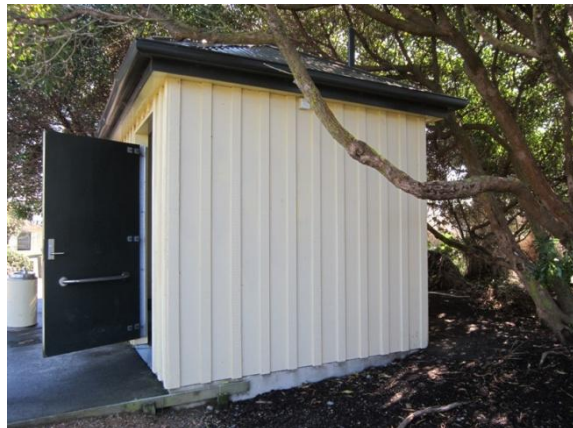
Photo 3: South elevation

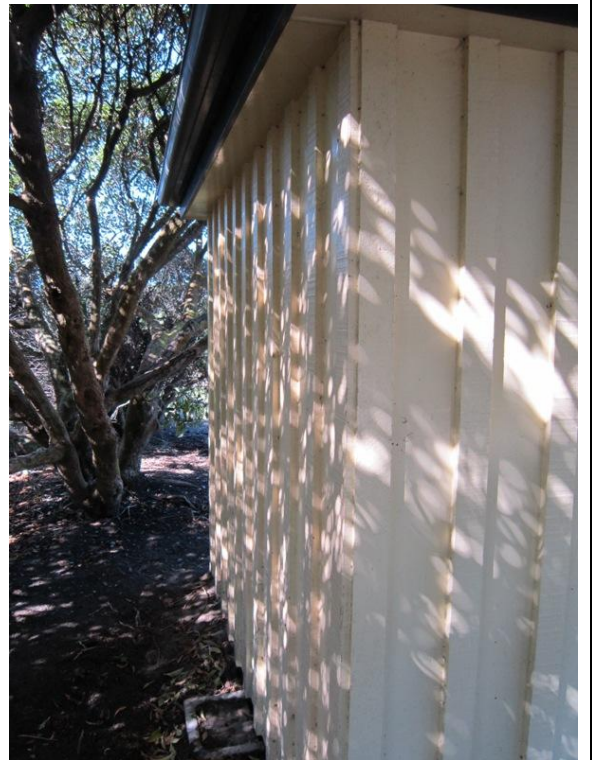
Photo 4: East elevation

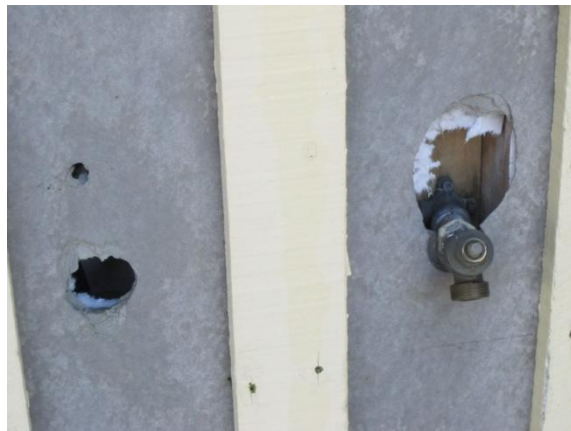
- 1) No earthquake-related damage was observed during our site inspection.
- 2) Holes in external wall cladding on the west side of the building. This is believed to be deliberate damage to install a tap and is not earthquake-related damage.
- 3) Gaps opening up between timber wall cladding elements. This is not believed to be earthquake-related damage.
- 4) Impact damage on gutter on the east side of the building. This is not believed to be earthquake-related damage.
- 5) Tearing of internal wall lining between the north and east walls. This is not believed to be earthquake-related damage.

Photo 5: Holes and tap in west wall

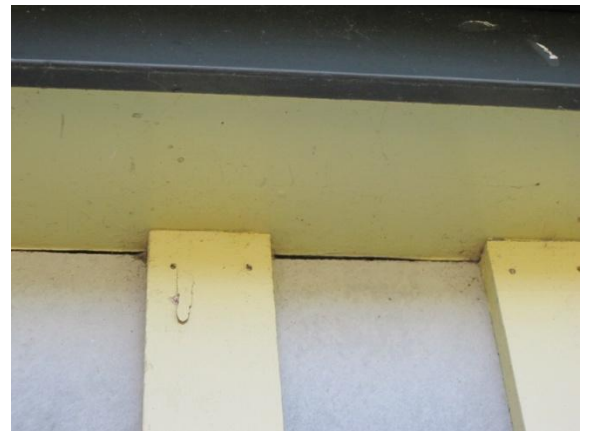
Photo 6: Gaps opening up between timber wall cladding elements

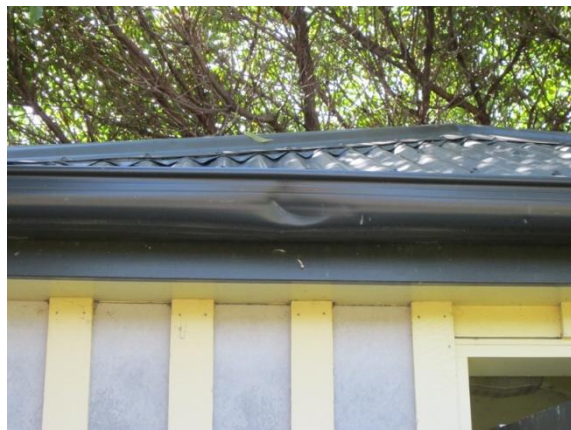
Photo 7: Impact damage on gutter on west side of building

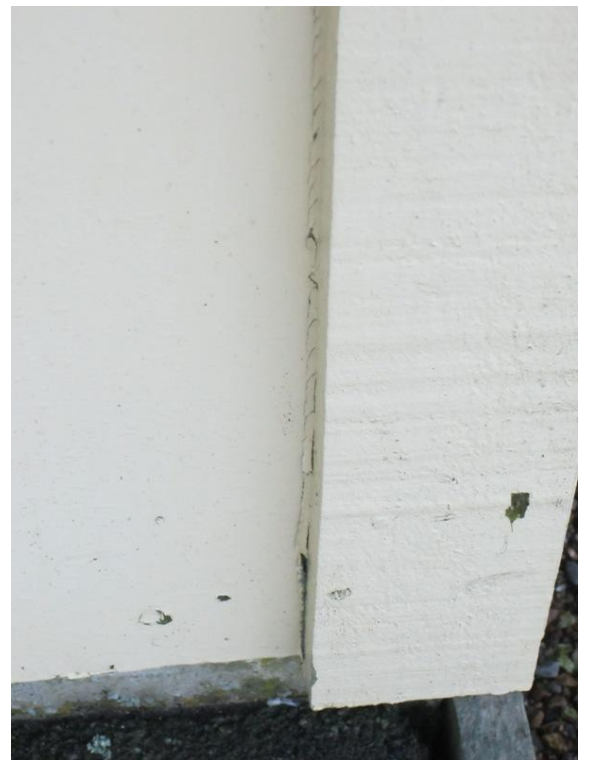
Photo 8: Gaps opening up between timber wall cladding elements

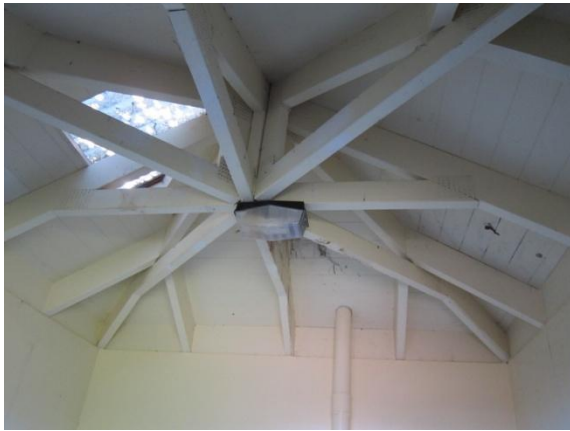
Photo 9: Timber framing in roof

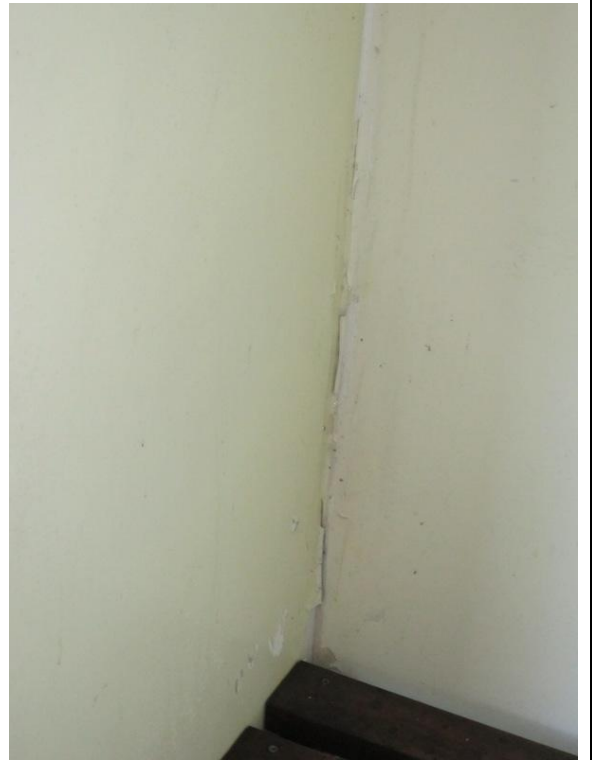
Photo 10: Tearing of internal wall lining

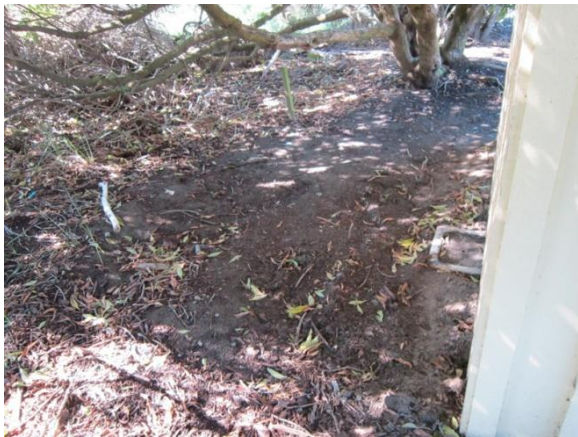
Photo 11: Soil ejecta east of building

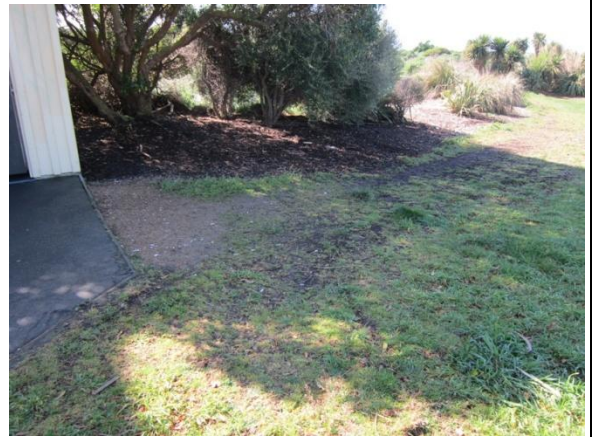
Photo 12: Cracking in the corner of the asphalt west of the building
