Spencer Park – Amenity Building

Qualitative Engineering Evaluation

Functional Location ID: PRO\_0157\_B009

Address: 100 Heyders Road, Spencerville

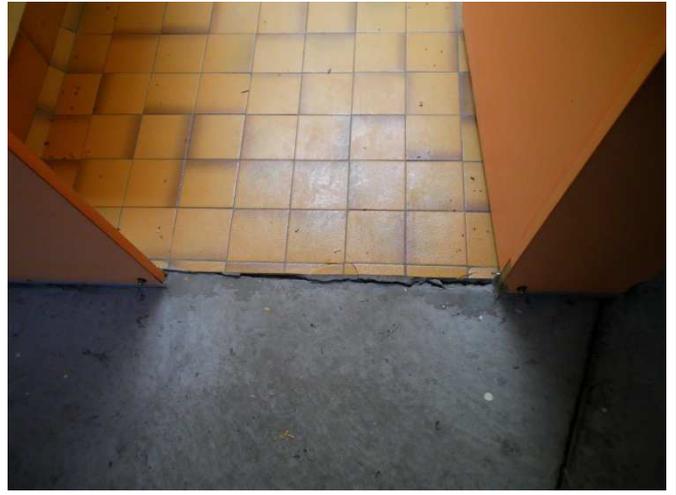
Plan view of the crack in the concrete floor – approximately 1.5 mm wide.

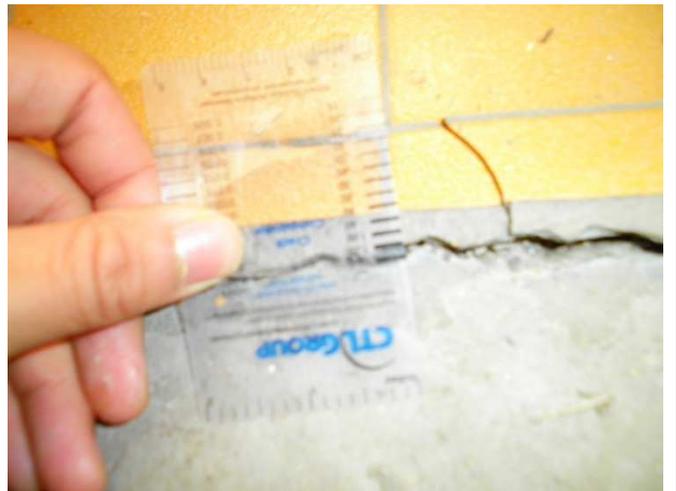
Side view of the crack in the concrete floor.

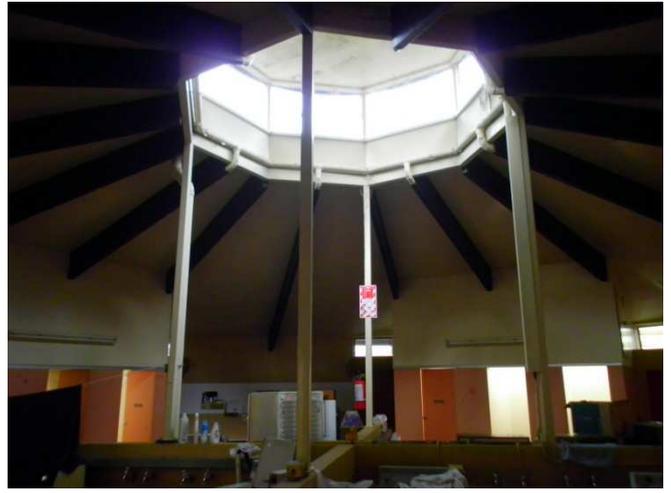
Steel square hollow sections are founded on waist-high concrete masonry walls.

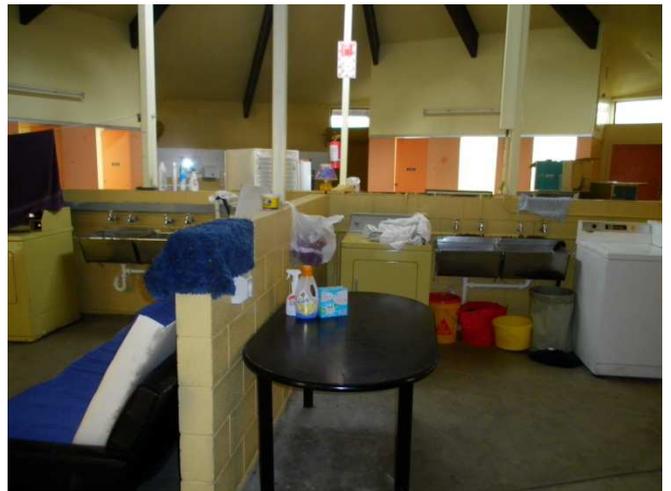
Cracking in the interior roof linings.

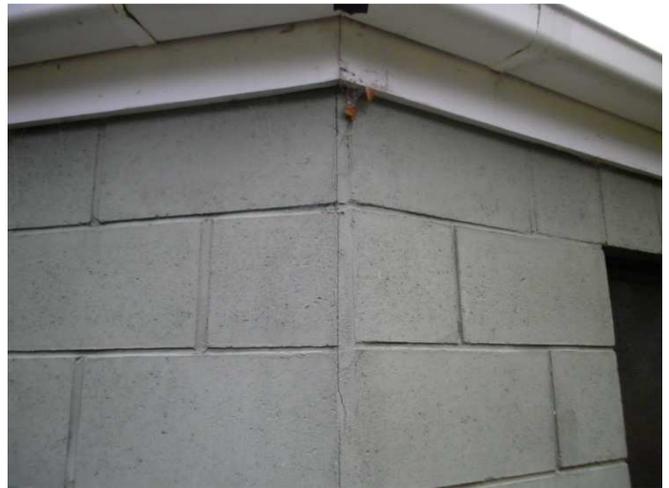
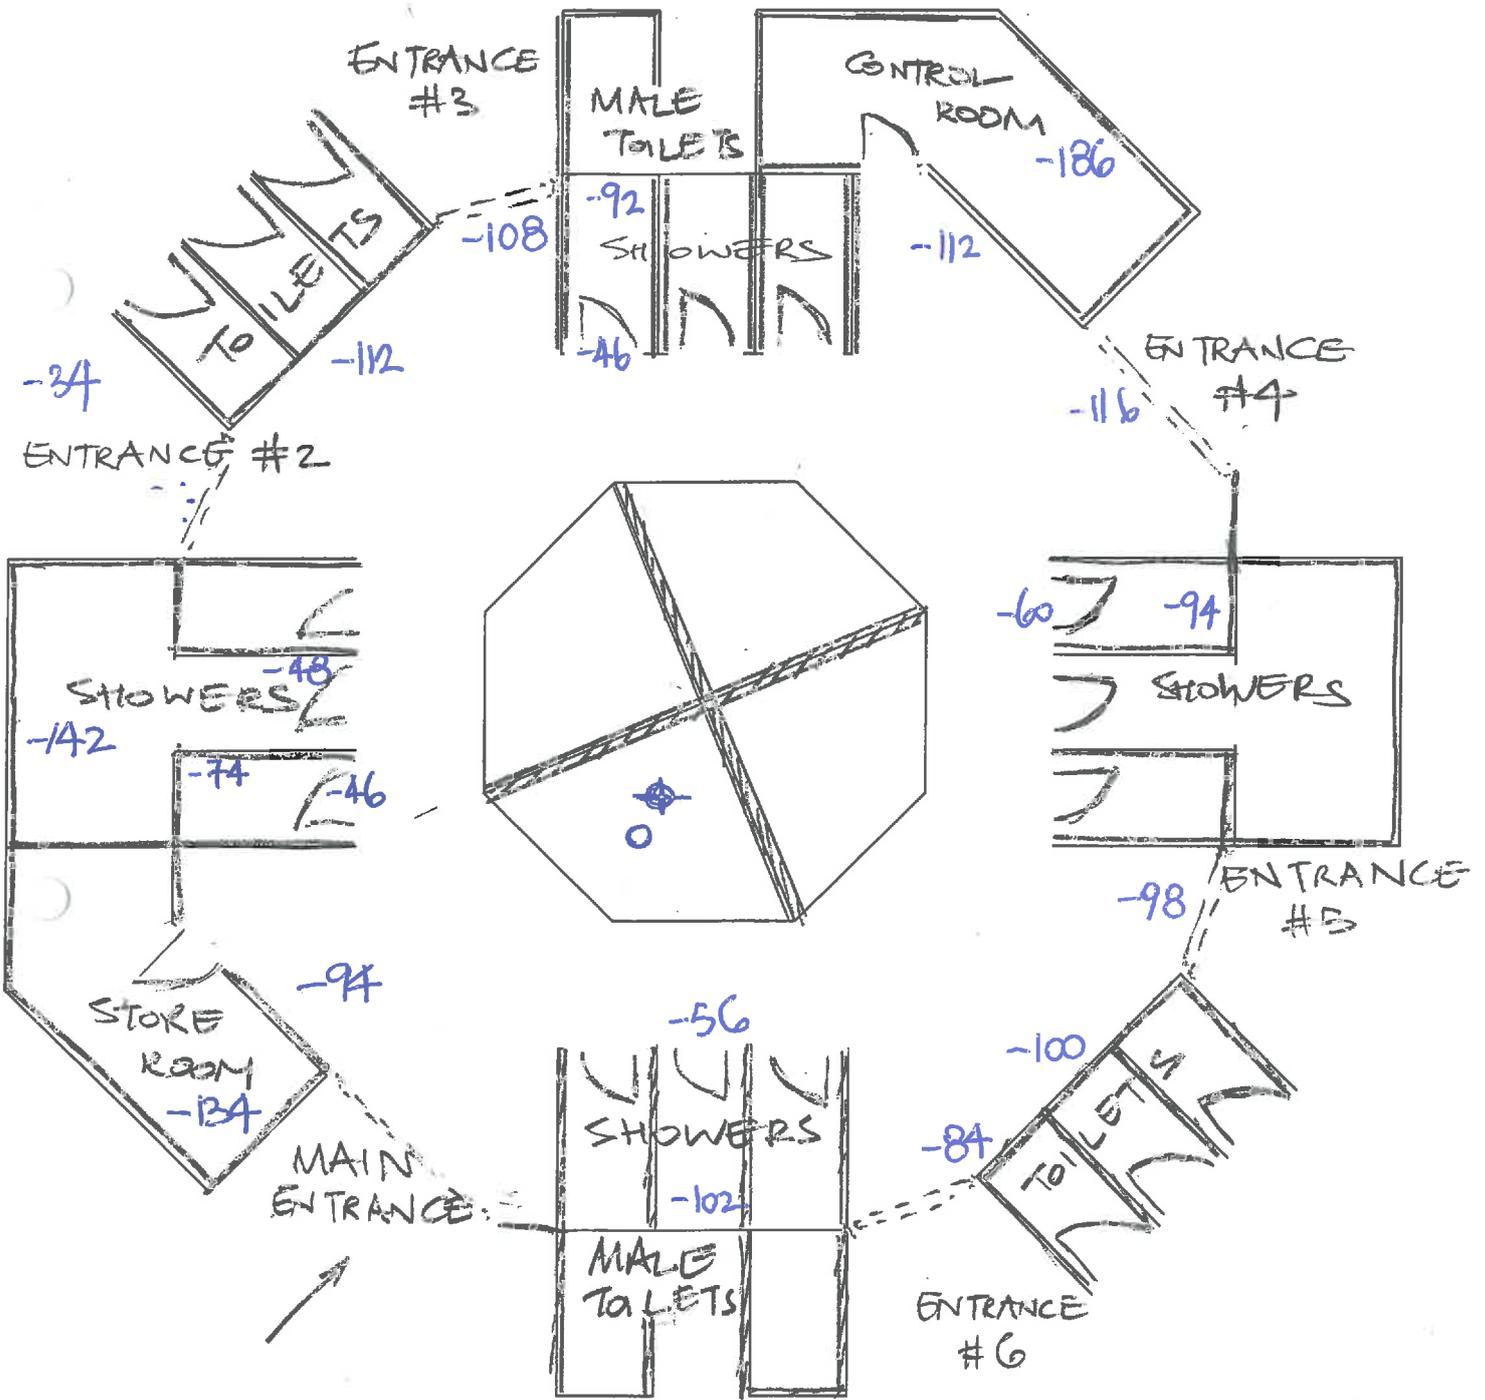
Client: CHCH CITY COUNCIL	Date: 5-6-12
Project/Job: S.P.C.G. OCTAGON	Job No: 228604
Subject: LEVELS SURVEY RESULTS (SKETCH)	Sheet No: A By: CB

A levels survey was undertaken on the building to quantify the level of post-construction subsidence. With allowance for falls to wet areas there was no indication of earthquake induced differential settlement outside acceptable limits.
