Spencer Park Camping Ground
Homestead
Qualitative Engineering Evaluation

Reference: 228606
Prepared for:
Christchurch City Council

Functional Location ID: PRO 0157 B019

Date: 3 July 2013

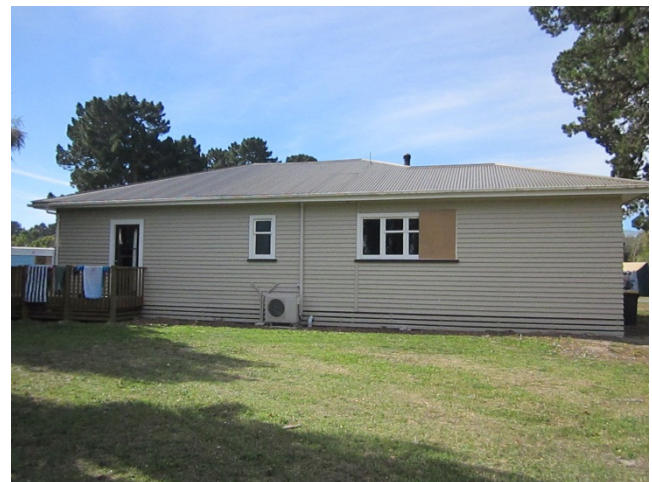
Eastern elevation of the Homestead.

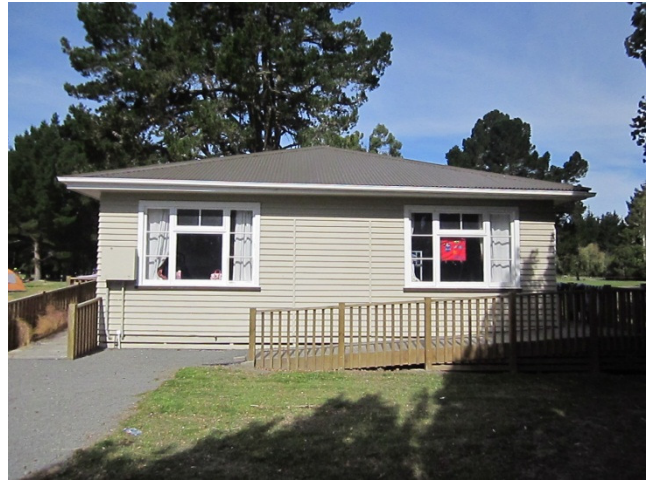
Northern elevation of the Homestead.

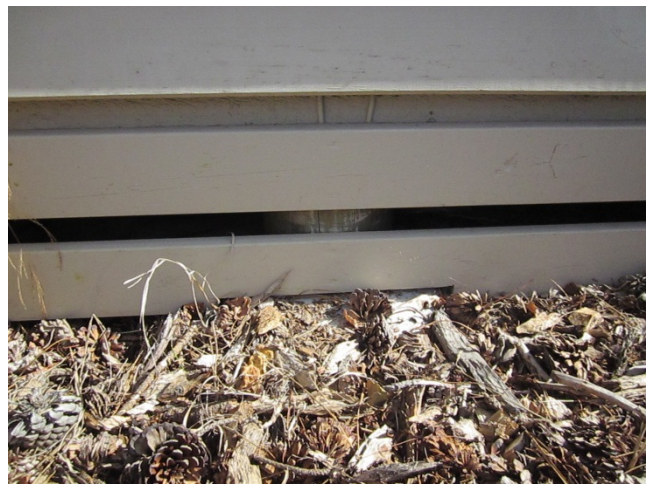
Timber bearer founded on a timber pole foundation typical around the perimeter.

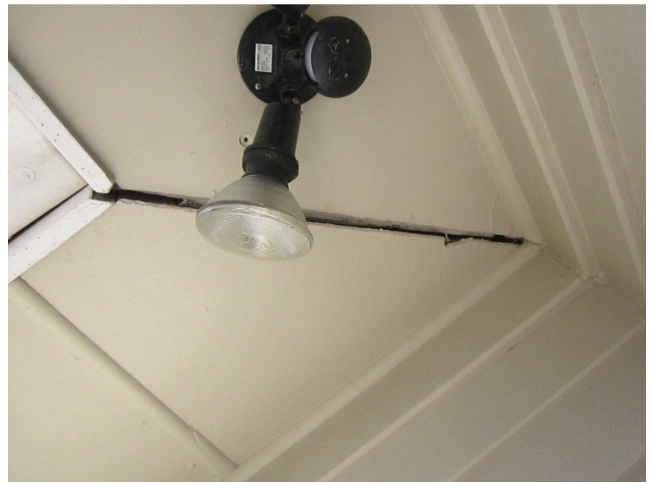
- Splitting in the gypsum plasterboard wall in the North Western corner; and
- Opening of gaps in the gypsum plasterboard ceiling linings.

Opening of the joints between the soffit board.

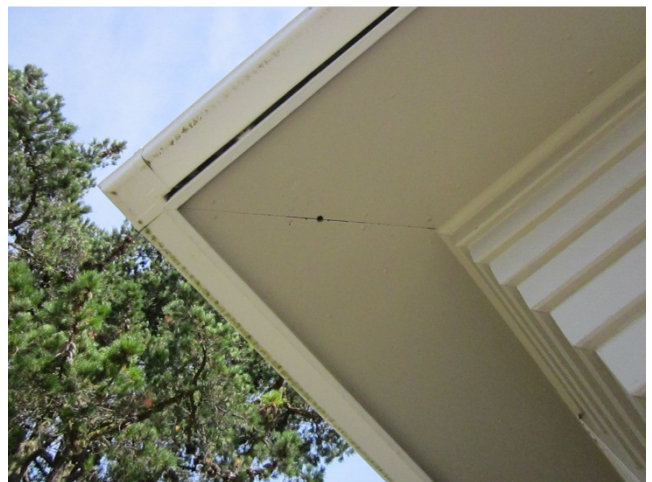
Opening of the joints between the soffit board.

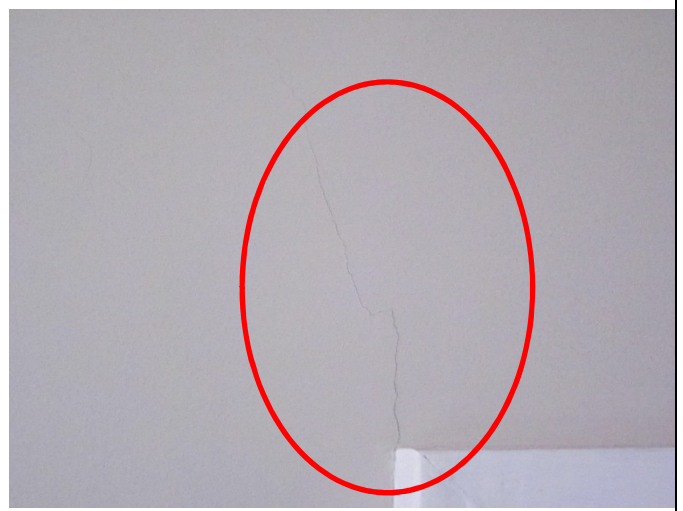
Cracking in the plasterboard above the door lintel in the North Western corner of the homestead.

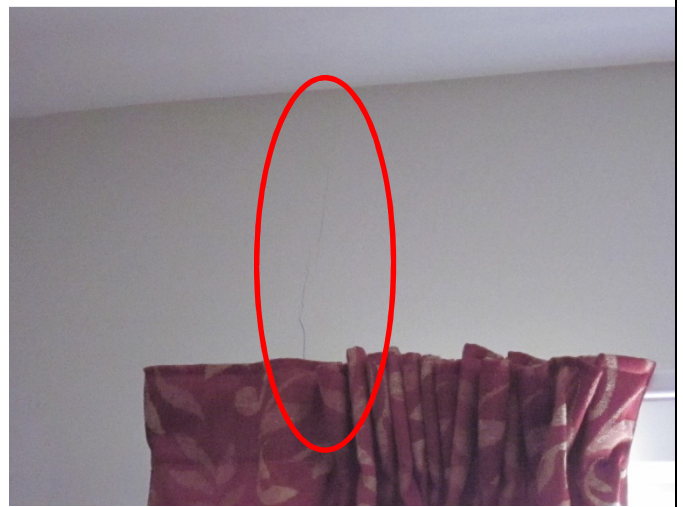
Cracking in the plasterboard above the door lintel in the North Western corner of the homestead.

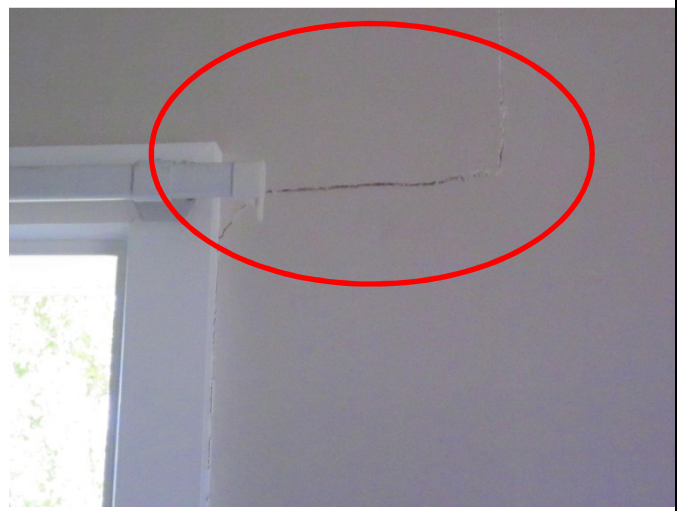
Cracking in the plasterboard above the door lintel in the North Western corner of the homestead.

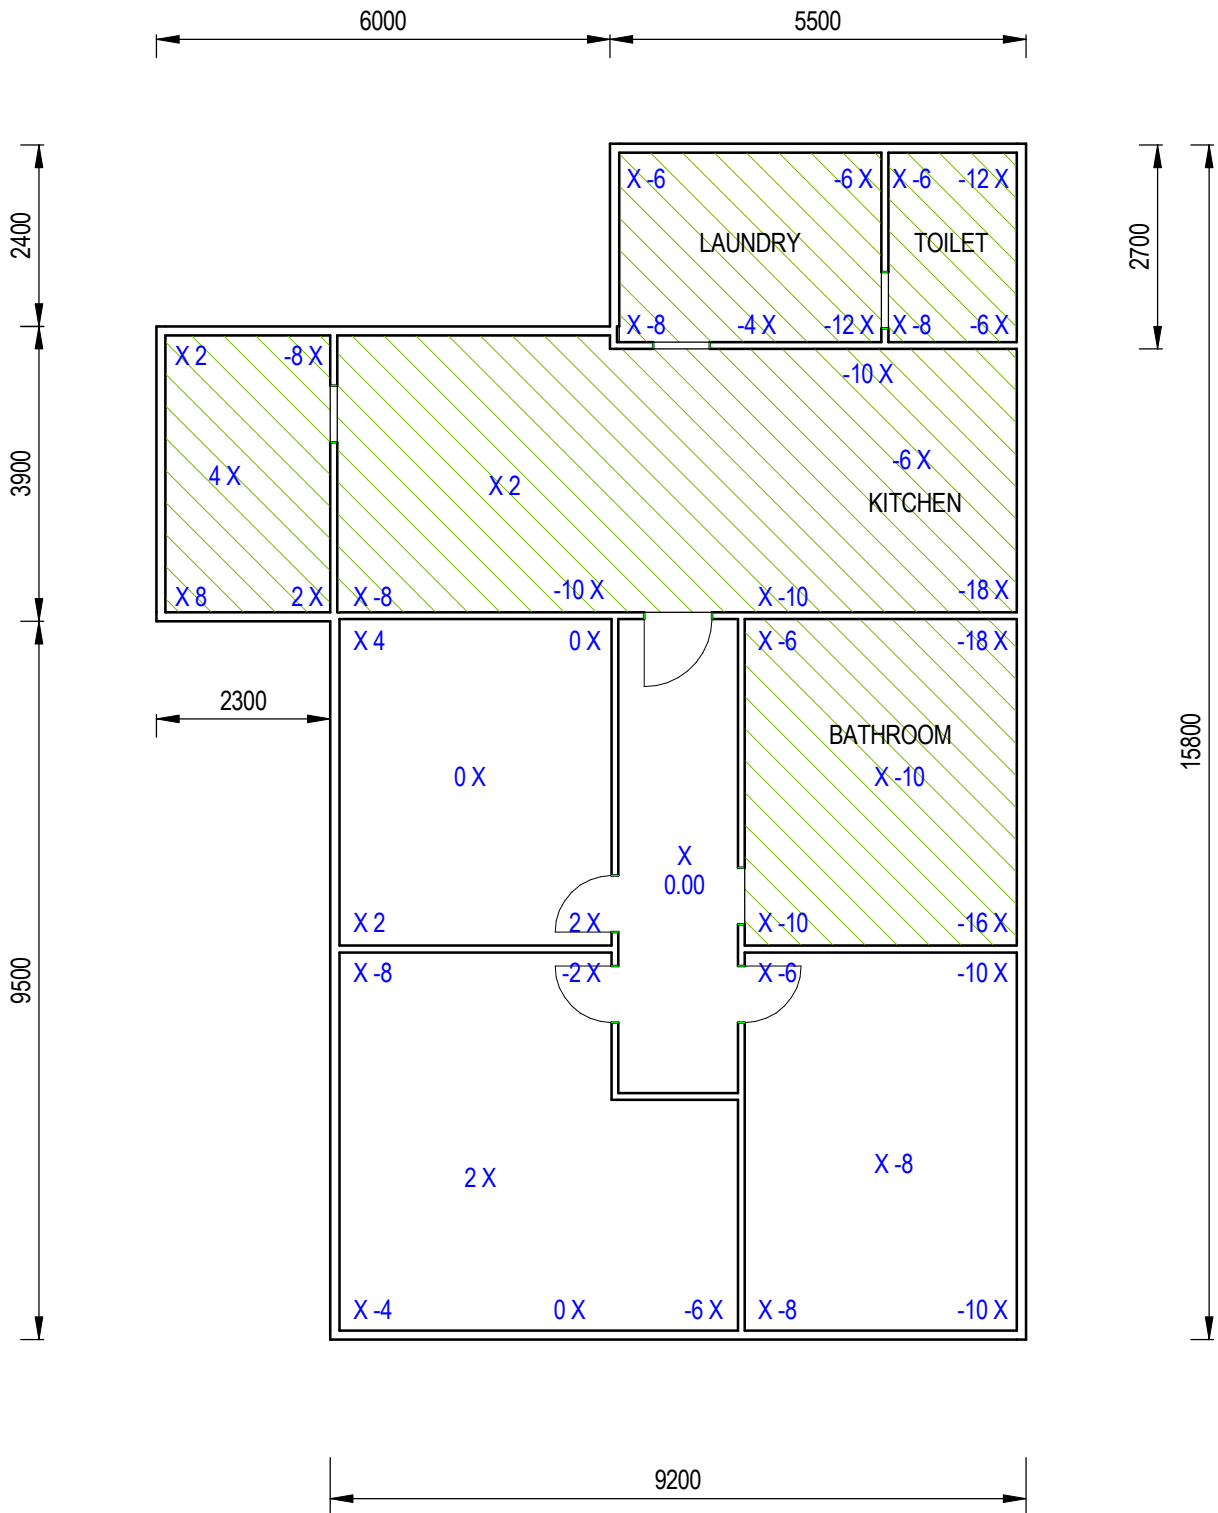
PROJECT
100 HEYDERS ROAD SPENCERVILLE
TITLE
HOMESTEAD LEVEL SURVEY

A levels survey was undertaken on the floor coverings of the building to quantify the level of any unevenness. The levels survey results were within the 1 in 200 or 0.5% slope threshold set by the Department of Building and Housing’s November 2011 Guidelines. Therefore no further action in the form of re-levelling is considered necessary.
