Spencer Park Camping Ground
Workshop
Qualitative Engineering Evaluation

Reference: 228609
Prepared for:
Christchurch City Council

Functional Location ID: PRO 0157 011

Address: 100 Heyders Road, Spencerville

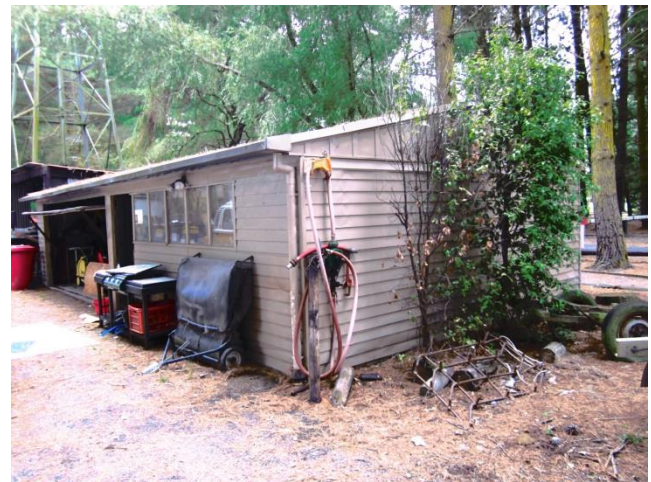
South Eastern elevation of the Spencer Park Camping Ground Workshop.

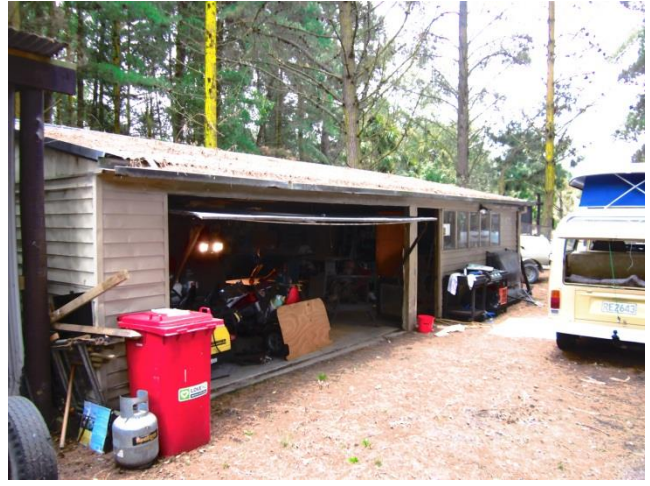
North Western elevation of the Spencer Park Camping Ground Workshop.

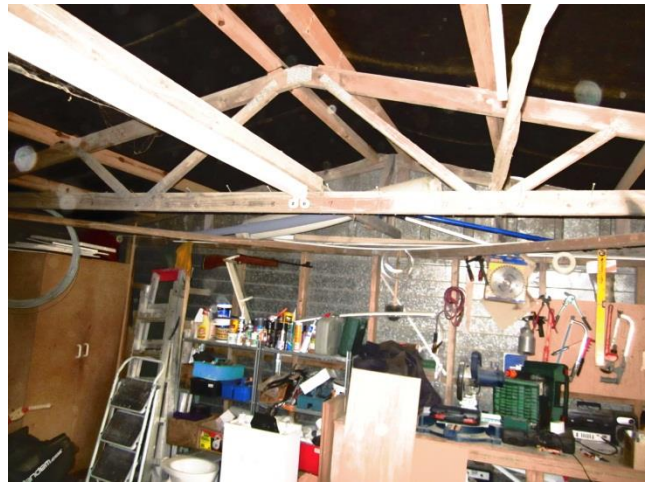
Timber purlins above the pre-nailed trusses.

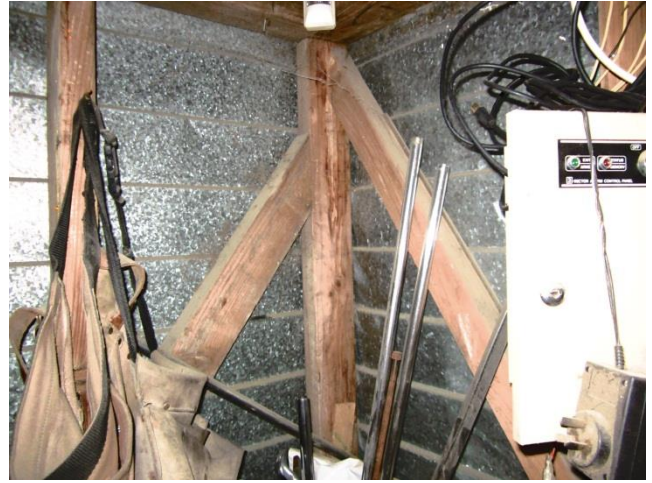
Equipment within the workshop with the primary structure in the background.

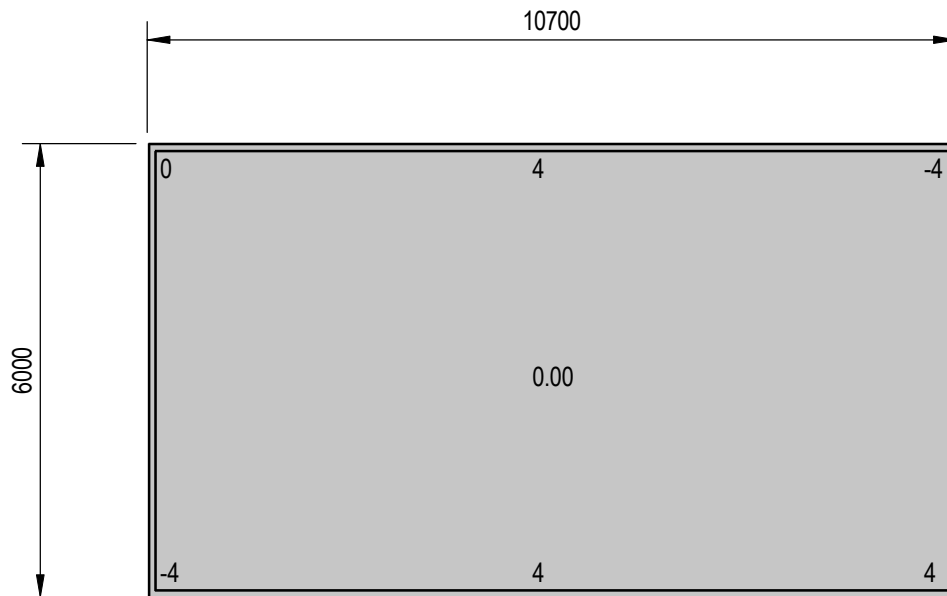
GROUND LEVEL FLOOR LEVELS PLAN

A levels survey was undertaken on the floor of the building to quantify the level of unevenness. The levels survey results were within the 1 in 200 or 0.5% slope threshold set by the Department of Building and Housing’s November 2011 Guidelines. Therefore no further action in the form of re-leveling is considered necessary.
