Spencer Park Fuel Shed  
Qualitative Engineering Evaluation

**Reference:** 228891

**Prepared for:**  
Christchurch City  
Council

**Date:** 2 October 2012

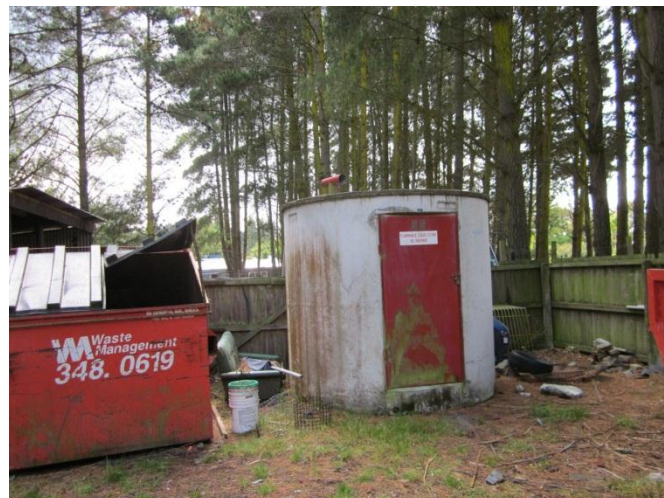
The Spencer Park Fuel Shed was in use at the time the damage assessment was carried out. The Spencer Park Fuel Shed has performed well and no damage was noted to the structure.

General view of the Fuel Shed
