Spencer Park Paddling Pool Tank  
Qualitative Engineering Evaluation

**Reference:** 228895  
**Prepared for:**  
Christchurch City  
Council

Functional Location ID: PRO 0157 BLDG 022

**Revision:** 2  
**Date:** 27 June 2013

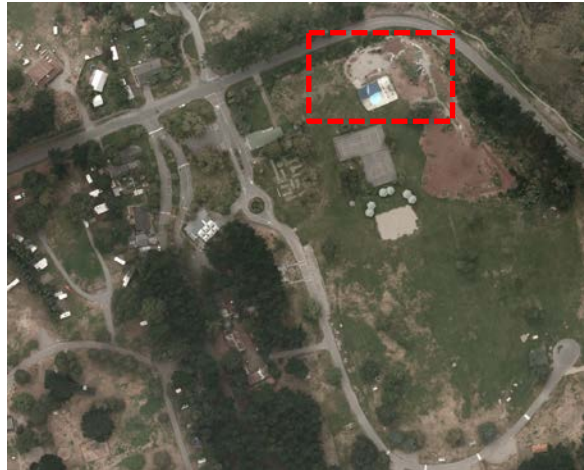
Aerial photograph of the Spencer Park site.

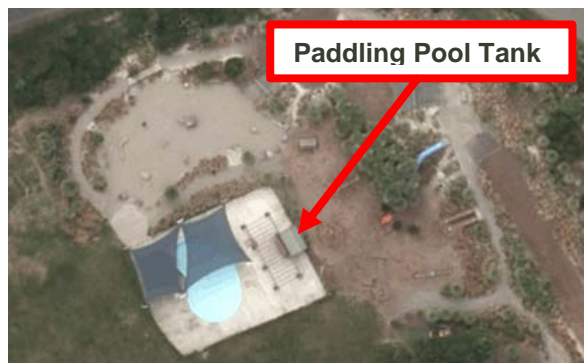
Location of the paddling pool tank.

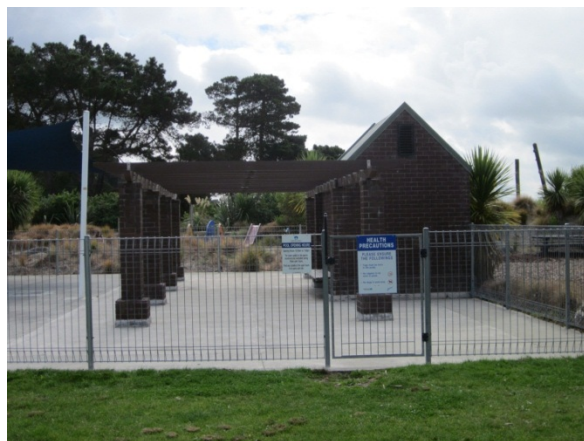
Building southern elevation.

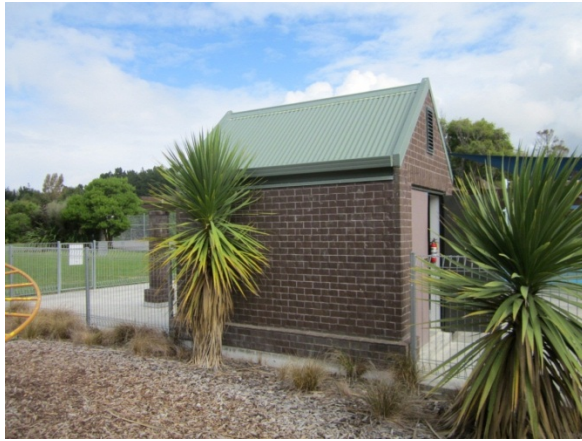
Building eastern elevation.

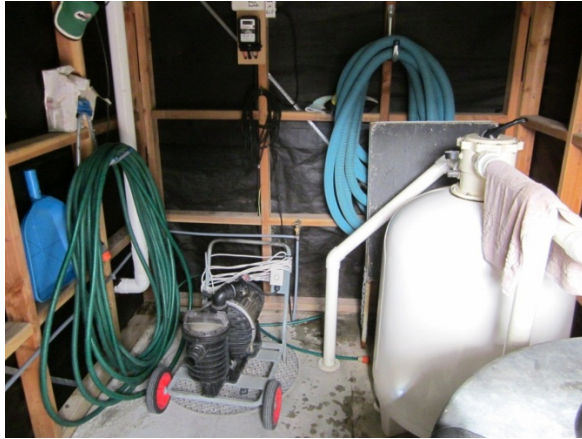
Building internal view.

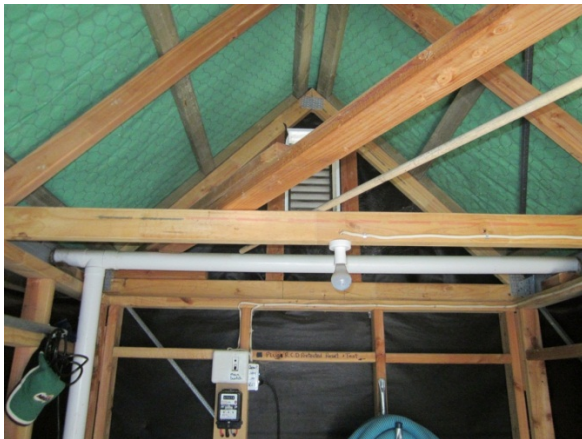
Building internal view.
