Spencer Park Pavilion  
Qualitative Engineering Evaluation

**Reference:** 228896

**Prepared for:**  
Christchurch City  
Council

**Date:** 28 June 2013

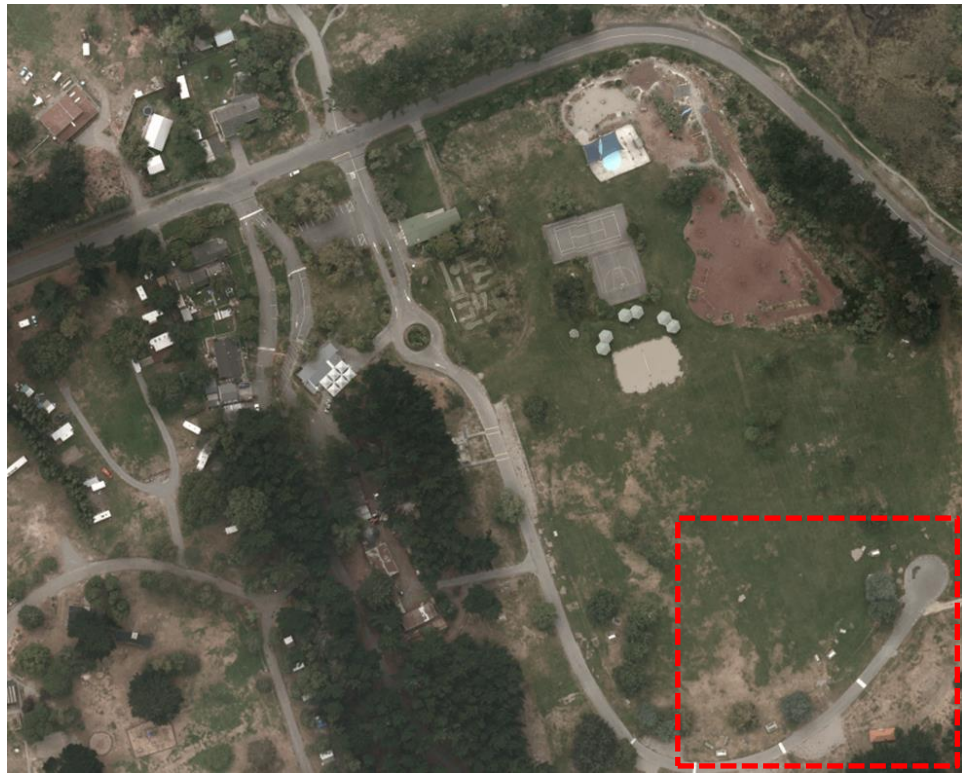
General view of  
Spencer Park site

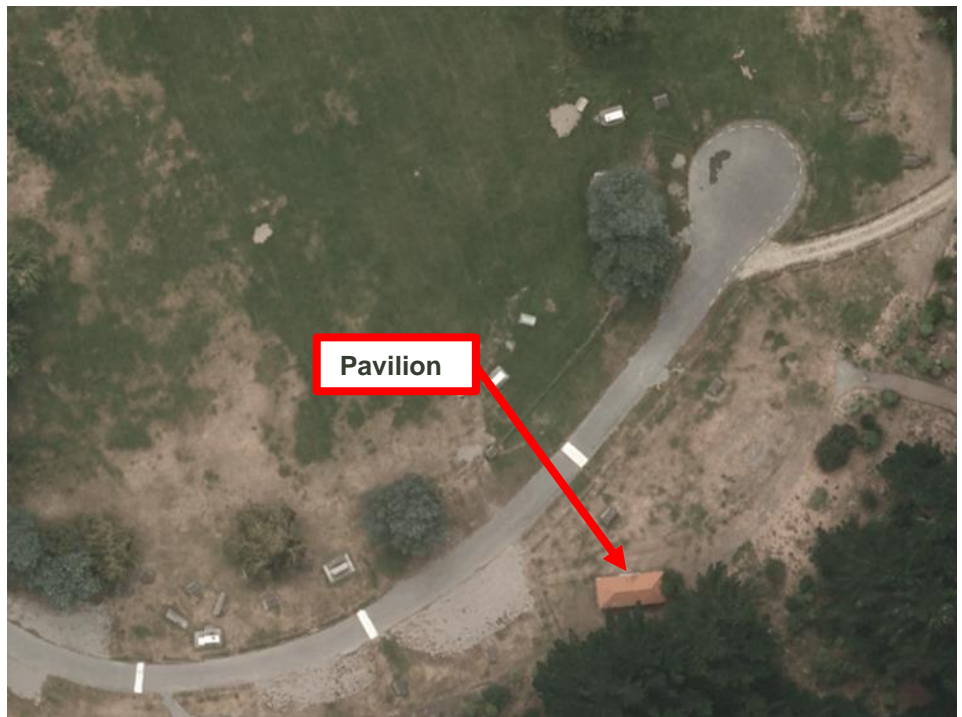
Location of  
Pavilion

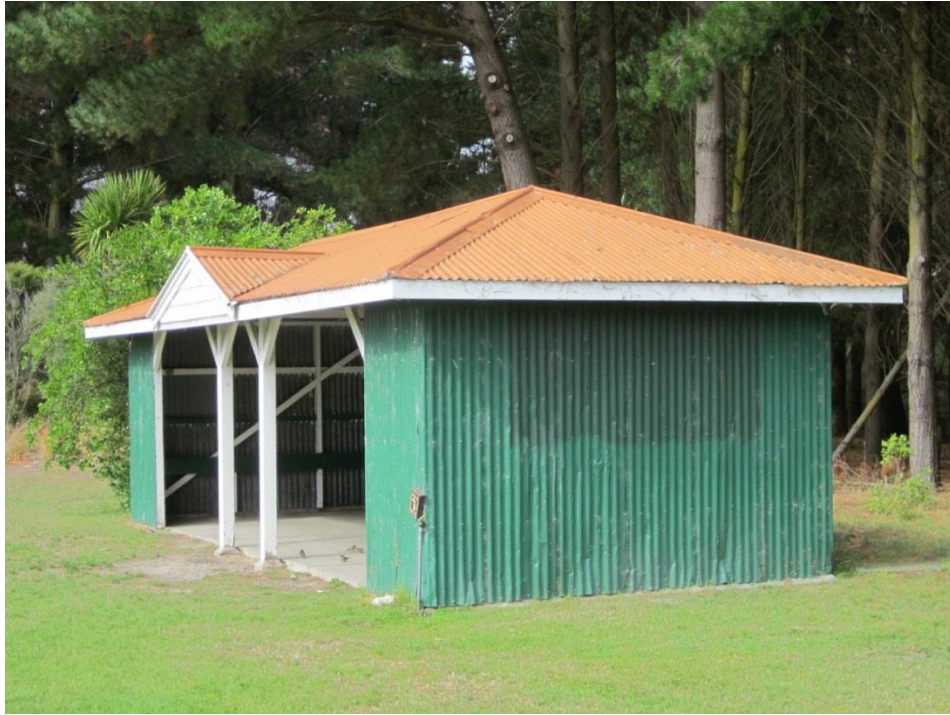
Building northern elevation

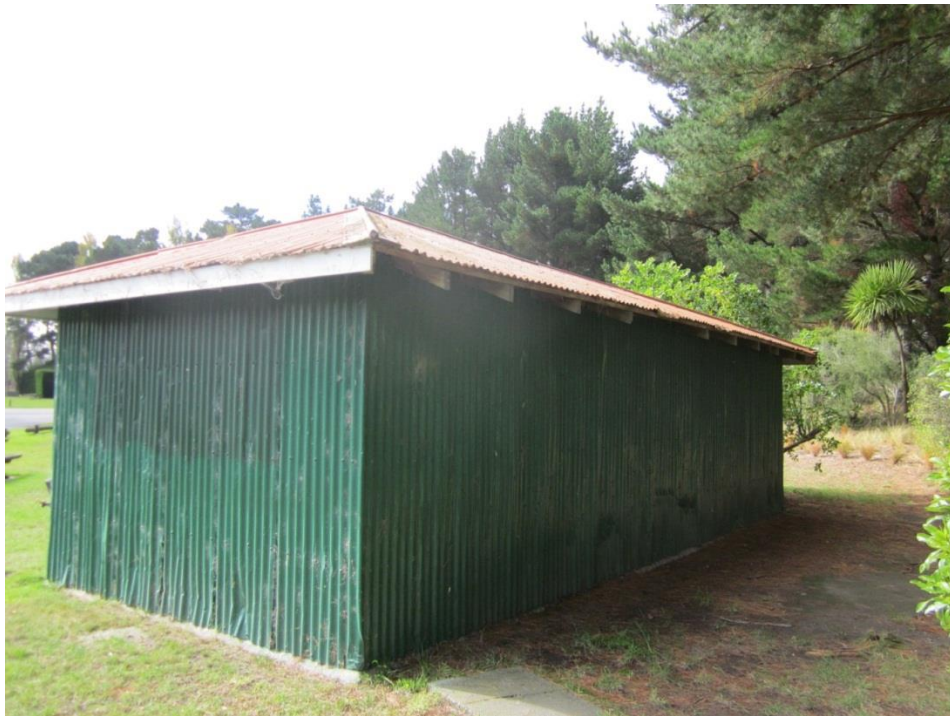
Building southern elevation

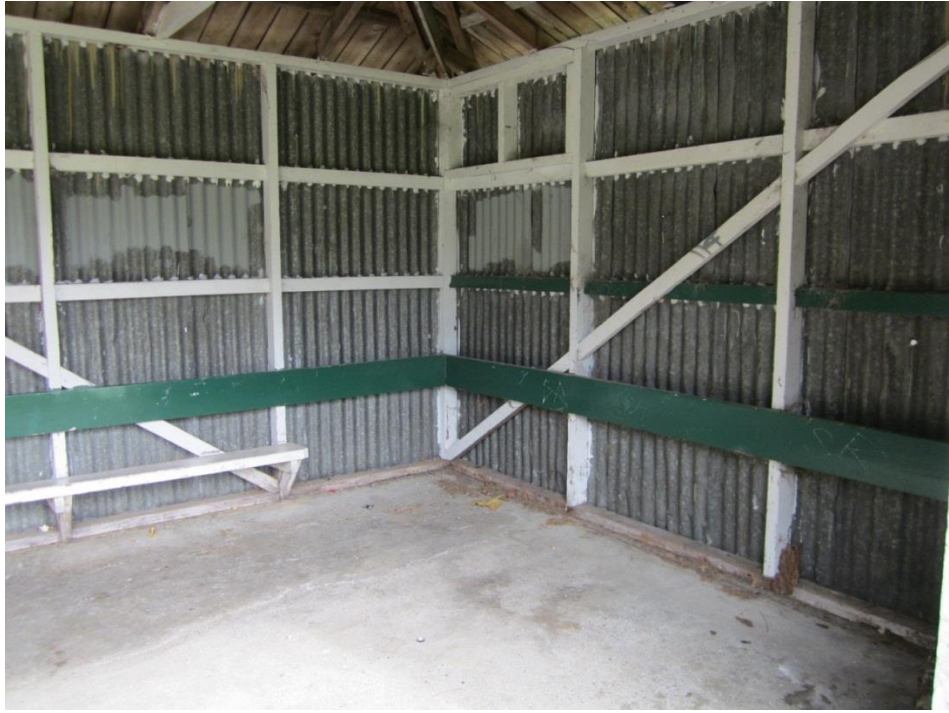
Internal view of the Pavilion

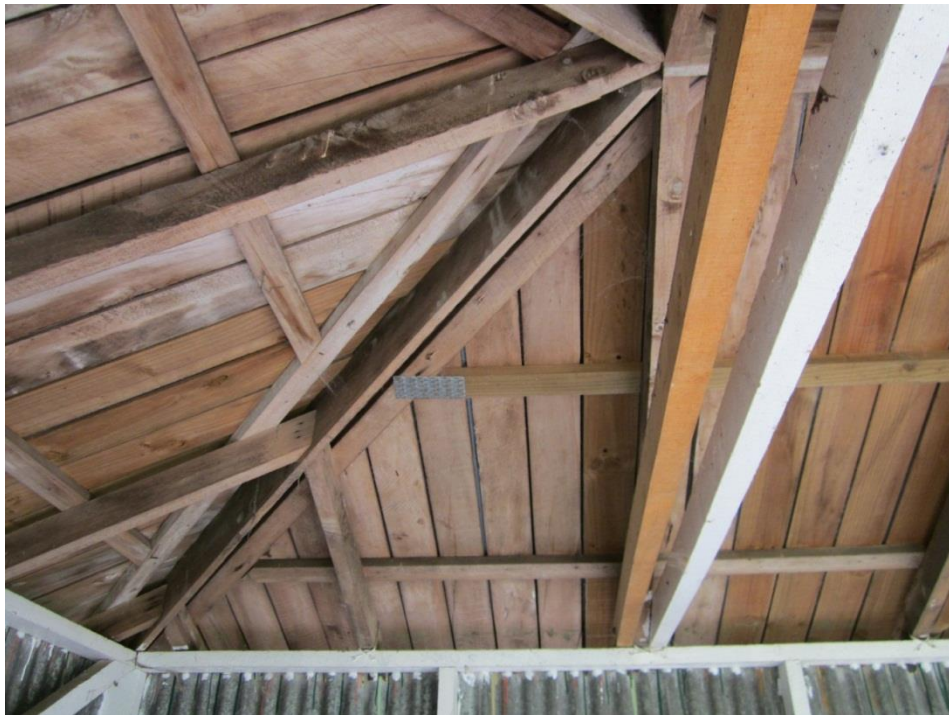
Internal view of the Pavilion
