Spreydon Domain - Equipment  
Shed and Changing Room  
Qualitative Engineering Evaluation

**Reference:** 229618  
**Prepared for:**  
Christchurch City Council

Address: 33 Domain Terrace, Spreydon

**Revision:** 2  
**Date:** 17 October 2013

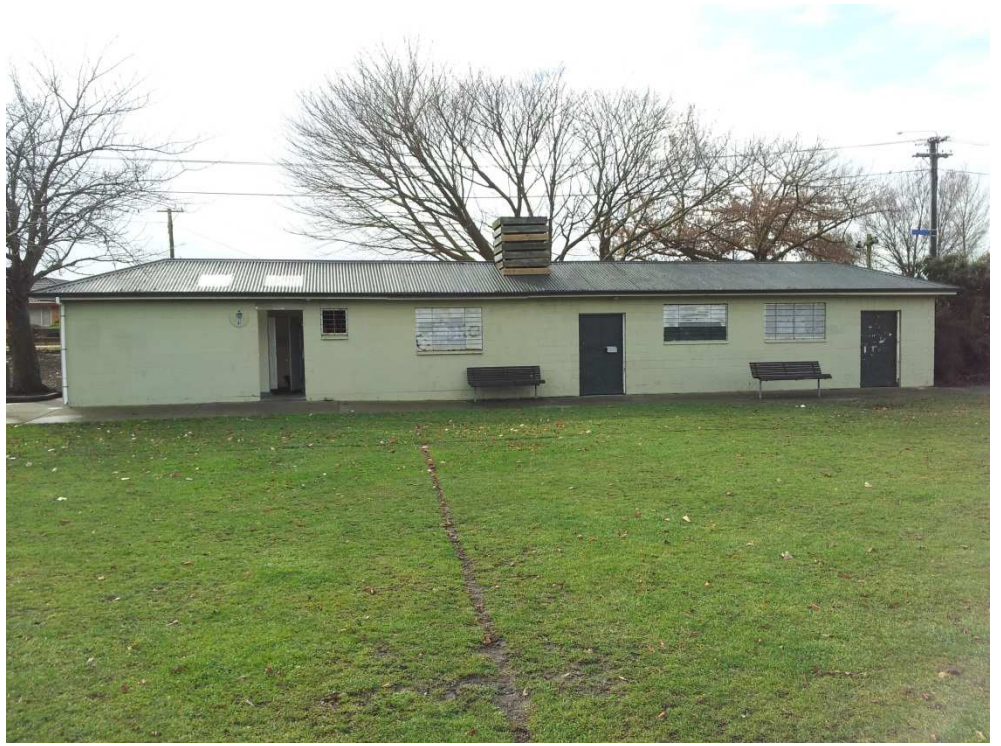
Building southern elevation.

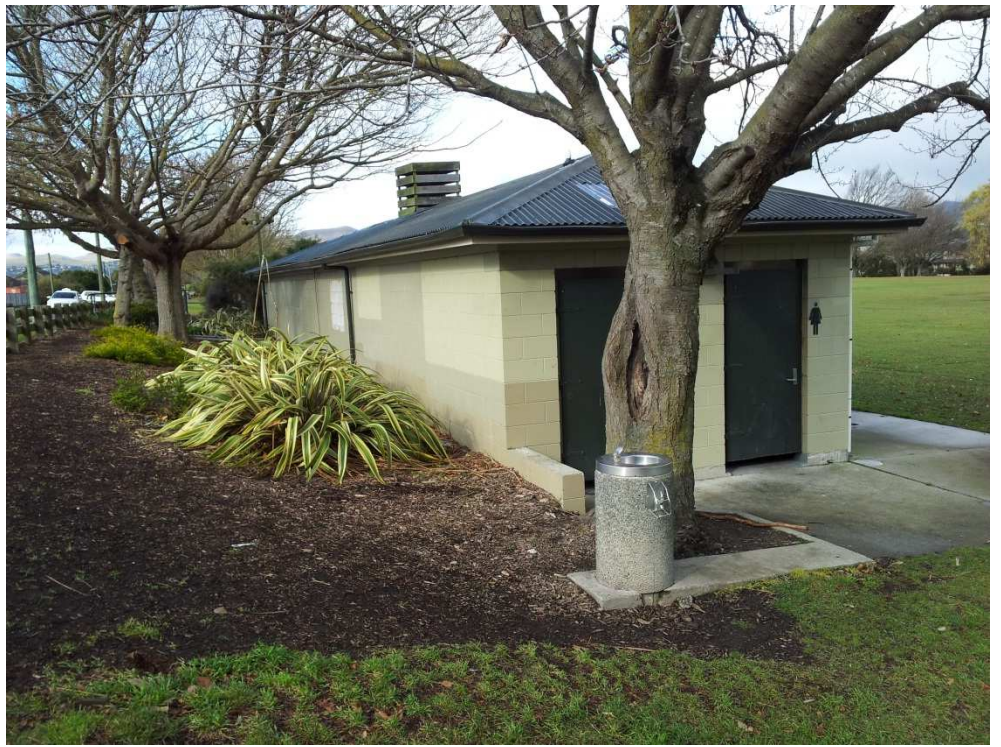
Building western elevation.

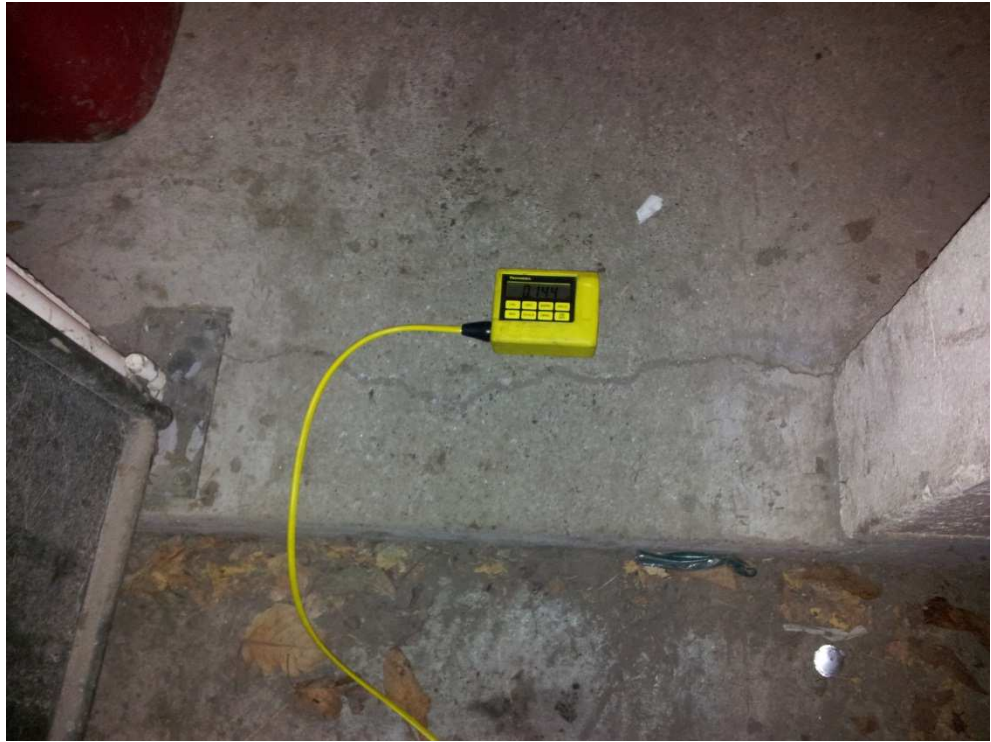
The Spreydon Domain - Equipment Shed and Changing Room is currently in use and was occupied at the time the damage assessment was carried out. The Spreydon Domain - Equipment Shed and Changing Room has performed well but has suffered minor damage to the floor and walls (see attached photographs). The floor has minor cracks running through it and the block-work wall has several minor cracks running along the mortar.

Crack in foundation slab.

Cracking to the floor slab and concrete blockwork walls should be repaired by epoxy grout injection.

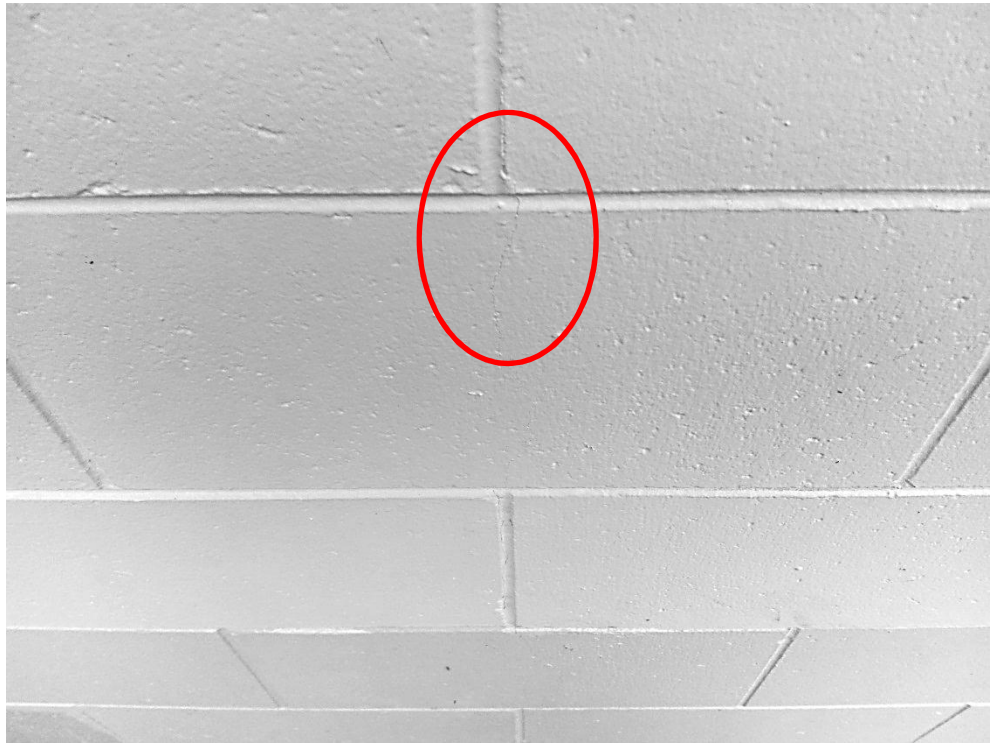
Minor cracking to block-work.

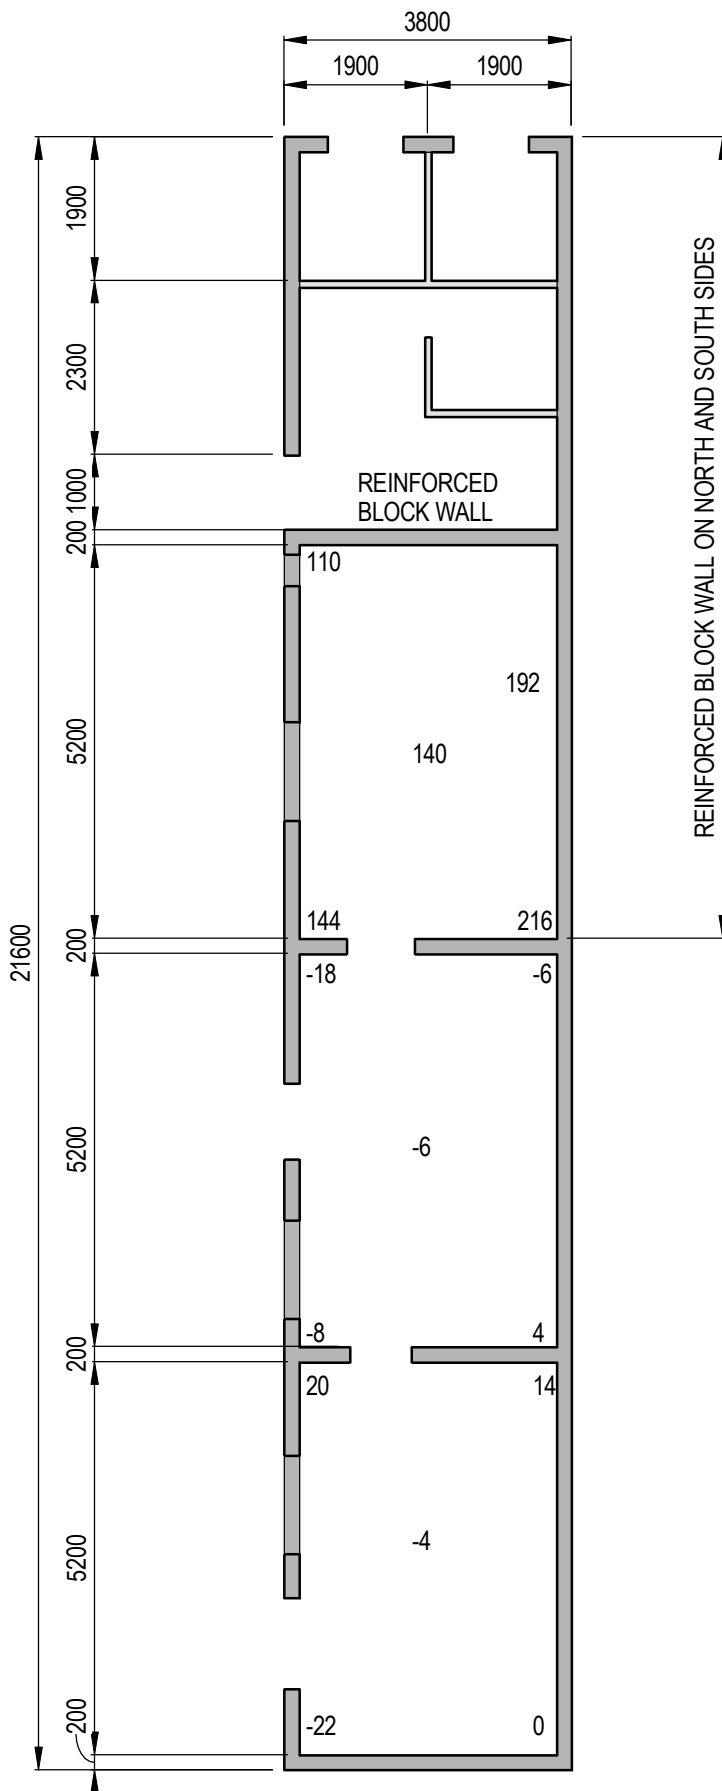
# FLOOR LEVELS PLAN

The floor levels for the Spreydon Domain - Equipment Shed and Changing Room were found to be outside the recommended tolerances, although the slopes would be required for drainage purposes and therefore do not represent foundation damage.
