Christchurch City Council
BU 0626-001 EQ2
St Albans Crèche
3 Thames St

QUANTITATIVE ASSESSMENT REPORT
FINAL

- Rev B
- 14 December 2012

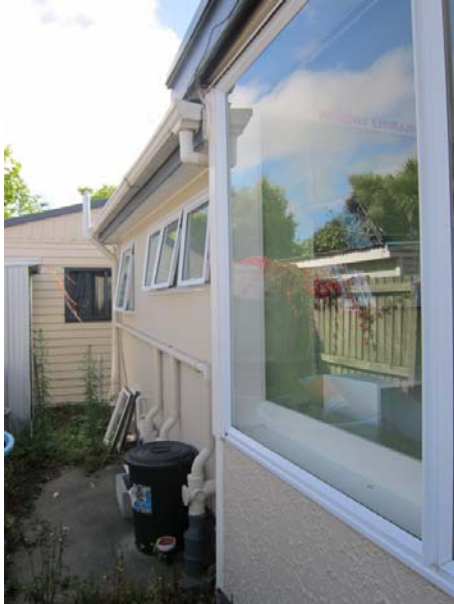
Photo 5: West side looking North along Creche to offices

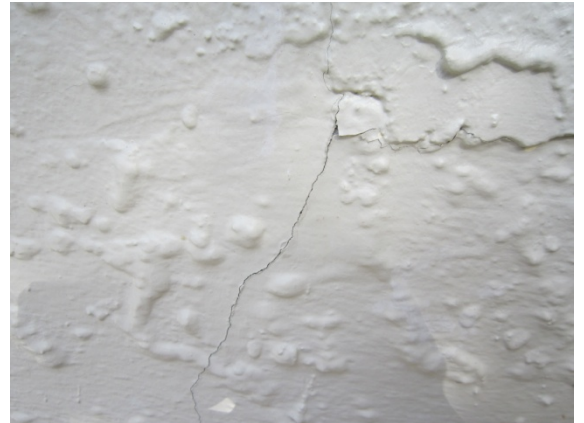
- 1) Cracking/ spalling to the foundation perimeter ring beam typically at building corners or ventilation points approx 1mm cracking photo 18 and >2mm cracking photo 16. Refer to Photo 13, Photo 14, Photo 15, Photo 16, Photo 17, Photo 18, Photo 19, Photo 20.
- 2) Vertical cracking $\leq 0.3\text{mm}$ to the exterior stucco, typical at the points where external and internal framing meet. Refer to Photo 6, Photo 7, Photo 8, Photo 9, Photo 10, Photo 11, Photo 12, Photo 21, Photo 23, Photo 24.

Photo 6: Typical cracking in stucco cladding, approx 0.5mm or less

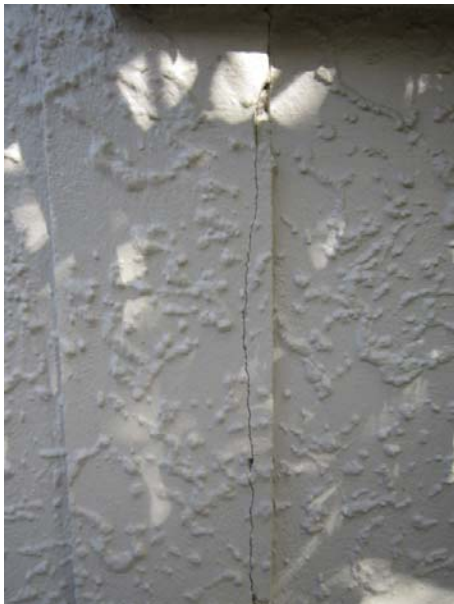
Photo 7: One of the larger exterior cladding cracks

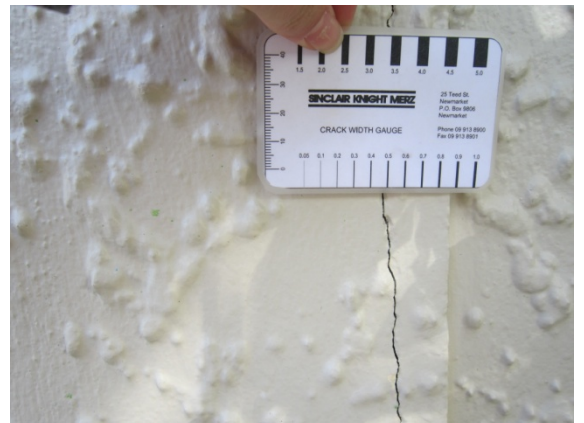
Photo 8: Approximately 0.6mm

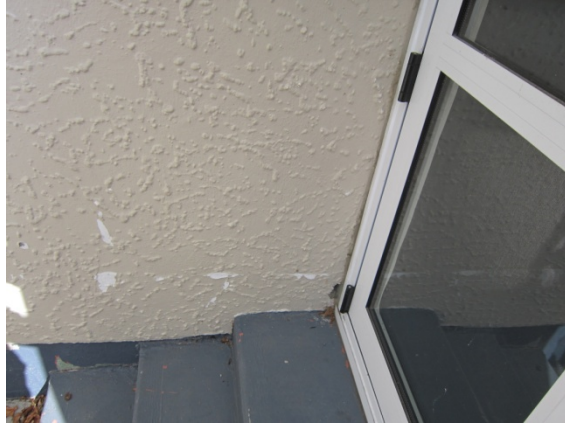
Photo 9: Cladding damage at the South east entry

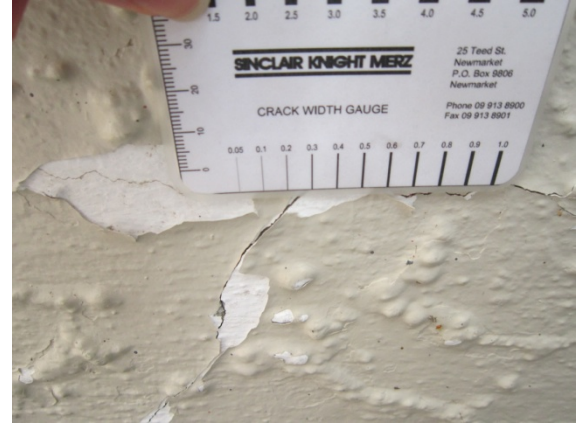
Photo 10: Cracking approx 0.3mm

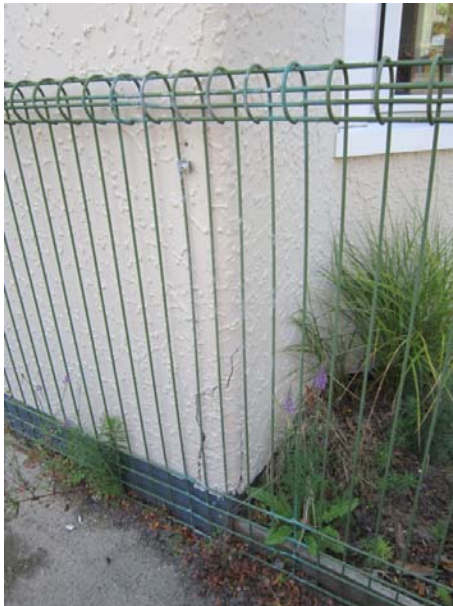
Photo 11: South west corner damage

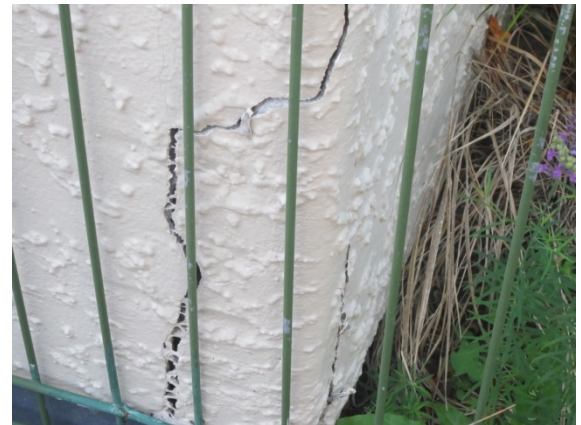
Photo 12: Close up of the displace section of Stucco cladding

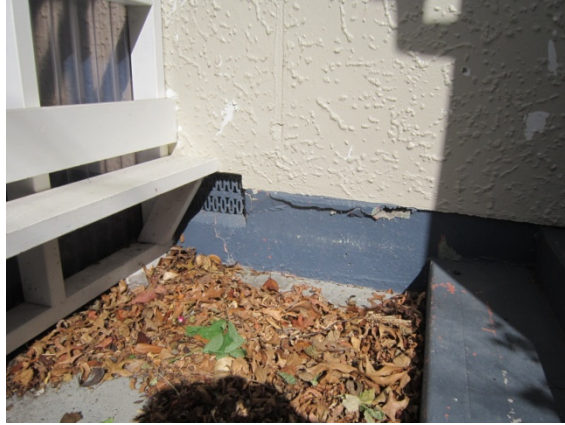
Photo 13: Cracking and spalling typical at foundation ventilation points

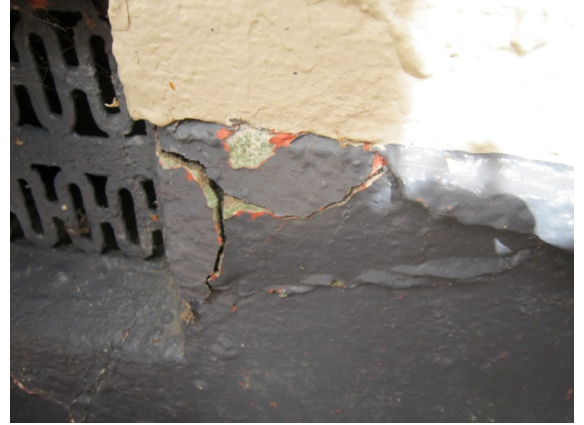
Photo 14: close up of perimeter ring beam damage

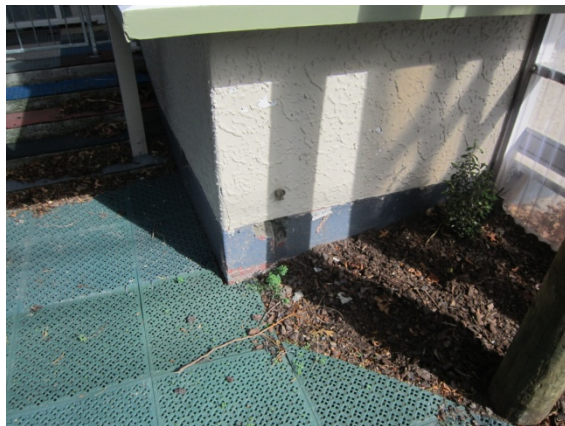
Photo 15: Cracking to the perimeter ringbeam south east corner

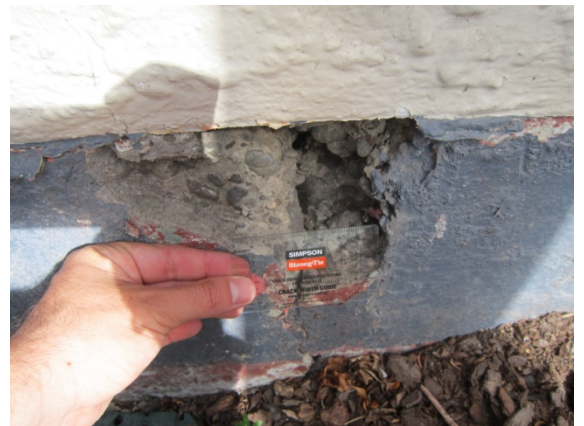
Photo 16: Full depth cracking through the perimeter ringbeam with approx 150 x 150 mm spalled area of covering plaster

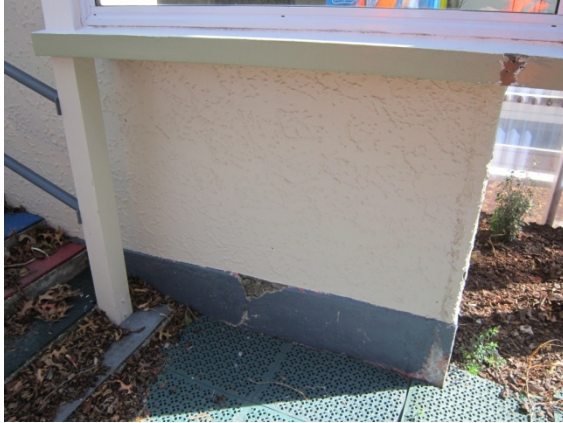
Photo 17: Further damage on the south face of the South east corner ring beam

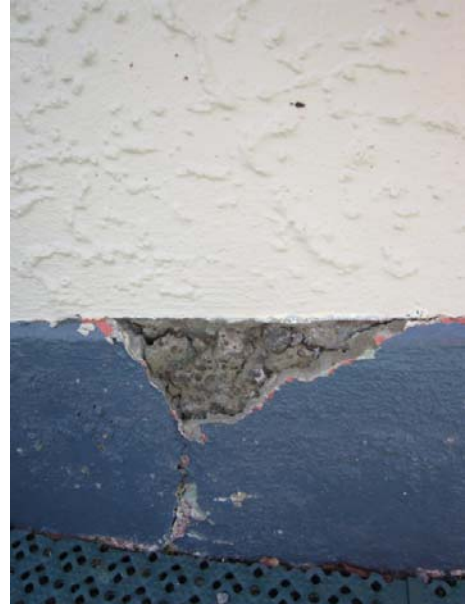
Photo 18: Potentially full depth cracking. Spalling of the plaster finishing

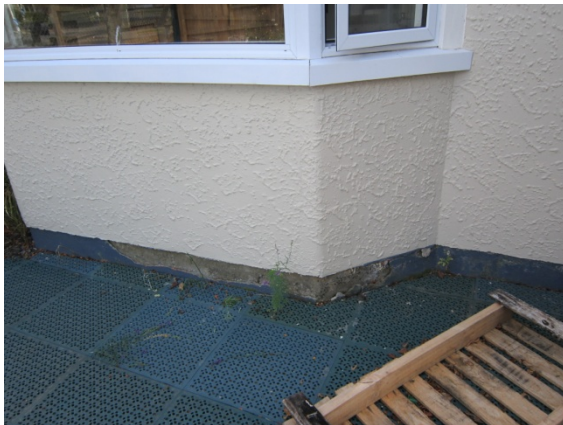
Photo 19: Photo of south wall perimeter ring beam showing plaster layer on concrete

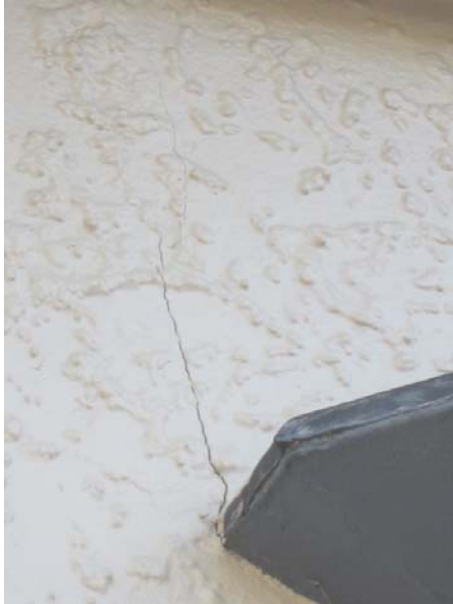
Photo 21: Typical cracking seen around wall penetrations

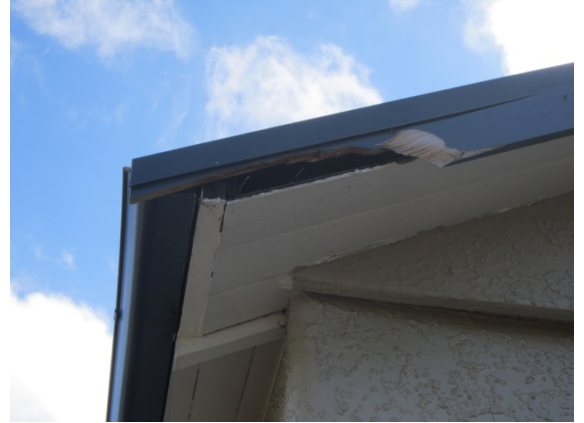
Photo 22: Damage to the roof flashing, unlikely to be EQ damage

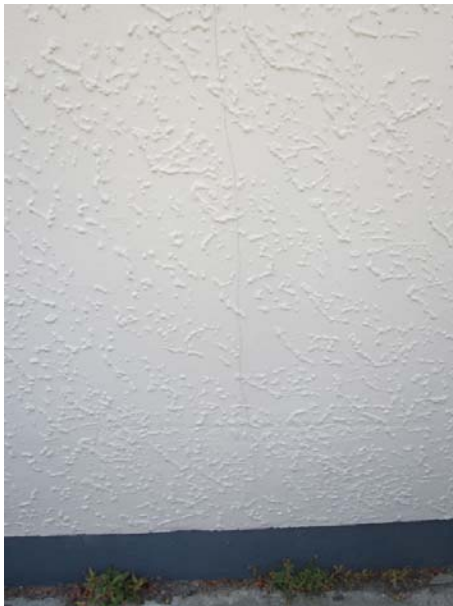
Photo 23: Vertical cracking typical around the building where internal timber framing is at a junction with exterior

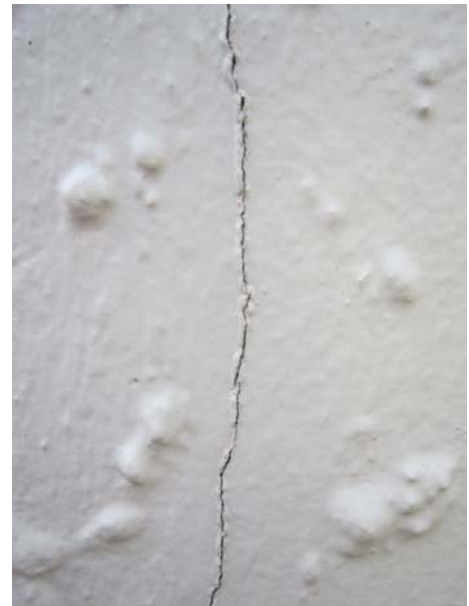
Photo 24: Cracking hairline – 0.3mm typically

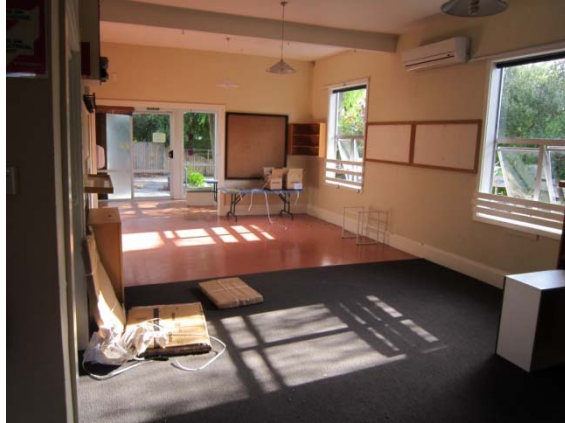
- 4) The internal piles and the perimeter foundation supporting the floor have settled in varying amounts causing the floor to be out of level. The slopes in the floor were measured to be between 0.5% -2% in most areas with the south most room having the greatest slope of 3%. This is outside the criteria outlined in the “Department of Building and Housing, Revised guidance on repairing and rebuilding houses affected by the Canterbury earthquake sequence”. All piles and bearers were visually confirmed to have adequate connection and hence it is not believed that there is any risk of bearers falling off piles.

Photo 25: Main creche open area, severe settlement of the carpeted area

- a) The current placard status of the building is changed to green 1, this is due to the fact that there is adequate connection between piles and bearers and as such collapse is unlikely.
- b) We consider that barriers around the building are not necessary.
- c) Options to bring the building to a target of 67% are investigated
- d) Areas of damage are repaired and the floor is relevelled.

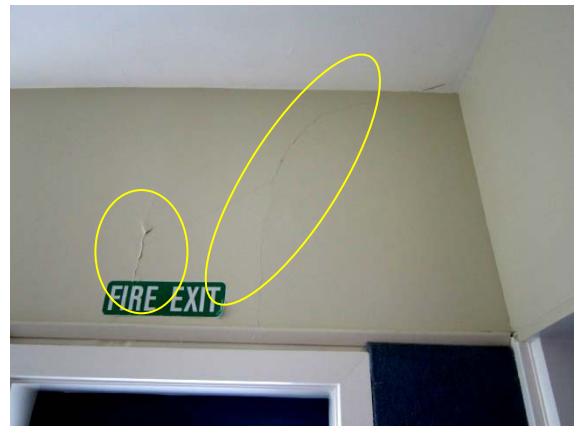
- 3) Cracking to lathe and plaster wall and ceiling linings with instances of spalling. Refer to Photo 28.

Photo 28: Typical damage to the lathe and plaster wall also seen in the ceiling lathe and plaster

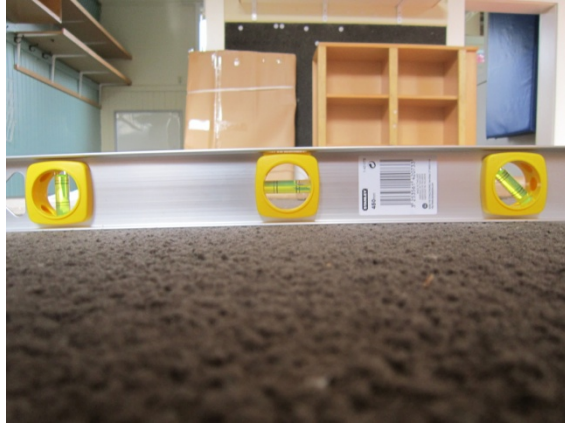
Photo 29: Distinct slope in the floor of the large eastern room. Room dips predominantly towards the south.

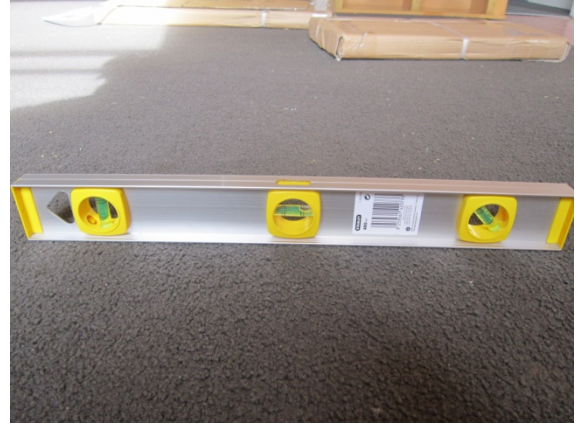
Photo 30: Room appears to bowl centred on the south wall of the main eastern room

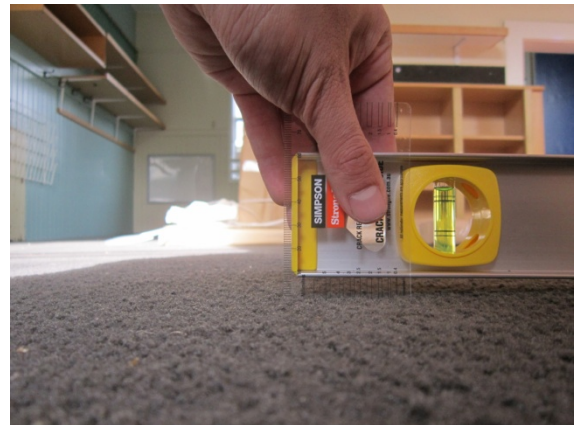
Photo 32: Approximate 2% slope

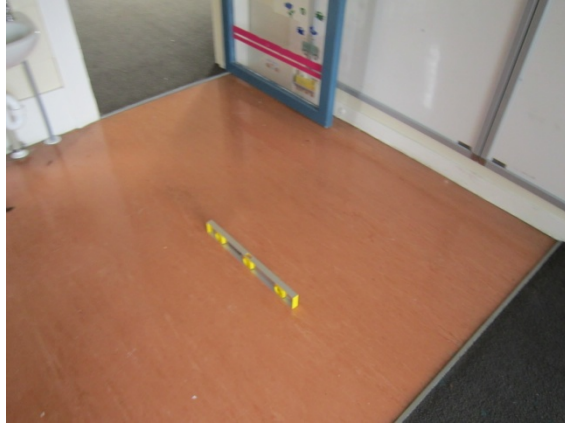
Photo 33: Southern room dips to the north

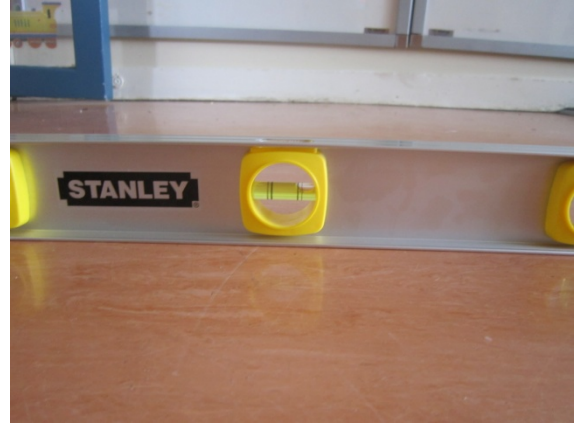
Photo 34: Severe dip to the North

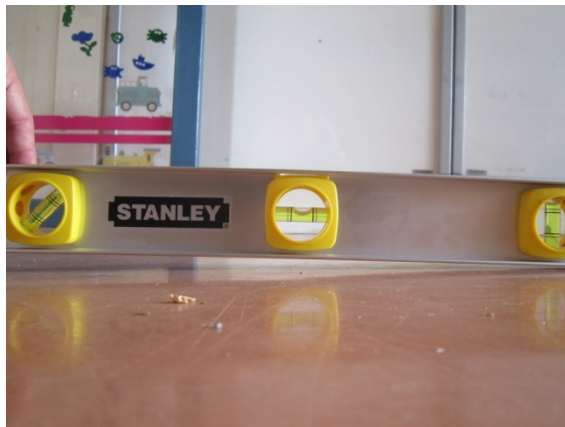
Photo 35: slope not approximated onsite but likely greater than 2% when compared to Photo 31

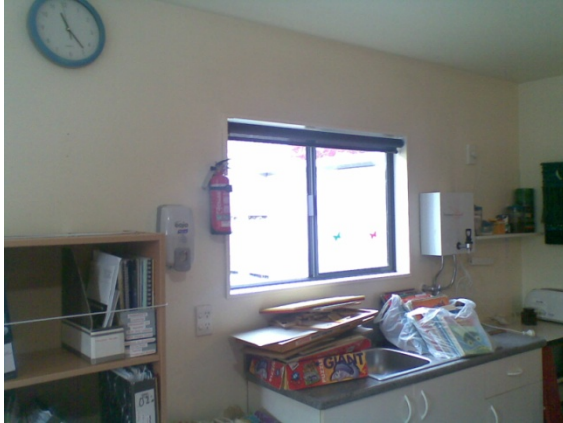
Photo 37: Office is approx 10 years old and showed little sign of damage with no noticeable separation of GIB linings along joints or cracking

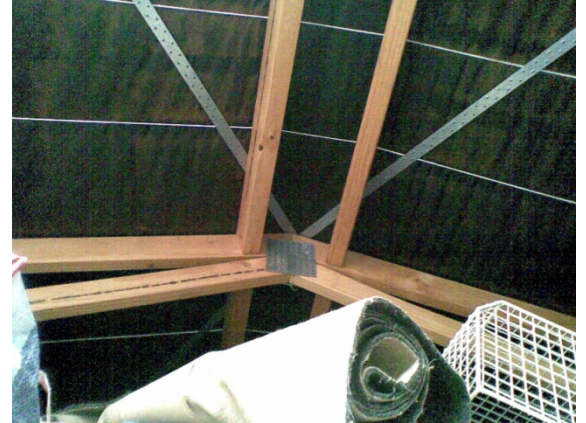
Photo 38: Storage area exposed roofing and bracing. Bracing appeared taut indicating low or no yielding

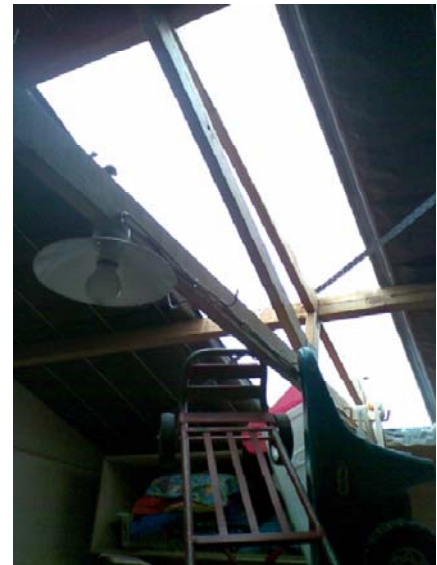
Photo 40: No damage to the timber trusses was observed
