PRK_1451_BLDG_001 EQ2

Toilets - St Leonards Sq

27 Campbell Street

QUALITATIVE ASSESSMENT REPORT

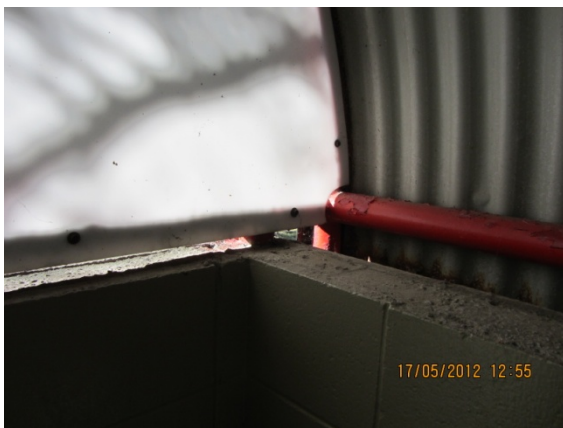
Photo 11: Photo above the walls showing the masonry is filled

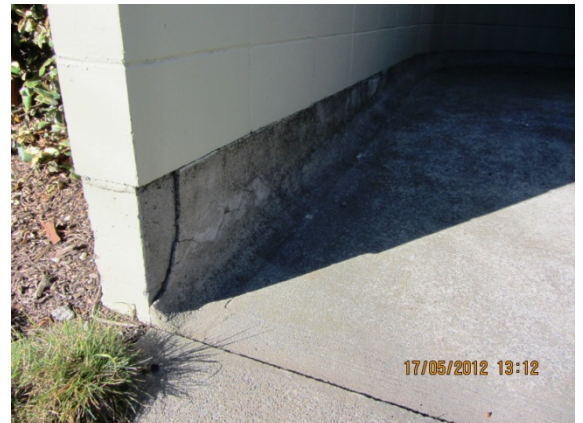
Photos of the above defect can be found in Appendix 1 – Photos. The defect does not appear to be as a result of the earthquakes and is most likely weathering damage.

Photo 16: Spalling at coving in womens toilet entrance (1)

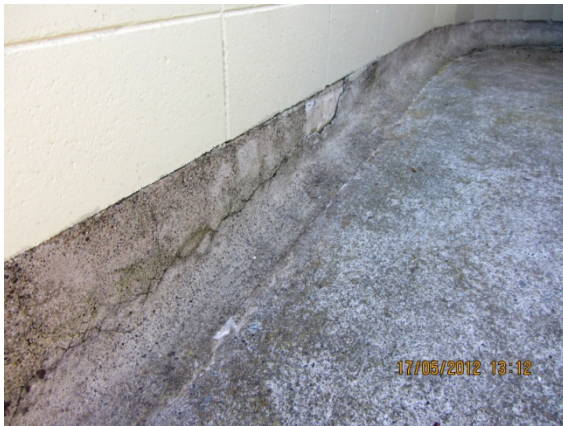
Photo 17: Spalling at coving in womens toilet entrance (2)

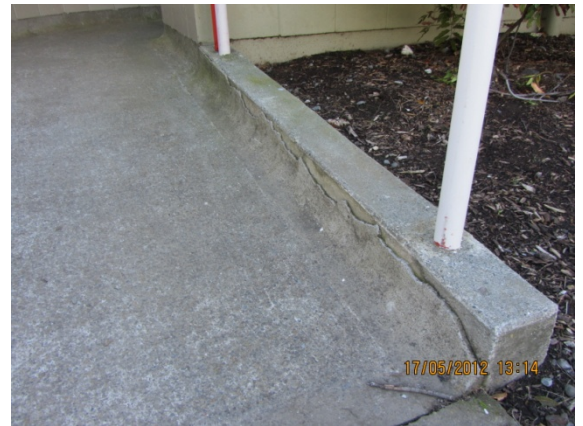
Photo 18: Spalling at coving in mens toilet entrance

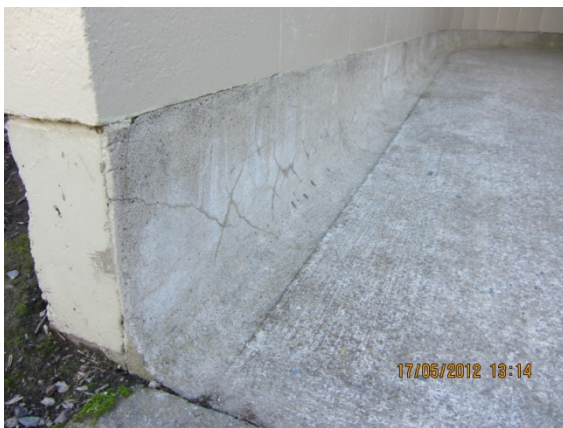
Photo 19: coving in mens toilet entrance showing signs of deterioration

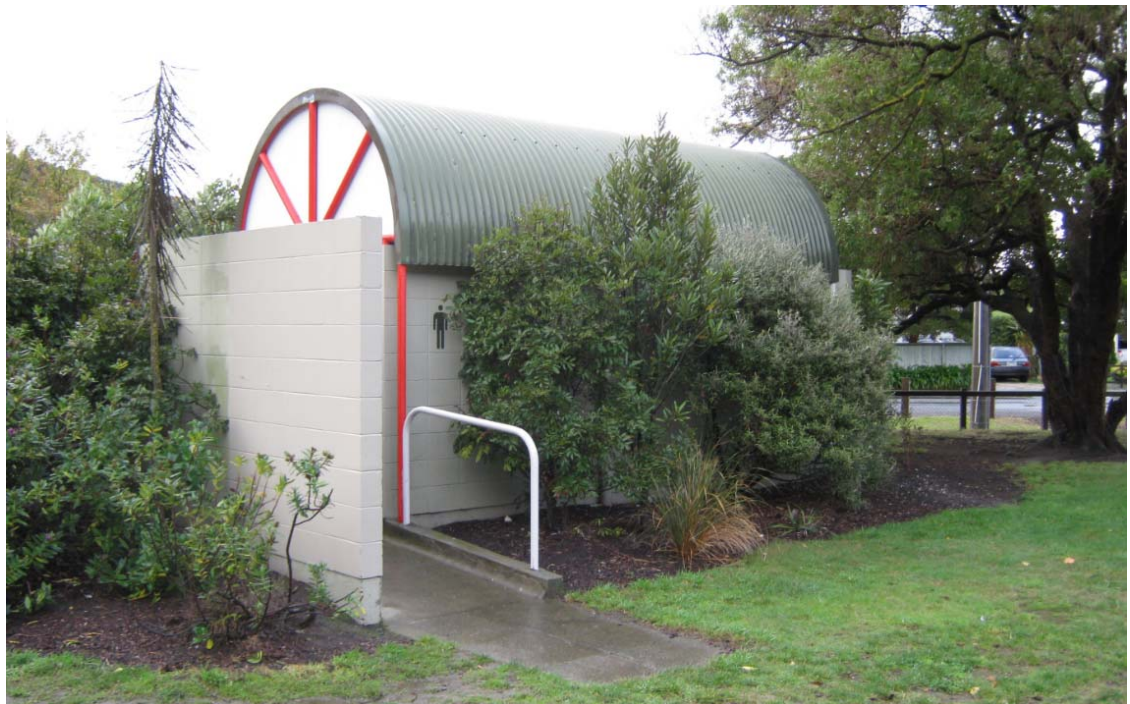
The toilet block is a masonry block building with concrete slab on grade foundations and sheet metal roof. Very little damage could be seen on the toilet buildings on site, with minor hairline cracks in the foundation.

■ **Figure 5** Toilet block at St Leonards Square.

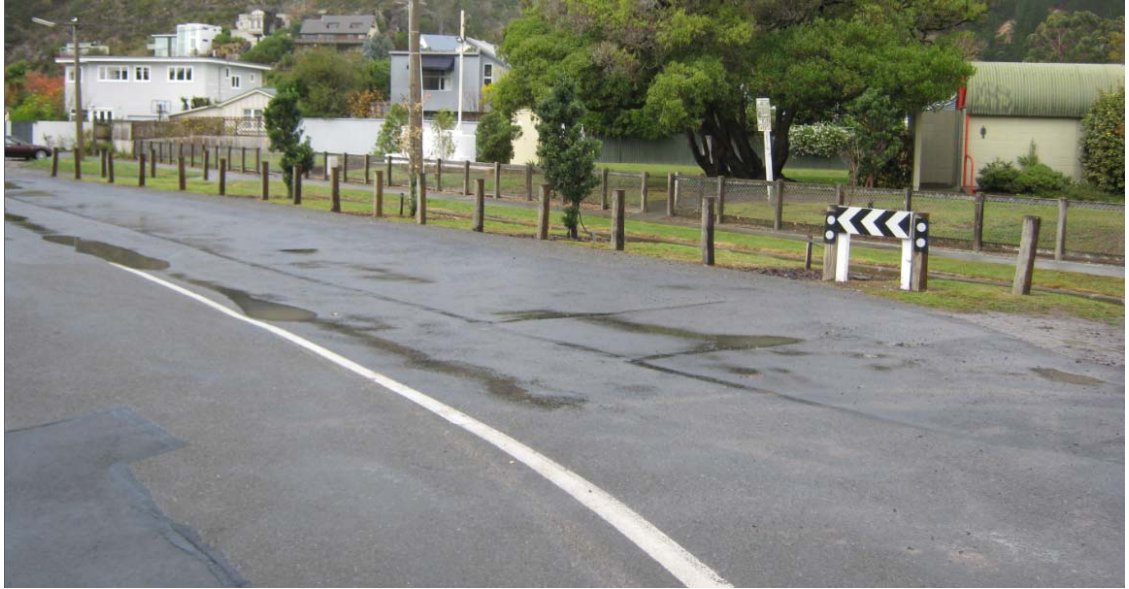
There is little evidence of land damage at the site with the exception of a mound adjacent to the toilet block which may be the result of liquefaction. The nearby Duncan Street appears to have affected by ground settlement of service trenches. The pathways appear undamaged.

■ **Figure 6:** Possible settlement of service trenches on Duncan Street near the toilet block.

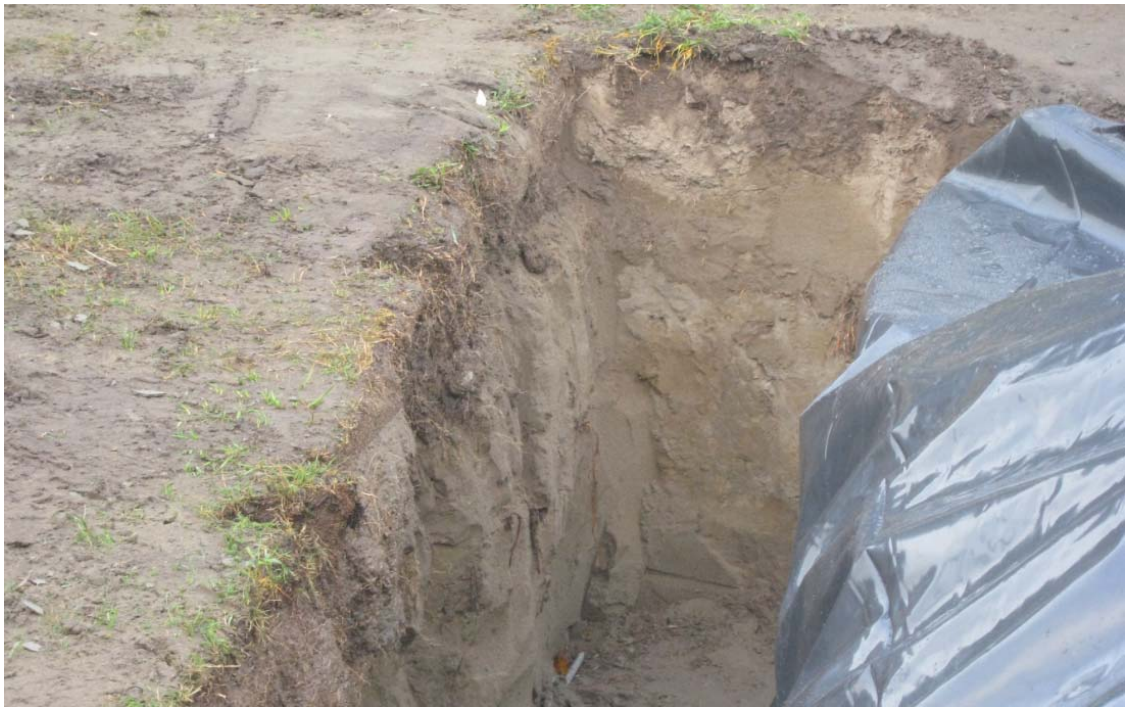
Ground excavating for the installation of a possible soak away structure was being undertaken nearby the toilet block. This exposed approximately a 1 m depth of dune sand with no groundwater observed.

■ **Figure 6:** Excavation of ground indicating sand to 1 m depth with no groundwater.
