Christchurch City Council
PRK_3555_BLDG_014 EQ2
Stoddart Point Reserve Garage
1J Waipapa Avenue, Diamond Harbour

QUALITATIVE ASSESSMENT REPORT
FINAL

- Rev B
- 23 May 2013

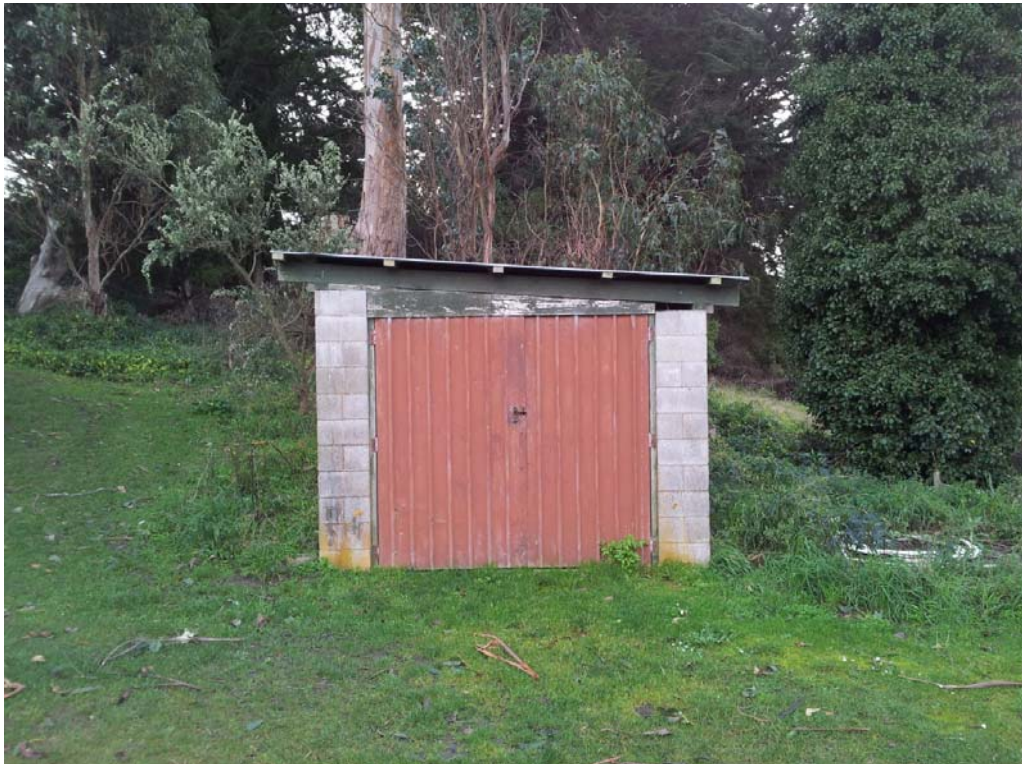
■ **Figure 3 - Overview of the building (southern elevation)**

The building was noted to be constructed from masonry walls with a timber framed roof and slab on grade foundation. No liquefaction was identified or would be expected from the soils at this location. A brief site walkover of the area identified that the slopes above were covered by loess and vegetation.

No visual evidence of tension cracks or land slips was observed within the site. The nearby Waipapa Avenue appeared to be undamaged.
