Styx Mill Ranger House
PRK 0340 BLDG 003
Detailed Engineering Evaluation
Qualitative Report
Version FINAL

130 Hussey Rd, Northwood

Christchurch City Council

Date
23 May 2013

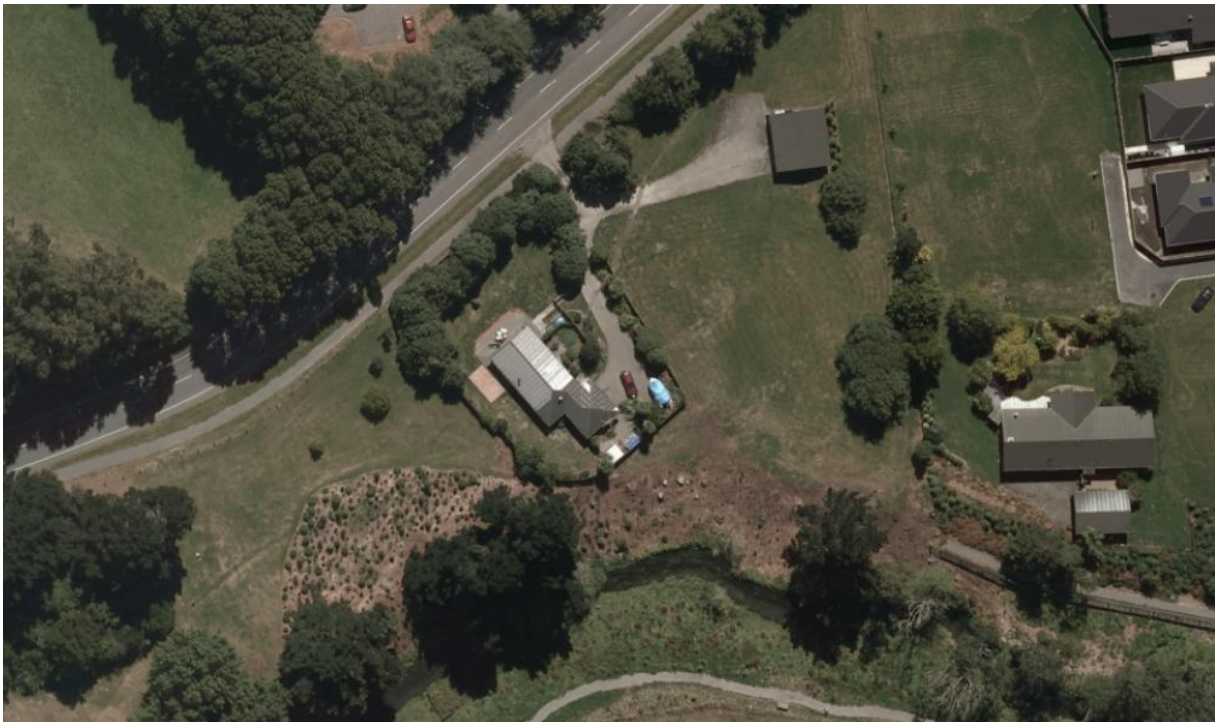
Figure 3 Post February 2011 Earthquake Aerial Photography ²

Aerial photography taken following the 22 February 2011 earthquake doesn't show any clear signs of liquefaction, as shown in Figure 3.

It is not clear from the post-earthquake aerial photography (Figure 3) whether liquefaction occurred at the site. The ground conditions suggest that the soils may be prone to liquefaction.

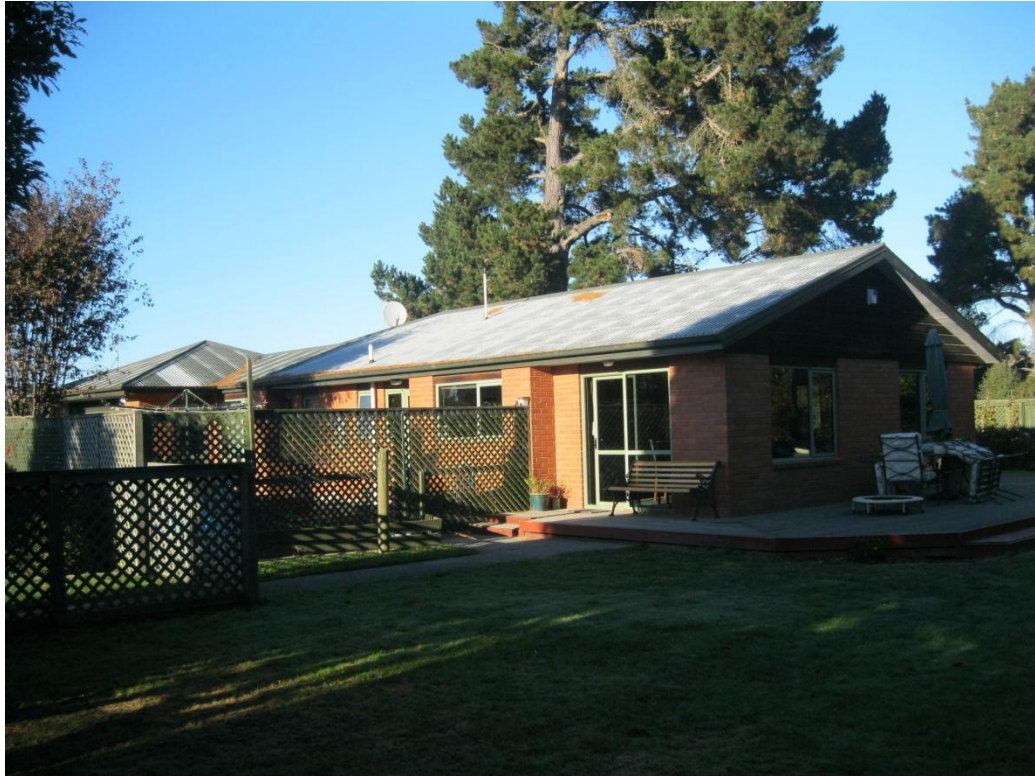
Photograph 1 North elevation.

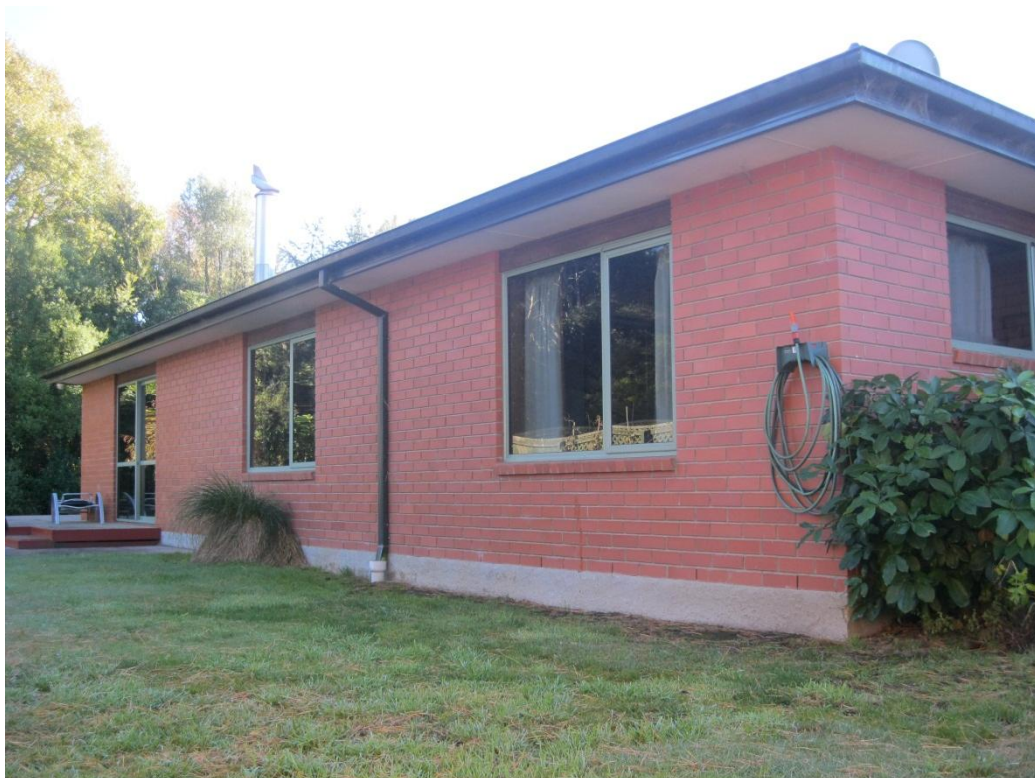
Photograph 2 View of the south side of structure.

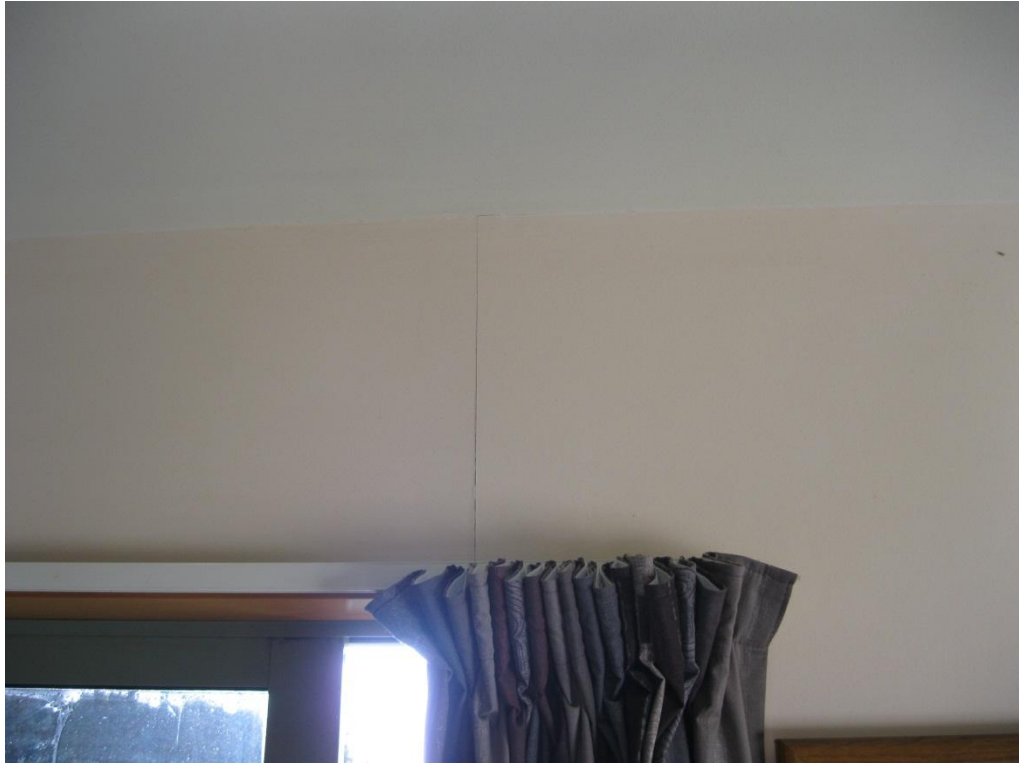
Cracking was noted to the internal plasterboard lining in several locations throughout the building, These were above doors/windows, in a ceiling at a re-entrant corner and along a wall/ceiling connection. See photographs 3 and 4. These cracks are not considered to be structurally significant.

Photograph 3 Minor cracking above window.

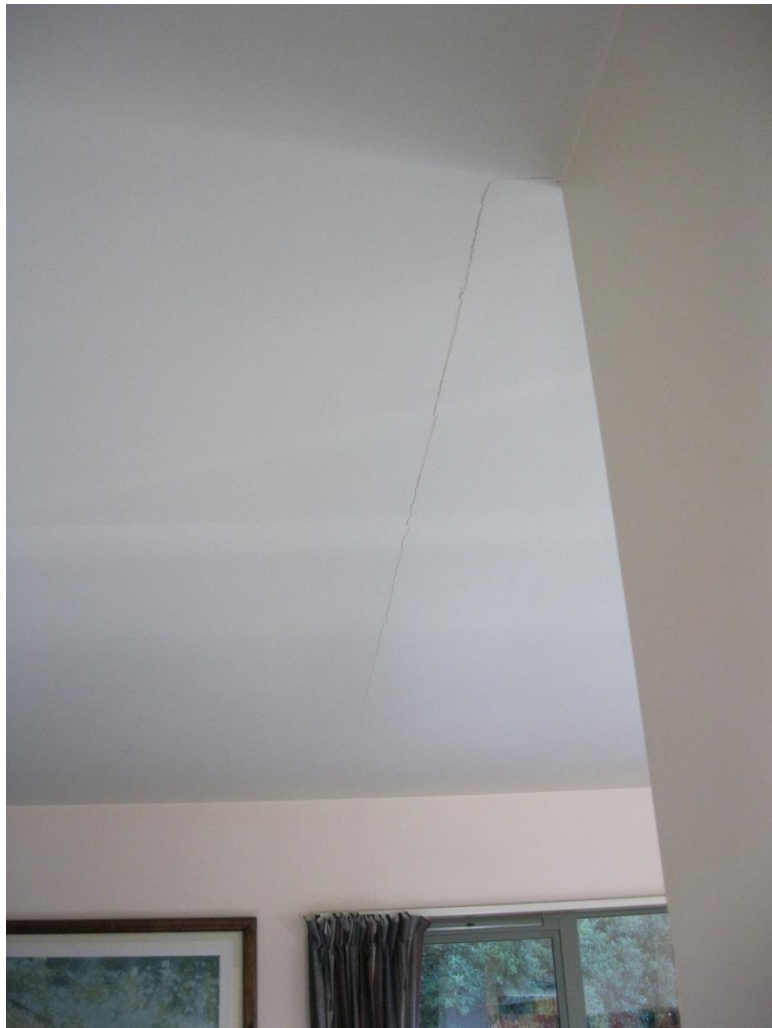
Photograph 4 Cracking in ceiling.

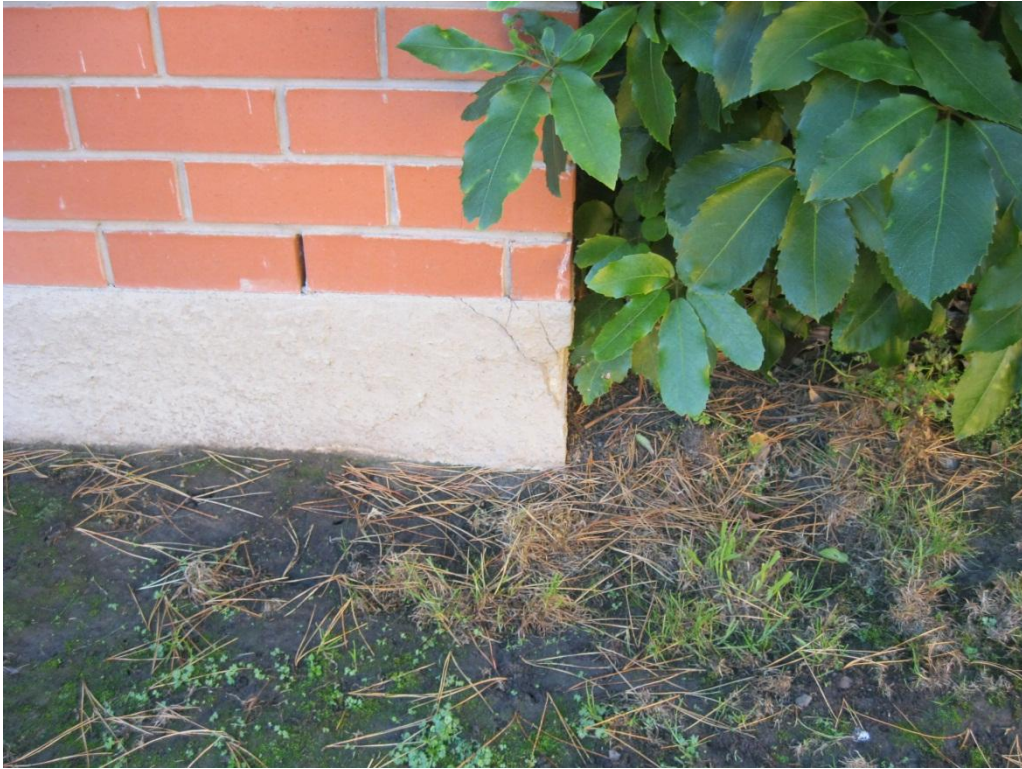
A single crack was noted in the strip foundation of the building, this being at the corner external to a bedroom. See photograph 5. The cracking appears to be cosmetic and affects only the render finish.

Photograph 5 Cracking in strip footing render.

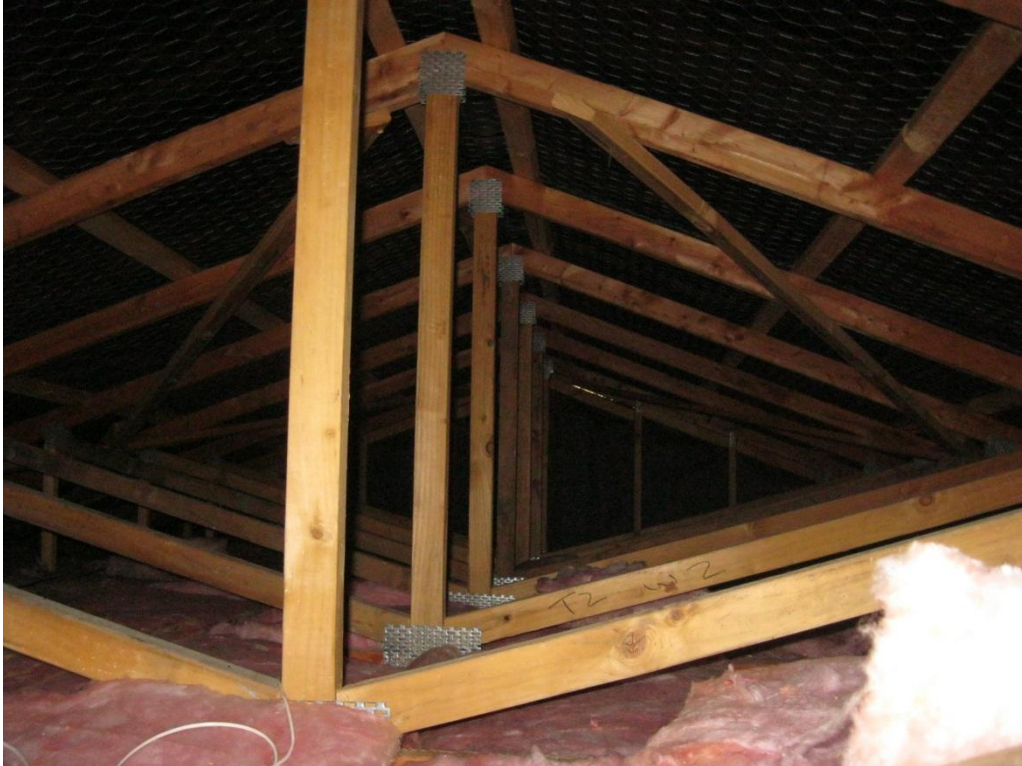
No critical structural weaknesses were observed in the roof structure. Metal cladding and ceiling plasterboard combining with the roof trusses to provide a diaphragm action for roof stability. This was further increased by diagonal bracing attached to the underside of roof plane timber.

Photograph 6 View of roof trusses and diagonal bracing.
