**Aviary**  
**PRK 2635 BLDG 008**  
Detailed Engineering Evaluation  
Qualitative Report  
Version Final

51 Lower Styx Road, Styx River Reserve

Christchurch City Council

**Date**  
23<sup>rd</sup> May 2013

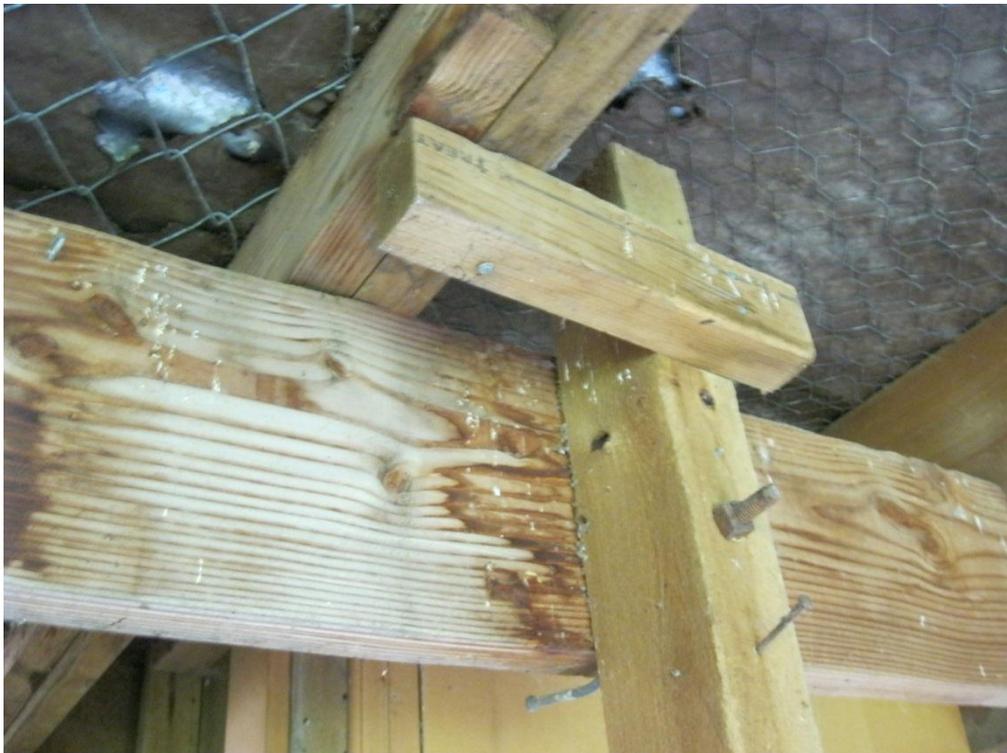
During the site inspection some settlement and cracking of the concrete tiles was noted. There were also some missing bolts in the connection between posts and rafters (see photograph 10). These missing bolts have been provided on the 16<sup>th</sup> August 2012 (See photograph 12-15).

**Photograph 10 Missing bolts of the joint between rafters and timber post.**

GHD have recommended that the missing bolts to the connections between the timber posts and rafters be provided in order to strengthen the building should CCC want to reinstate use of the building as an aviary. Bolts were provided to a number of the connections throughout the aviary on the 16<sup>th</sup> of August 2012.

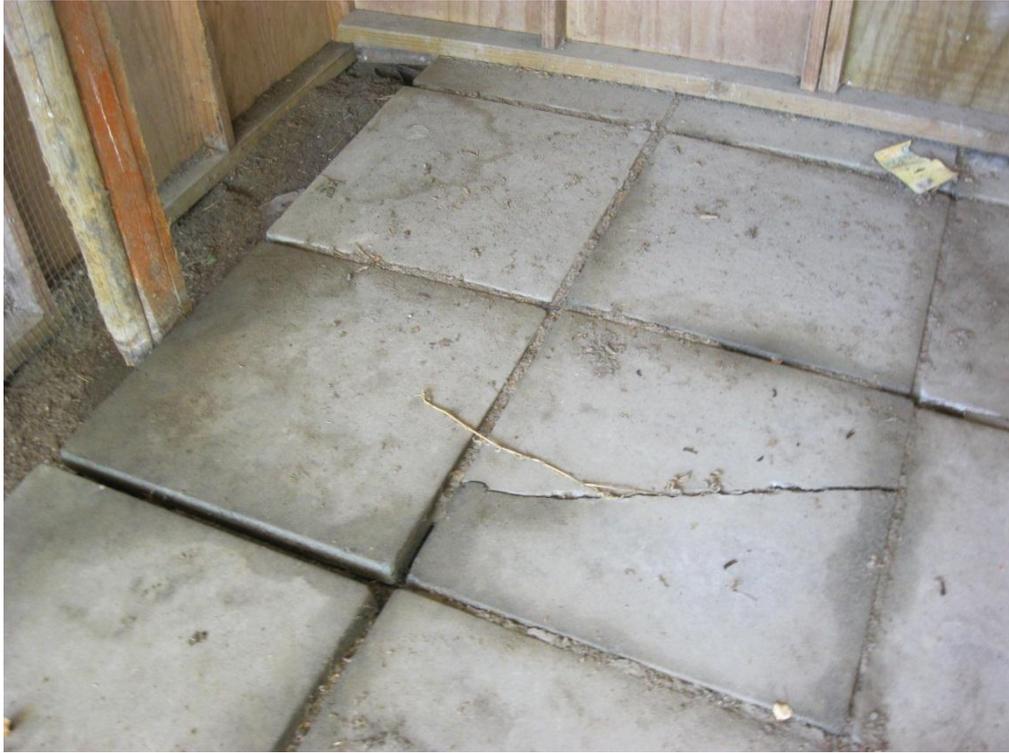
**Photograph 11 Differential concrete tiles settlements.**

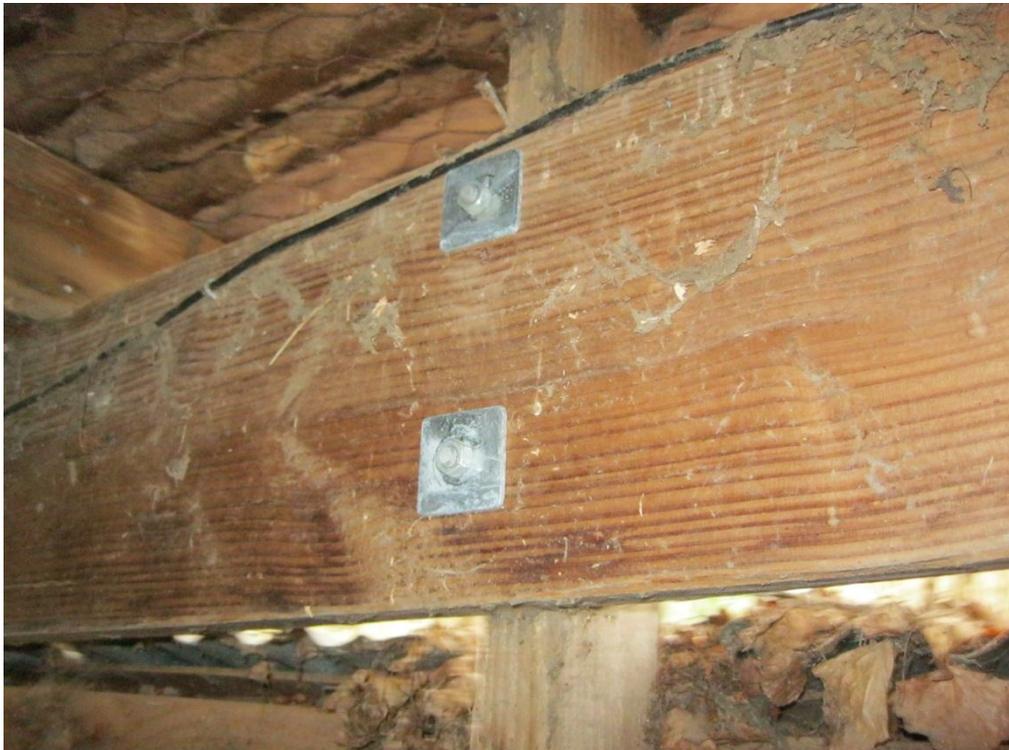
**Photograph 12 A number of bolts provided to a connection.**

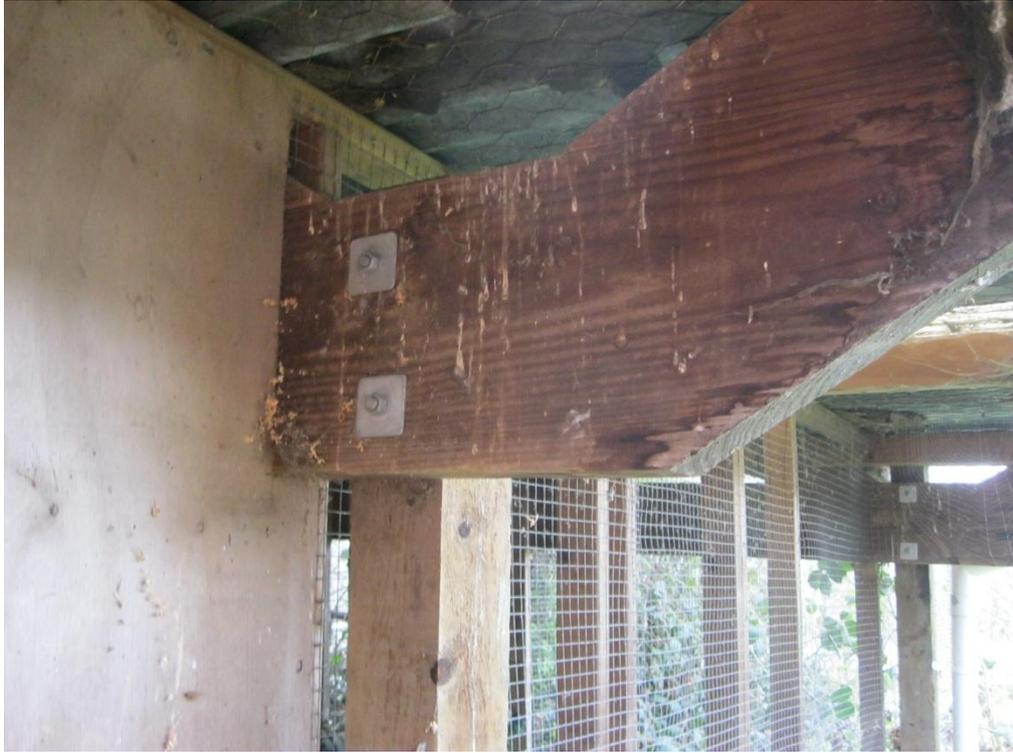
**Photograph 13 Provision of bolts to the joint between rafters and timber post.**

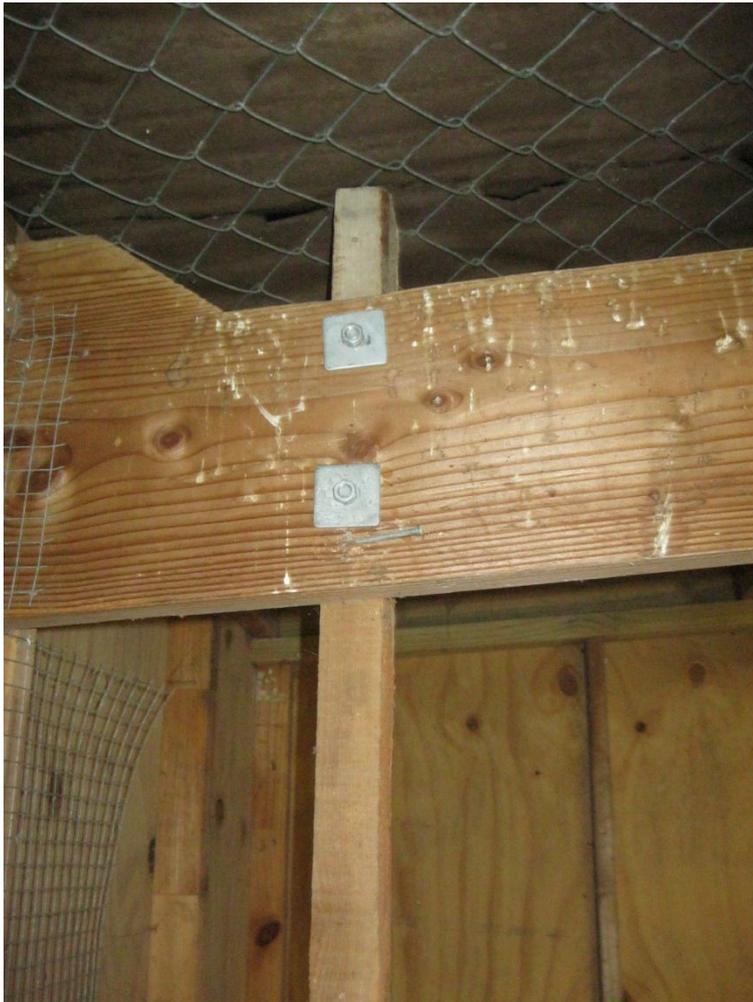
**Photograph 14 Provision of bolts to the joint between rafters and timber post.**

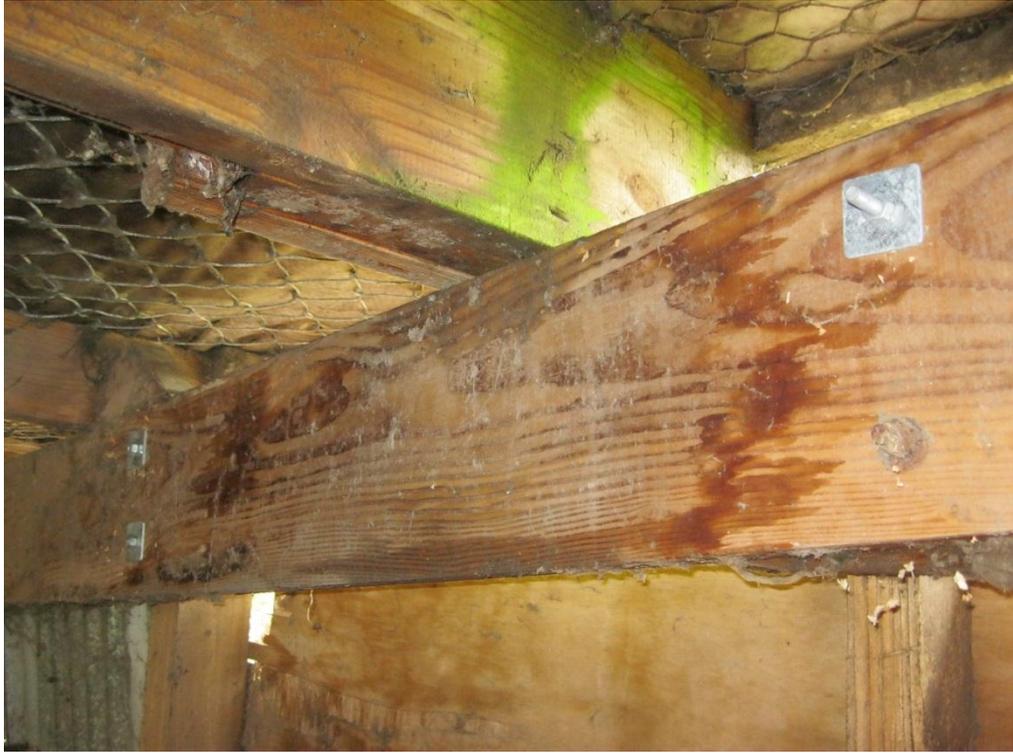
**Photograph 15 Provision of bolts to the joint between rafters and timber post.**
