**Sumner Beach Toilets**  
**PRK 1474 BLDG 009 EQ2**

**Detailed Engineering Evaluation**

**Quantitative Assessment Report**

Date: February 2013  
Reference: 6-QUCC1.75  
Status: Final

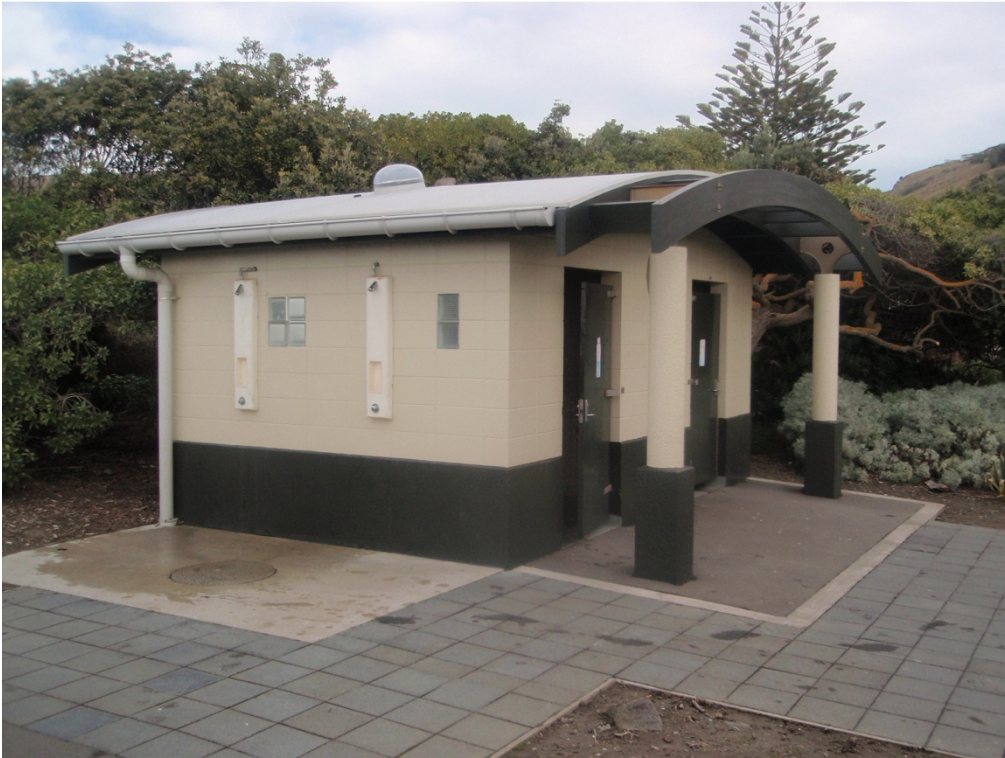
Photo 1: North-East view of Sumner Beach Toilets

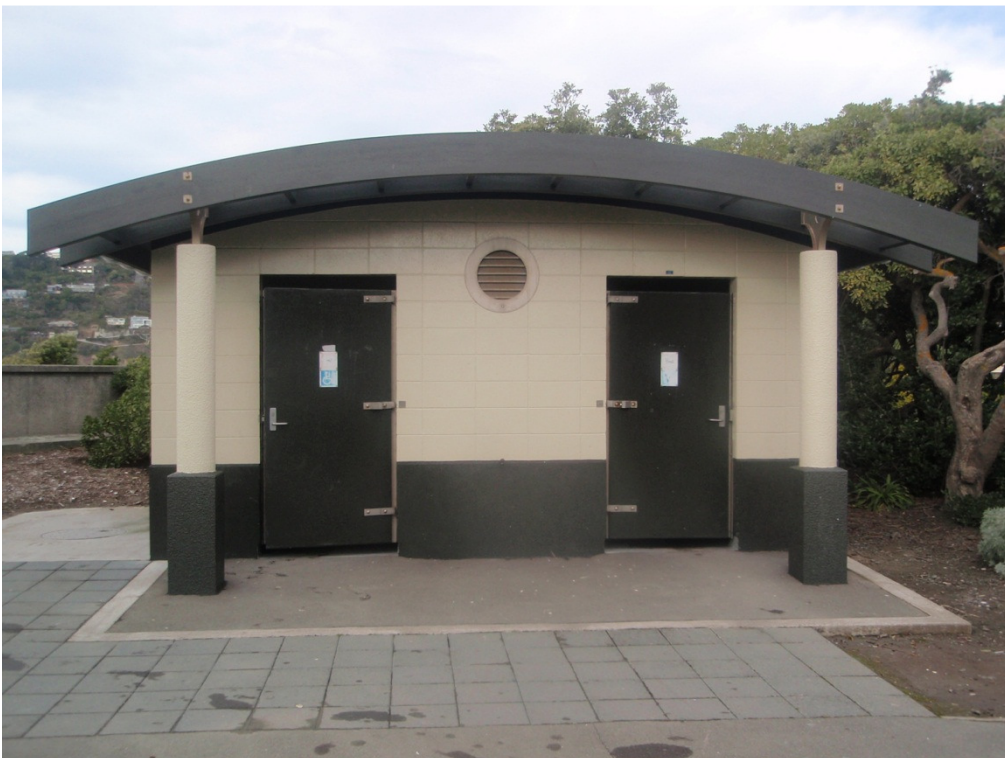
Photo 2: North Wall Elevation

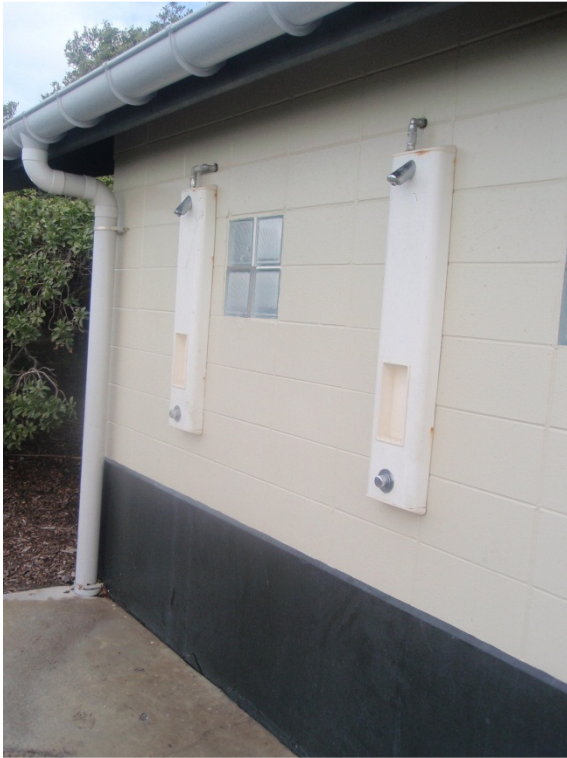
Photo 3: East Wall Elevation  
(wash down area)

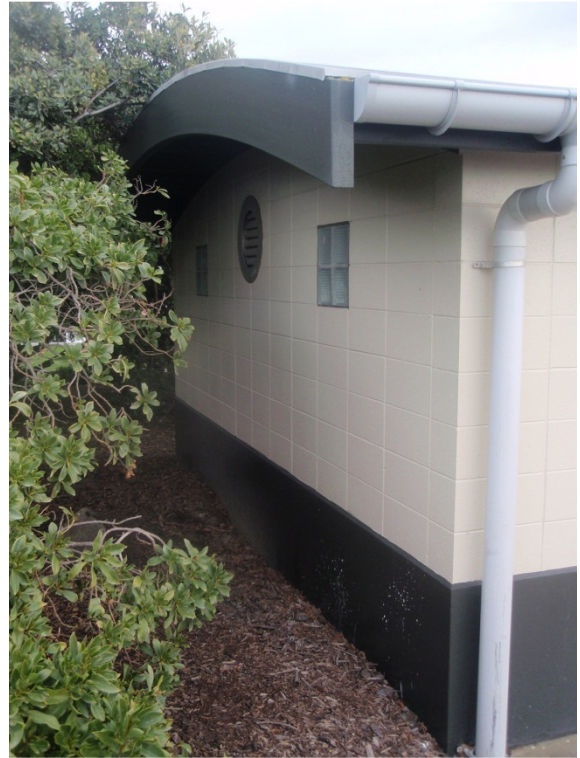
Photo 4: South Wall Elevation

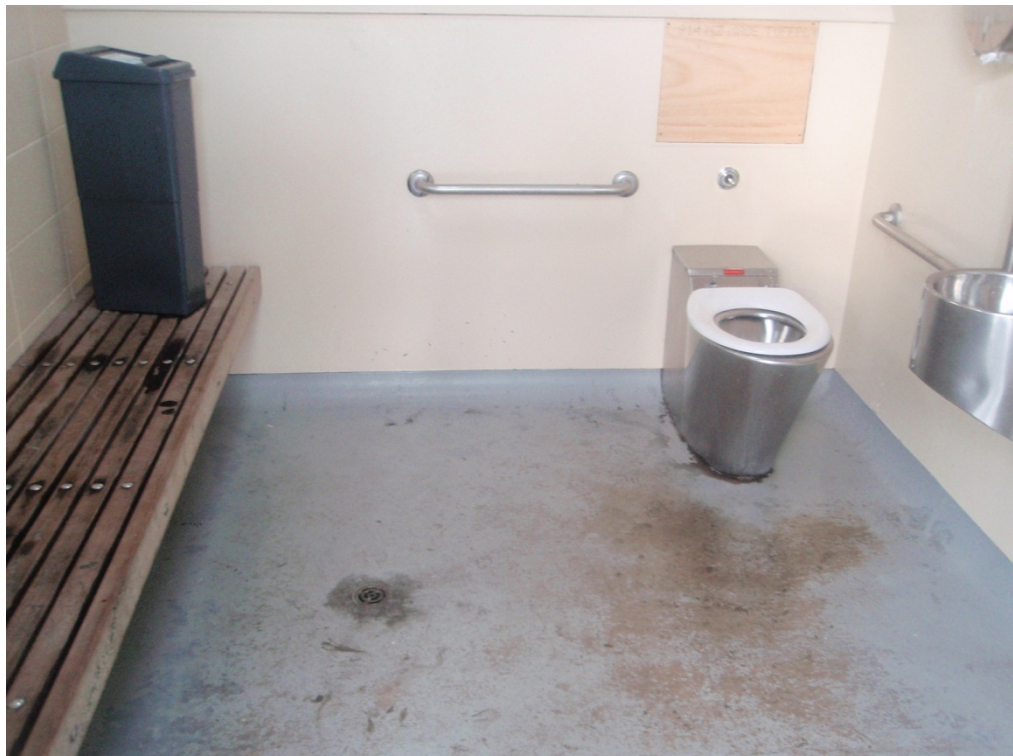
Photo 5: East Toilet Cubicle (West similar)

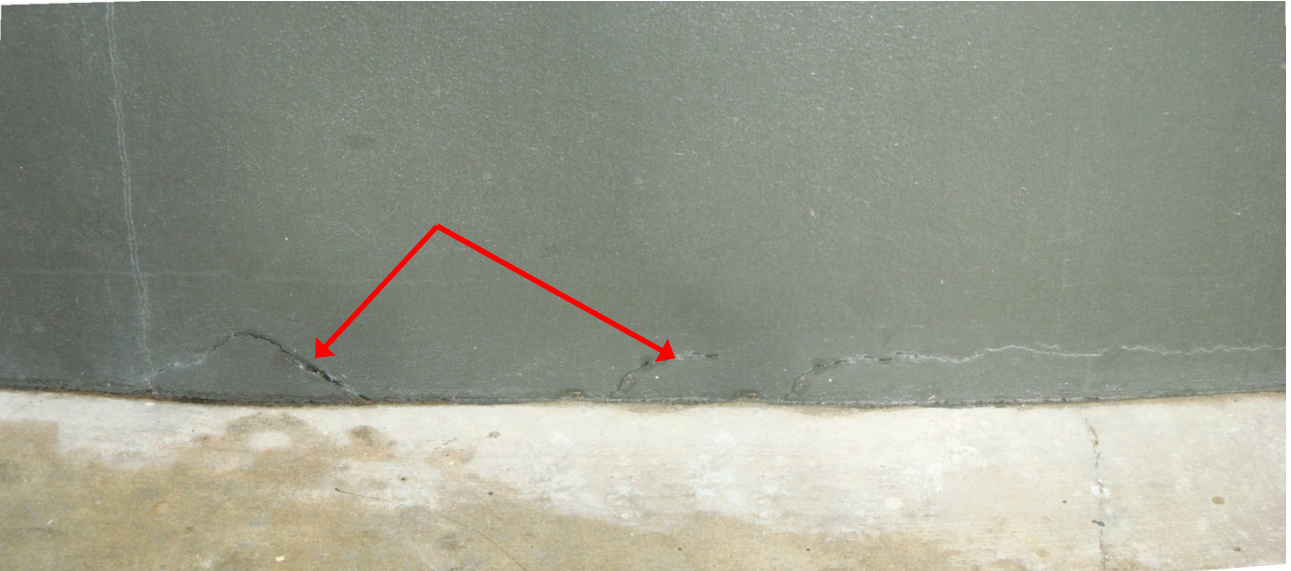
- 5mm crack on the 20mm solid plaster of concrete on south side of building. Refer to Photograph 5.
- Some minor cracking (2mm wide hairline crack) on concrete slab on the wash down area, east elevation of the building. Refer to Photograph 6 in Appendix A.

Cracks in the solid plaster on the east elevation of the toilet could not be observed in the perimeter footing, possibly shallow. There is no evidence of liquefaction at the site.

**Photograph 5: 5mm crack on the 20mm solid plaster of concrete on south side of building.**

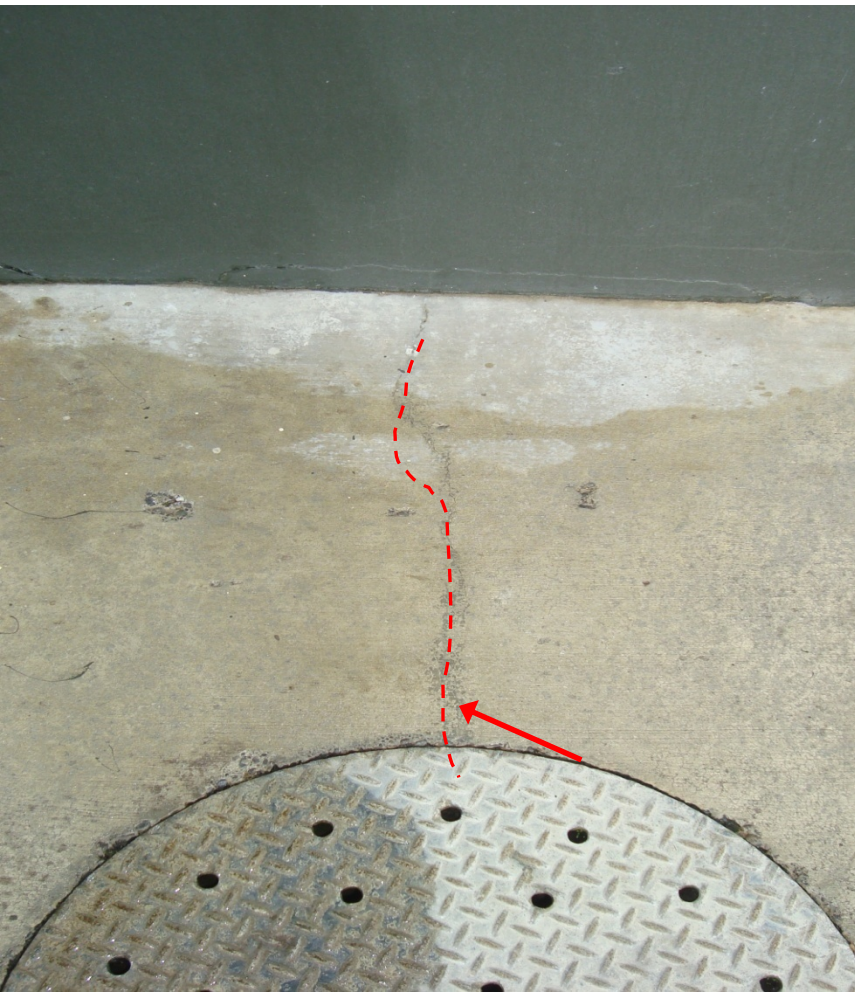
**Photograph 6: Some minor cracking (2mm wide hairline crack) on wash down area (east elevation).**

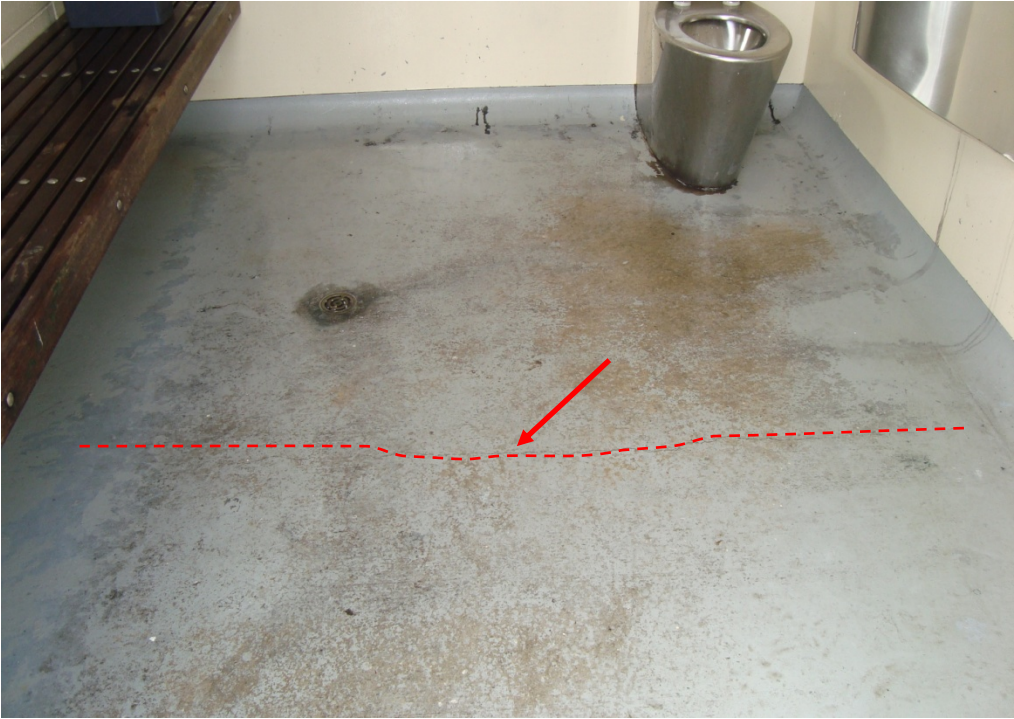
- 2mm hairline crack on the concrete floor of the toilets. Refer to Photograph 7a and 7b in Appendix A.
- An approximate 5mm wide cracks around the right most 300mm x 300mm concrete column, cracks radiating outward the 20mm asphalt paving. Asphalt ground lifted roughly 5mm. Refer to Photograph 8 in Appendix A.

The hairline cracks in the toilets' floor slab appear to be negligible and have the no potential to affect the structural integrity of the building and its performance in future earthquakes.

**Photograph 7a: 2mm wide cracks floor slab inside the toilets.**

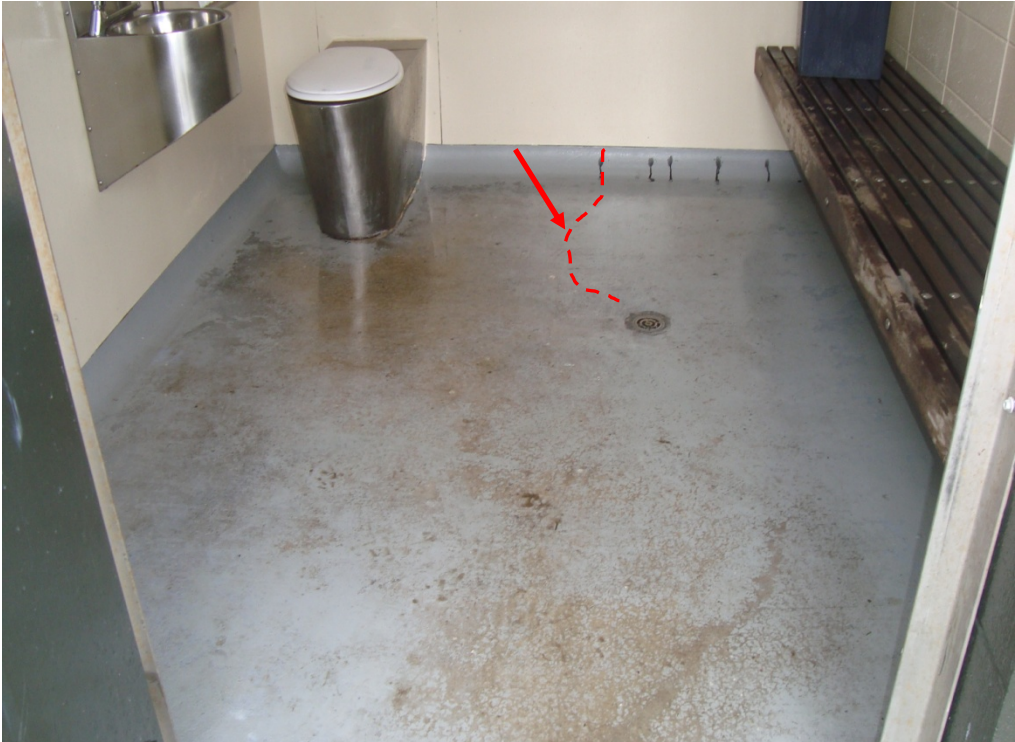
**Photograph 7b: 2mm wide cracks floor slab inside the toilets.**

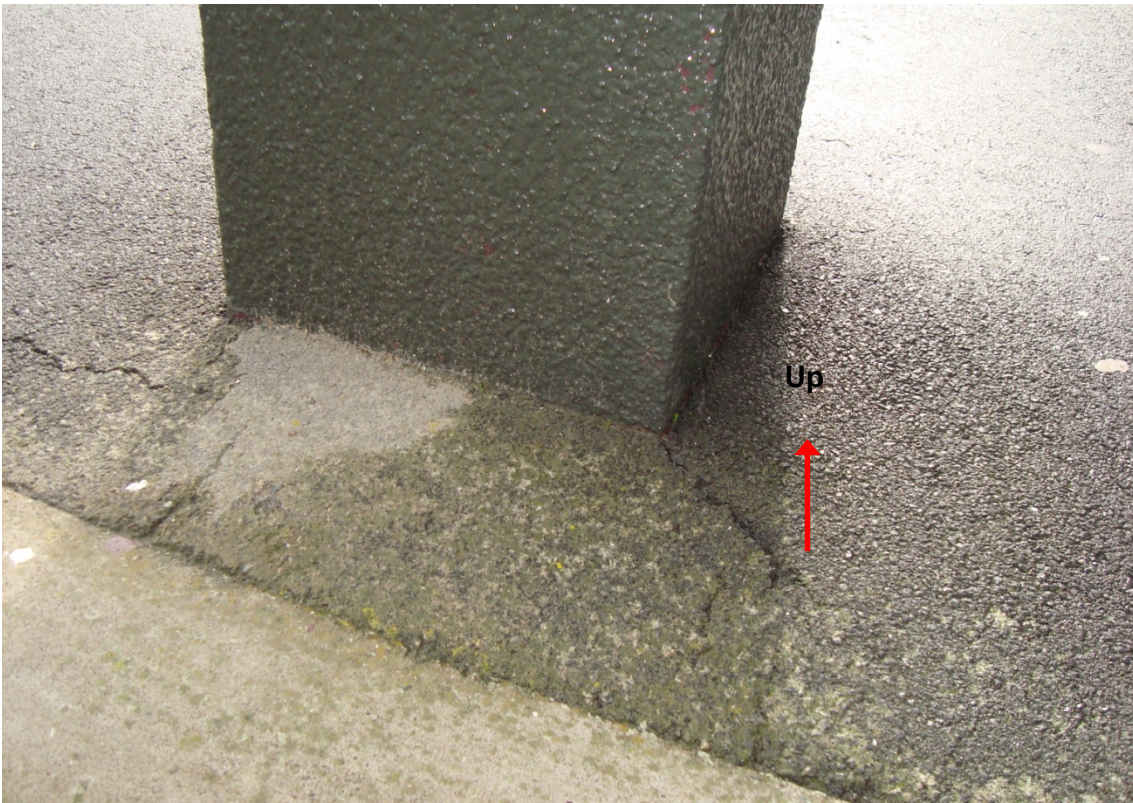
**Photograph 8: Approximate 5mm wide shallow cracks around the right most 300mm x 300mm concrete column, cracks radiating outward the 20mm asphalt paving. Asphalt ground lifted 5mm.**

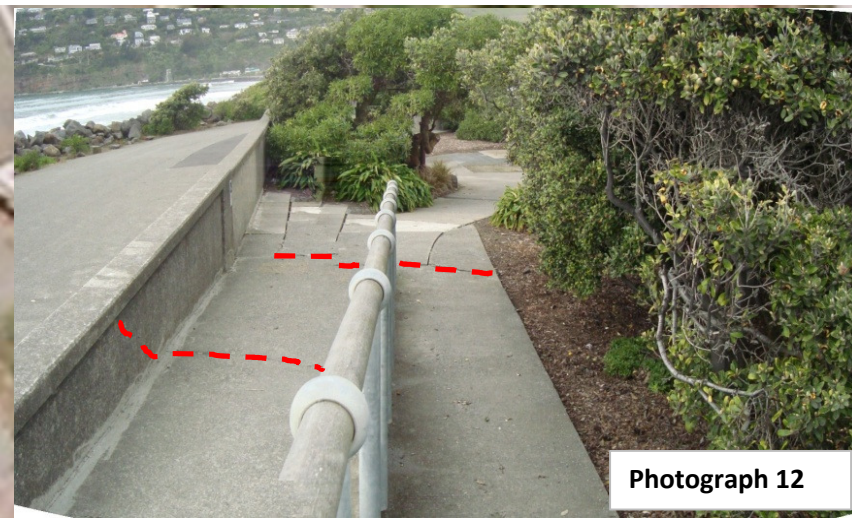
Photograph 12

- Approximately 10mm to 15mm wide cracks on the concrete walkway, north of the toilets, leading toward the promenade. Refer to Appendix C -Site Walkover Plan, Photograph 12.

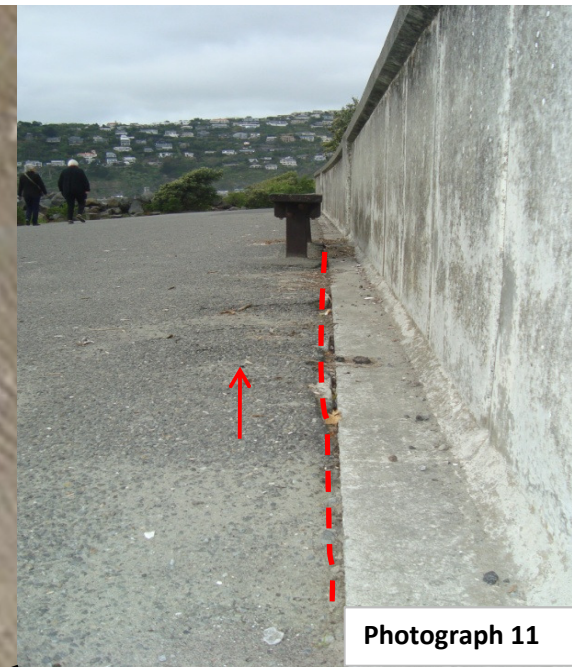
Photograph 11

- Small ground heave within 5mm to 10mm at the bottom of the concrete wall with estimated 10mm wide cracks separating bottom of wall and paved ground. Refer to Appendix C -Site Walkover Plan, Photograph 11.

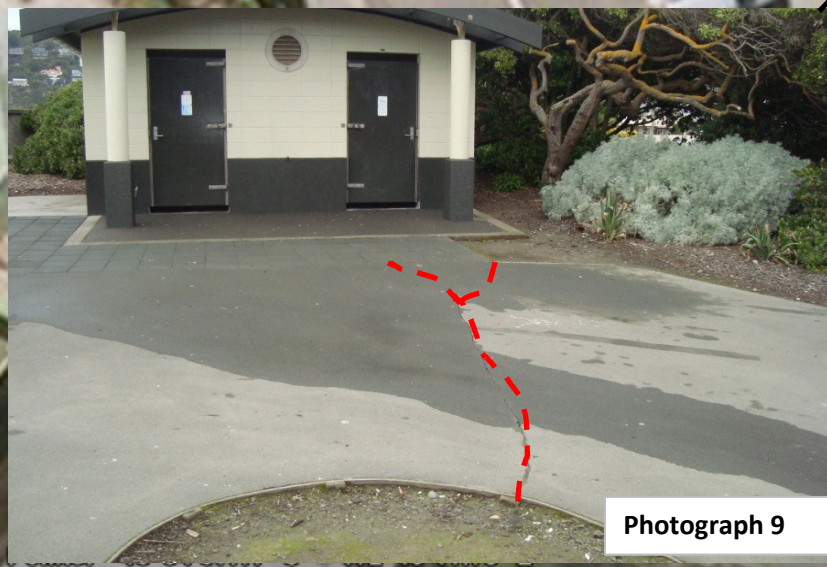
Photograph 9

- Minor 5mm wide cracks on the asphalted footpath north of the toilets. Refer to Appendix C -Site Walkover Plan, Photograph 9.
- 10mm wide cracks from the top to base of the concrete wall separating the toilets from the promenade. This is also accompanied by a lift and subsidence of approximately 10mm as indicated by the arrows. Refer to Appendix C -Site Walkover Plan, Photograph 10.
