Sydenham Community Centre
Qualitative Engineering Evaluation

Reference: 227681
Prepared for:
Christchurch City Council

Functional Location ID: BU 1068 001 EQ2

Date: 20 December 2012

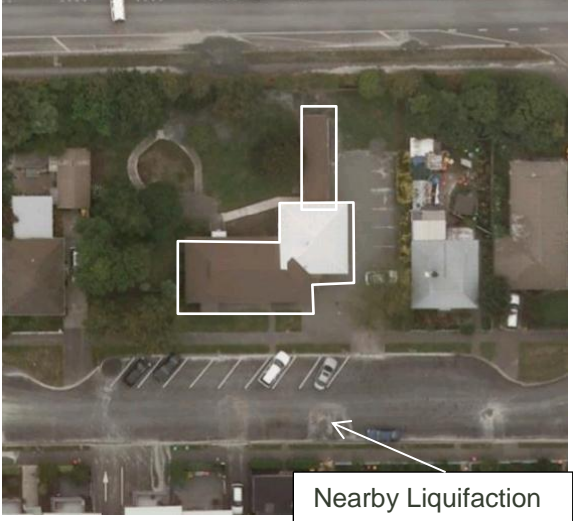
<p>Nearby Liquifaction</p>
<p>Front elevation of the Sydenham Community Centre.</p>

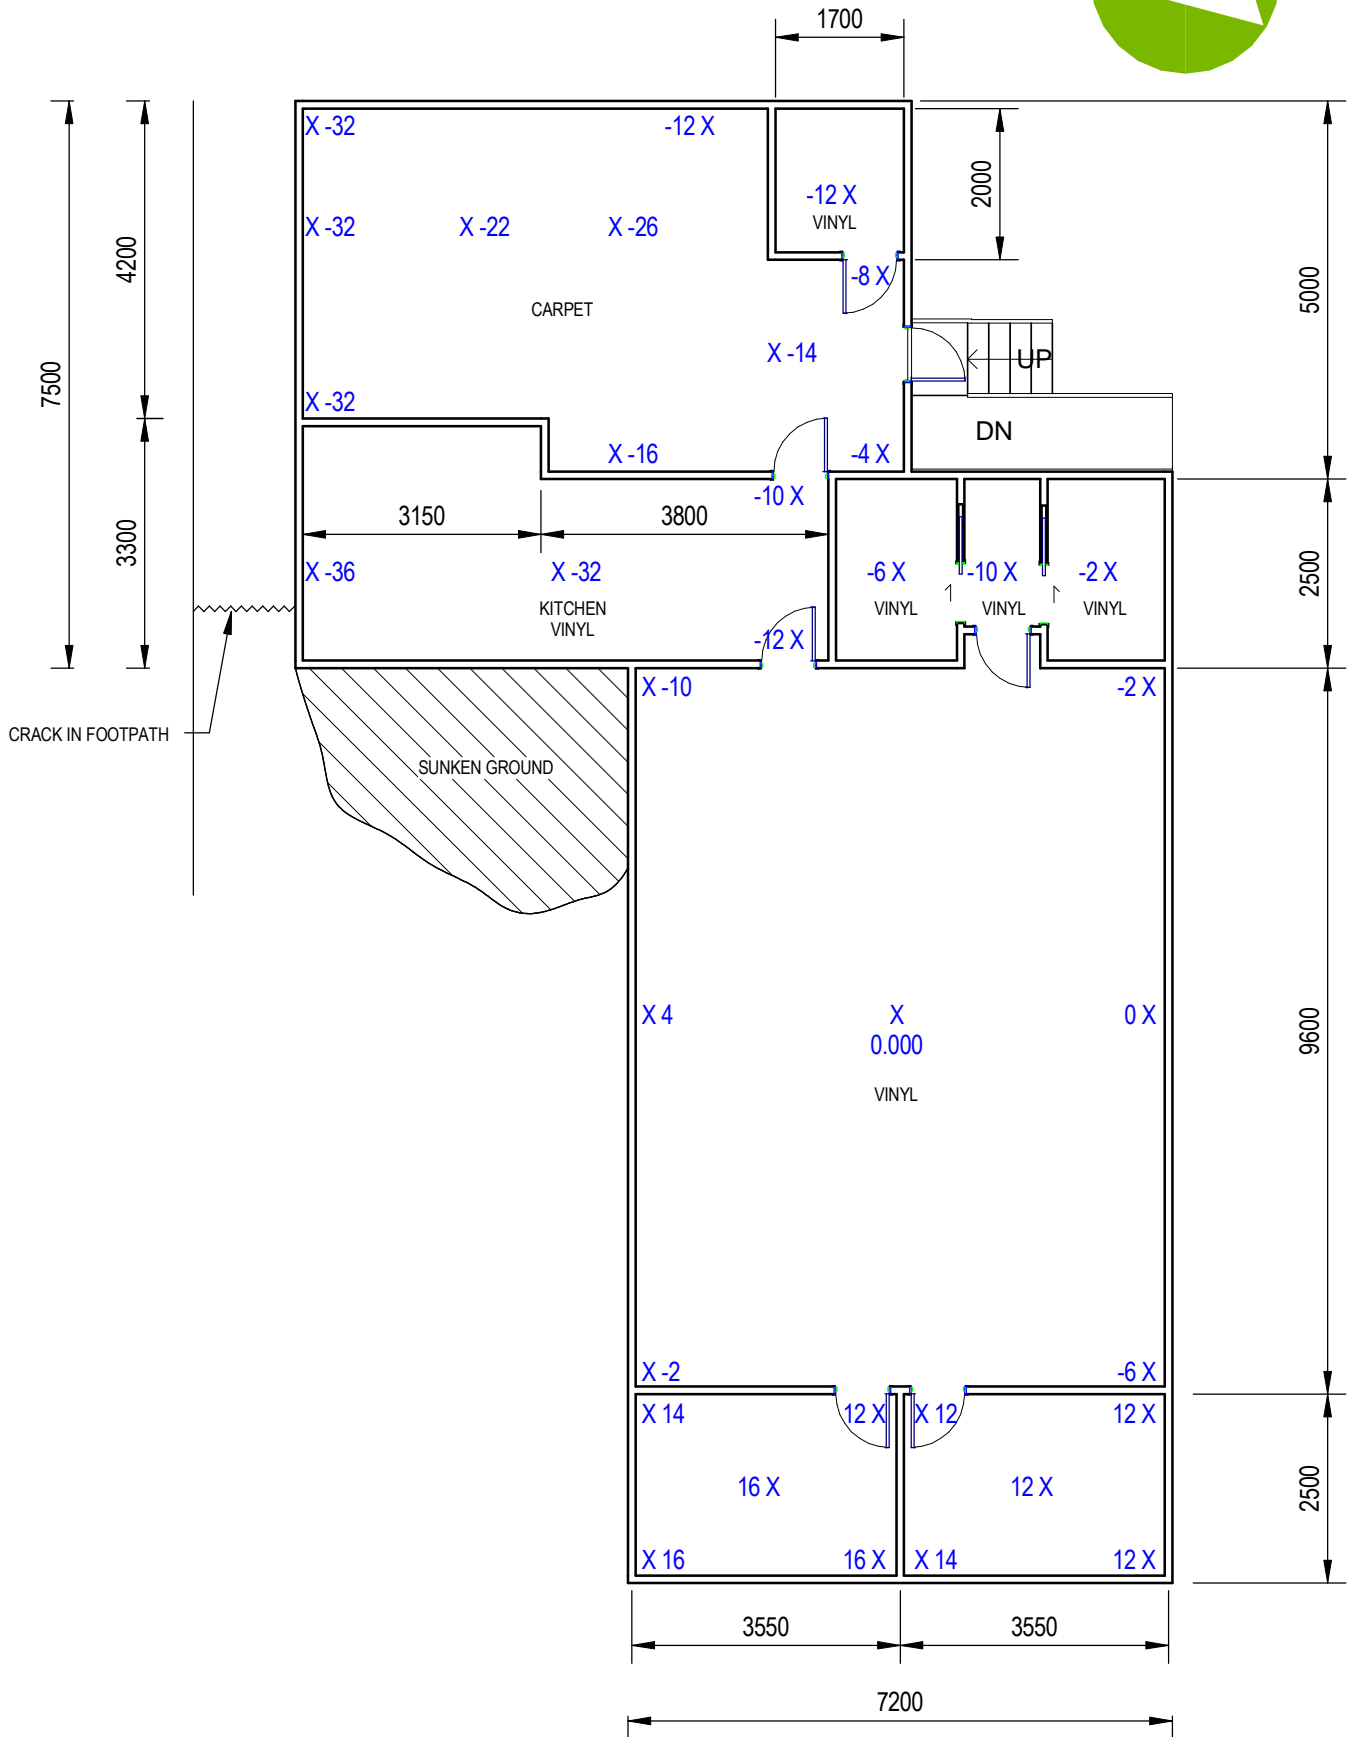
PROJECT	
SYDENHAM COMMUNITY CENTRE 21-27 HUTCHESON STREET	
TITLE	
LEVEL SURVEY

The floor levels for the Sydenham Community Centre are not within acceptable limits. The level damage was present before the earthquakes. It is recommended that the floor is re-levelled.
