Sydenham Crèche
BU 2194-001 EQ2
Detailed Engineering Evaluation
Quantitative Report
Version FINAL

113 Huxley Street, Sydenham

Christchurch City Council

Date
06/09/12

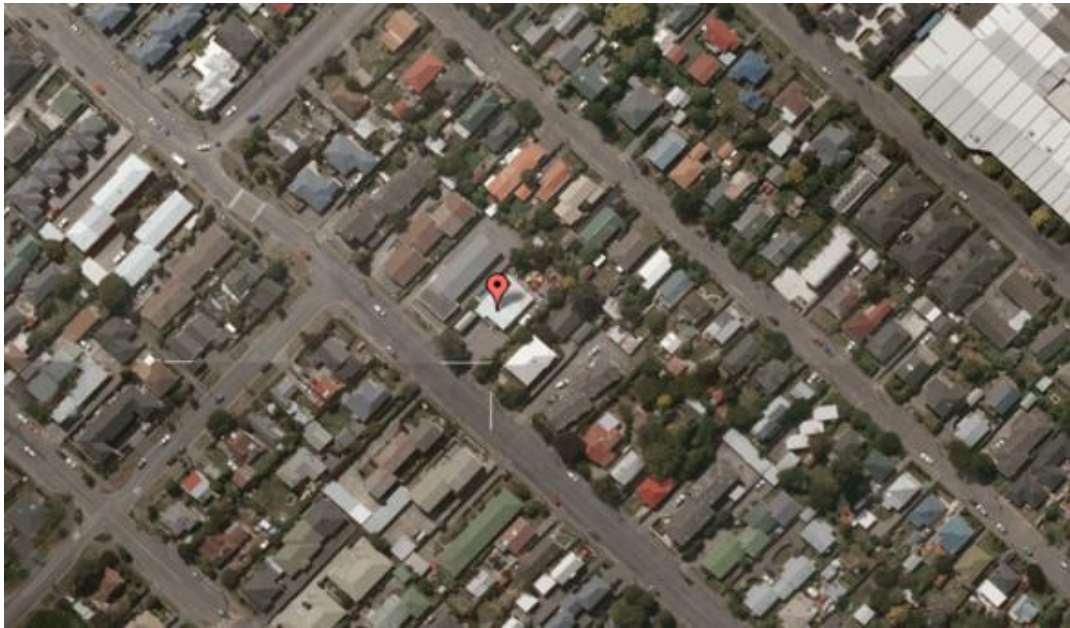
Figure 3 Post February 2011 Earthquake Aerial Photography³

Aerial photography taken following the 22 February 2011 earthquake shows no signs of liquefaction outside the building footprint or adjacent to the site, as shown in Figure 3.

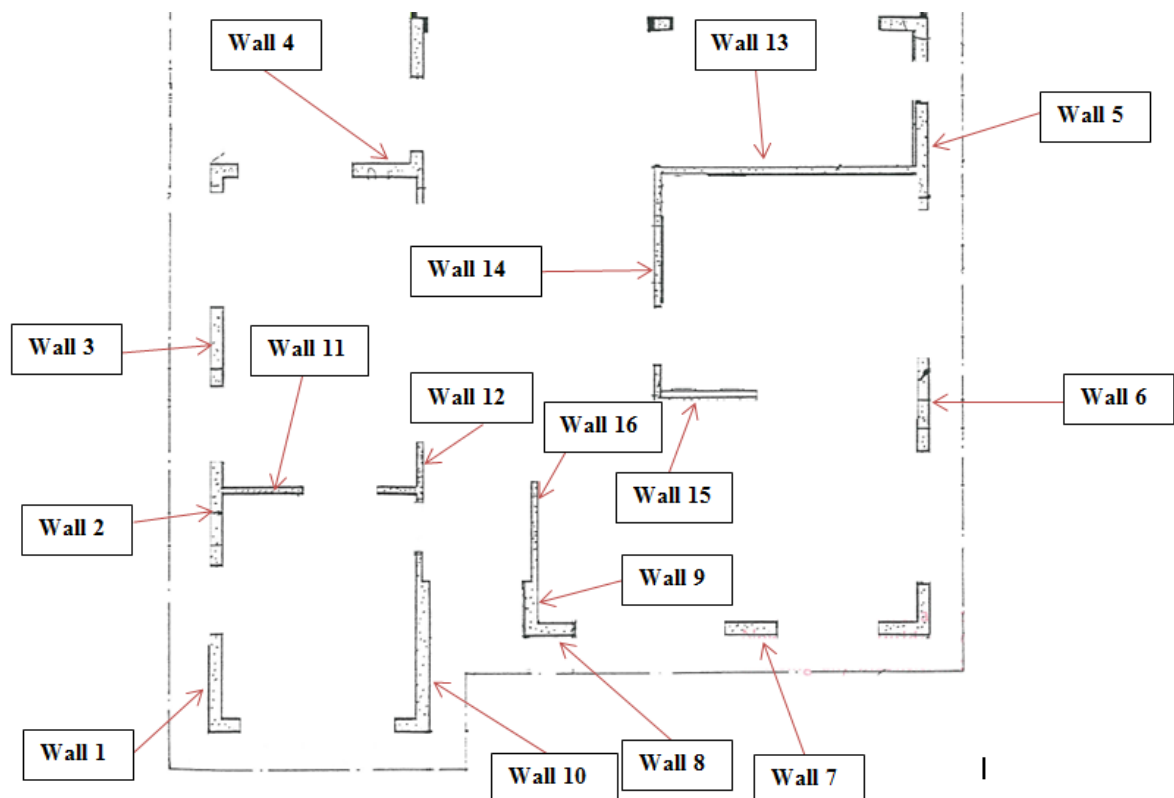
Figure 4 Walls assessed

The base shear demand of each wall highlighted in Figure 4 was assessed by completing a torsion analysis of the building which spread the seismic load between the walls of the building based on the dimensions of each wall. Loads were calculated both in and out of plane and the design base shear for each wall was calculated in accordance with Cl 5.3.1.2 of NZS 1170.5: 2004. Following the analysis it was found that Wall 7 has the lowest %NBS. The maximum base shear, V^* , for Wall 7 is:

Following detailed calculations being carried out, the in-plane %NBS was found to be in the order of 9%.

The out-of-plane flexural capacities of all the walls were calculated using the process outlined in the NZSEE Guidelines Section 10.3. The out-of-plane flexural capacity of the internal walls was found to be in the order of 8% NBS. The out-of-plane flexural capacity of the external walls was found to be in the order of 11% NBS.

As the %NBS of the building has been assessed at 8%, additional works are required to increase the in and out of plane capacity to achieve the minimum 67% as recommended by The New Zealand Society for Earthquake Engineering (NZSEE).

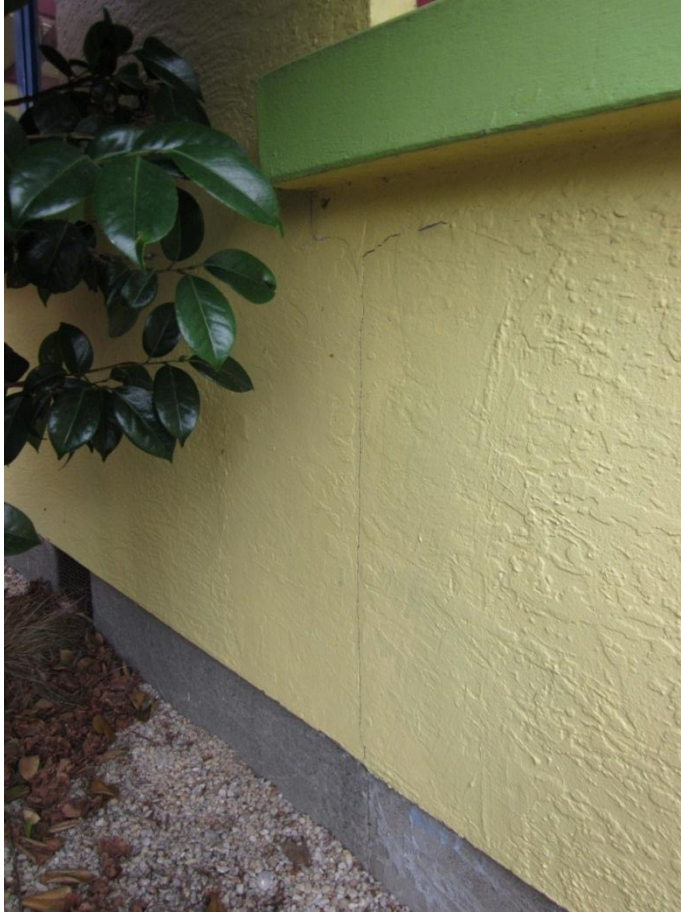
Photograph 3 Cracking below window at construction joint between the original building and the 1971 extension on the south-west.

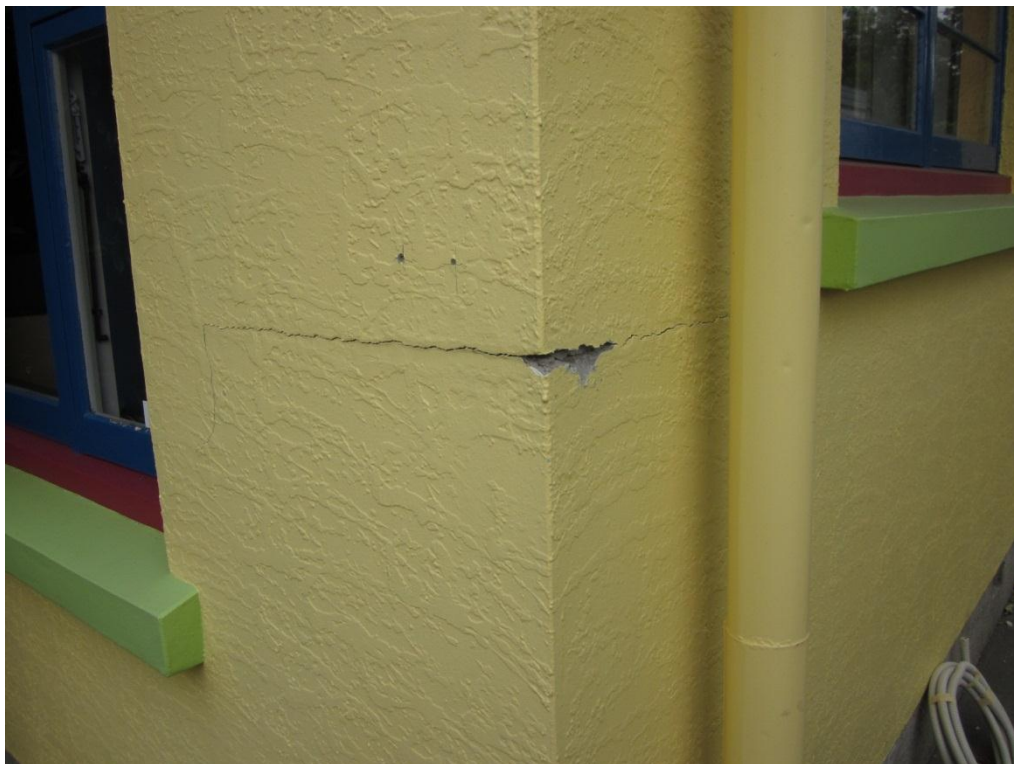
Photograph 4 Horizontal cracking traversing around the southernmost corner of the building, above and below window level.

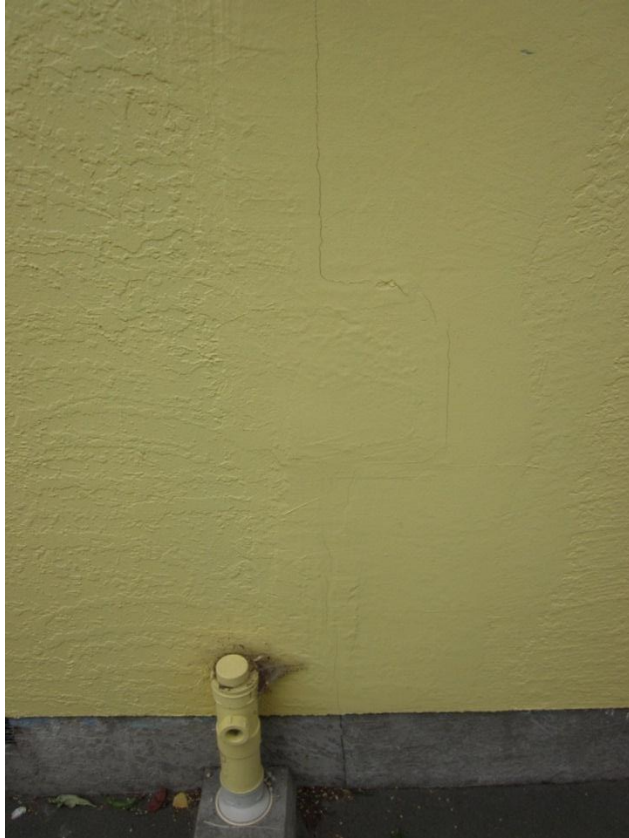
Photograph 5 Cracking along the construction joint between the original building and 1971 extension on the south-east wall.

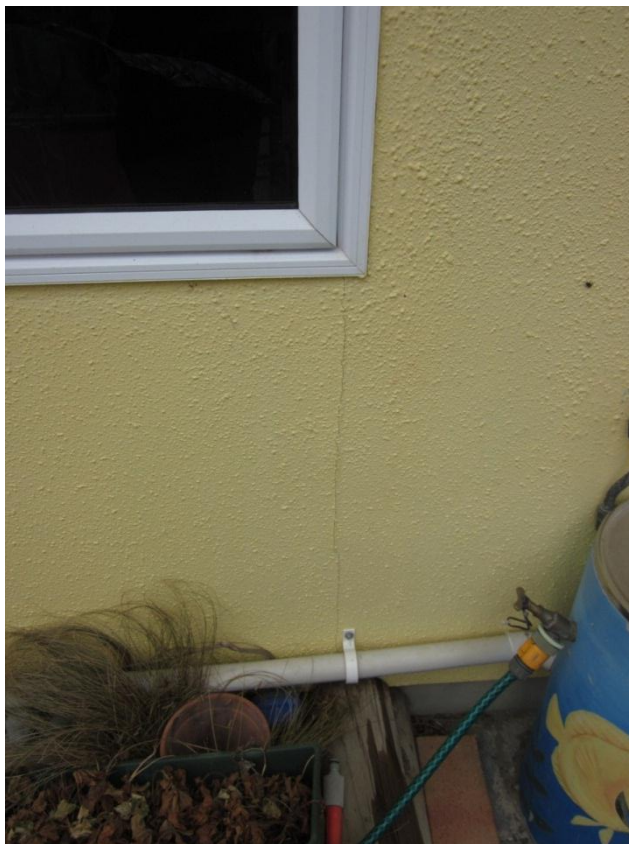
Photograph 6 Cracking below windows of the 1996 extension to the north-east of the building.

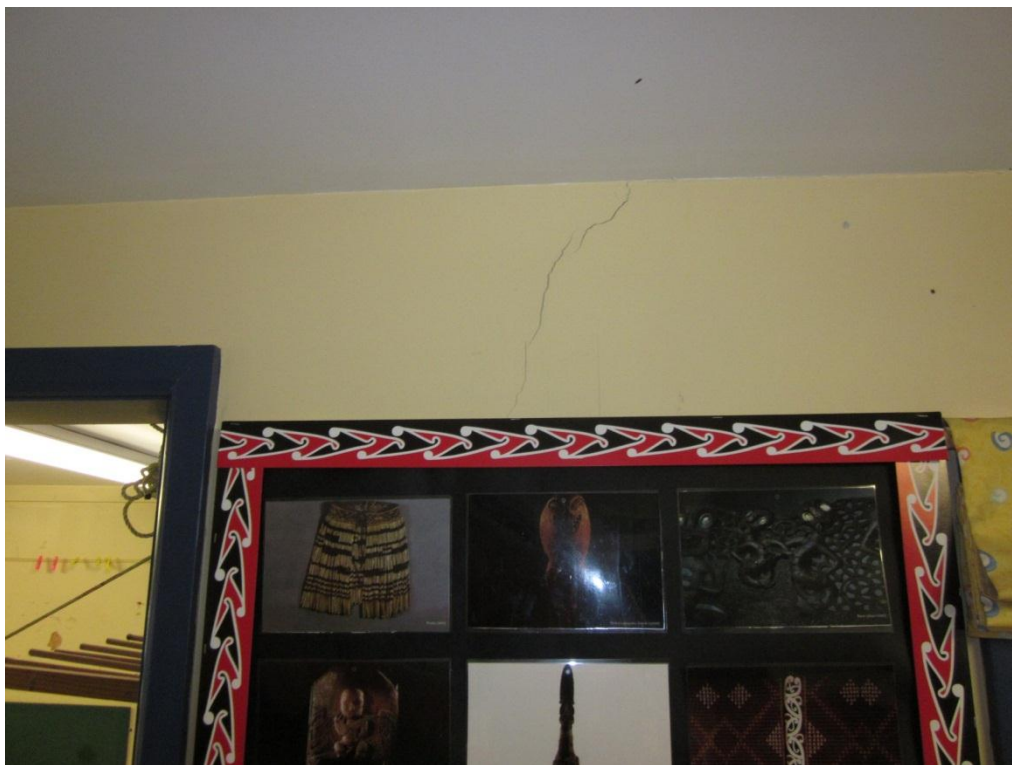
Photograph 7 Cracking of masonry wall where external walls connect to internal .

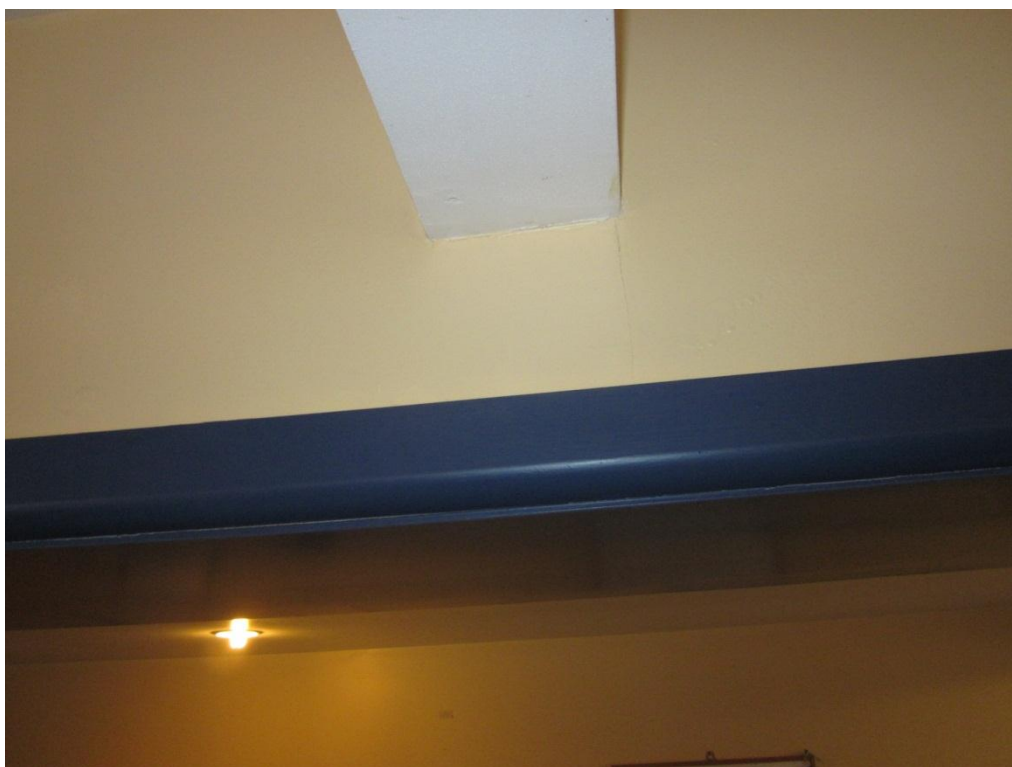
Photograph 8 Cracking to plasterboard lining around purlin, above opening to 1996 extension.

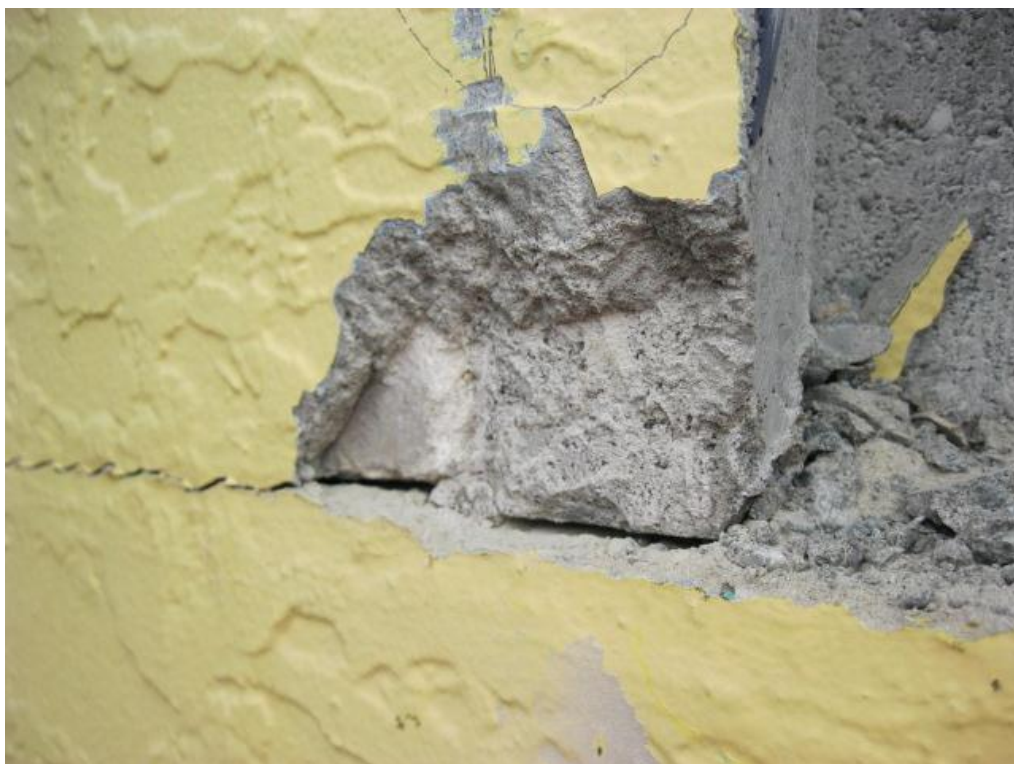
Photograph 12 Cracking penetrates through the wall along the mortar joint.

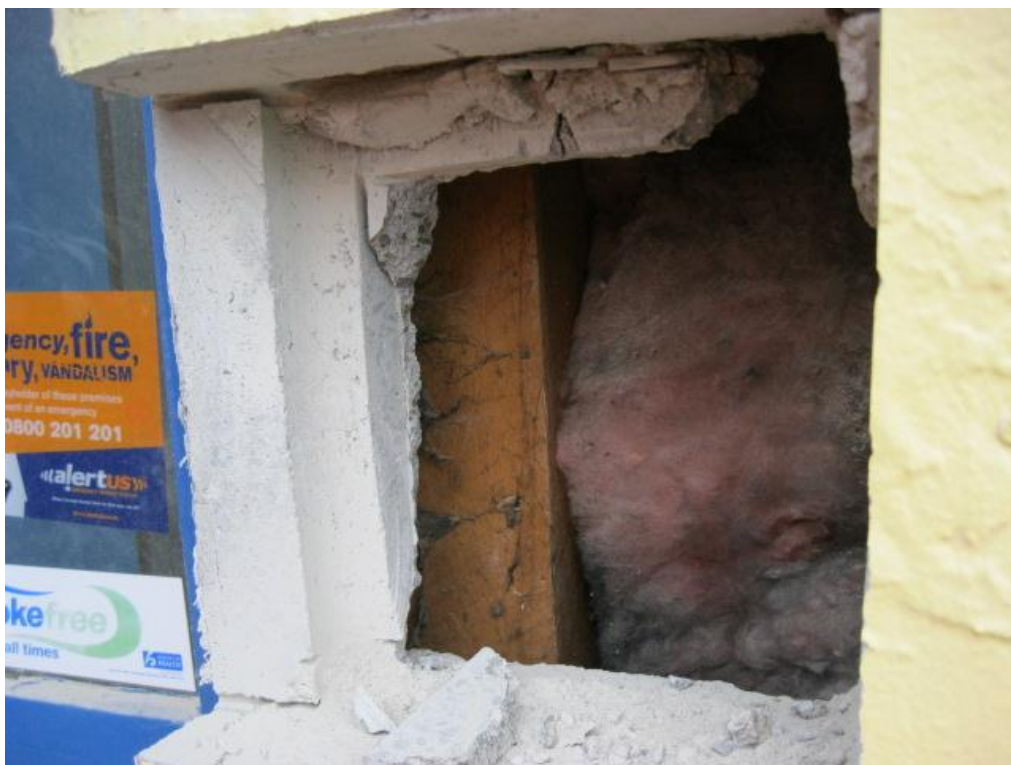
Photograph 16 No evidence of expected steel reinforcement as shown in CCC plans.

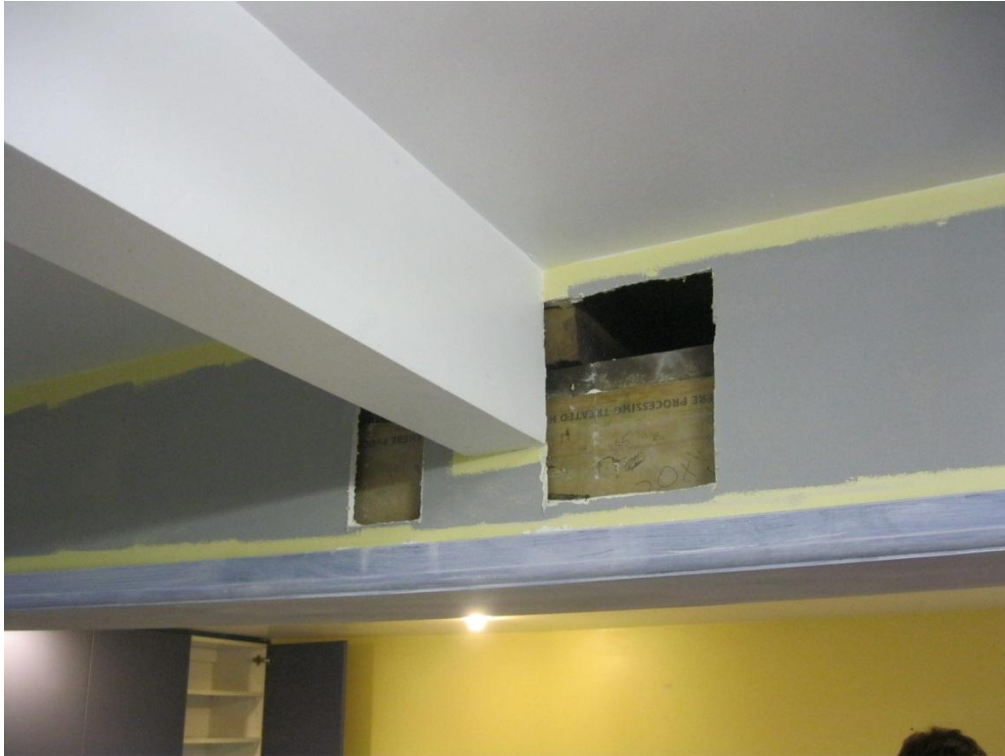
Photograph 19 Opening up around the connection of the 1996 extension beam to the roof support lintel. Connection detail differs to detail on record.

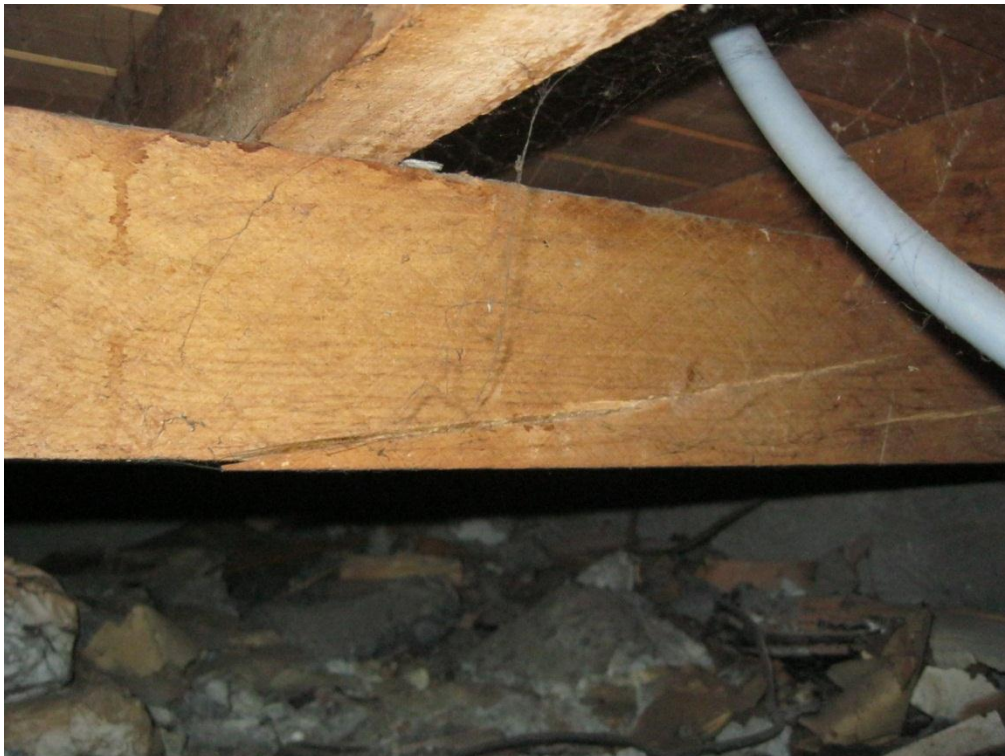
Photograph 20 Cracking noted to suspended timber ground floor bearers following opening up of a section of the floor.
