CHRISTCHURCH CITY COUNCIL
BU 1662-006 EQ2
Templeton Pool – Covered BBQ Area
62 Kirk Road, Templeton

QUALITATIVE ASSESSMENT REPORT

- Rev B
- 23 May 2013

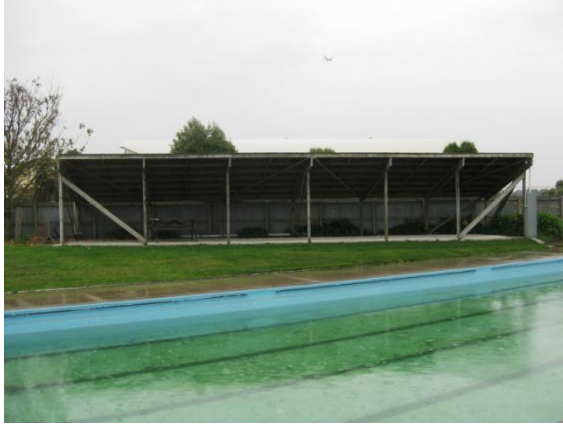
Photo 1: Front Elevation of Structure

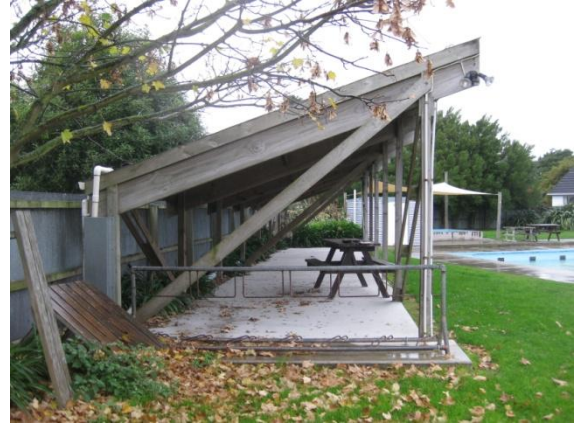
Photo 2: Side Elevation of Structure

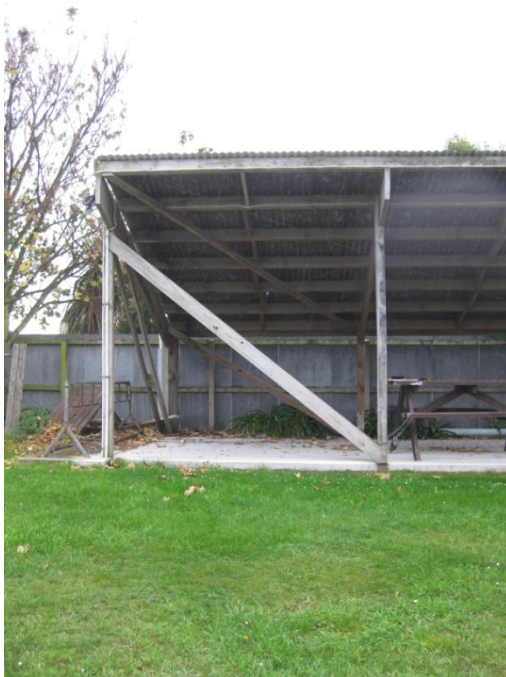
Photo 3: Typical Bracing

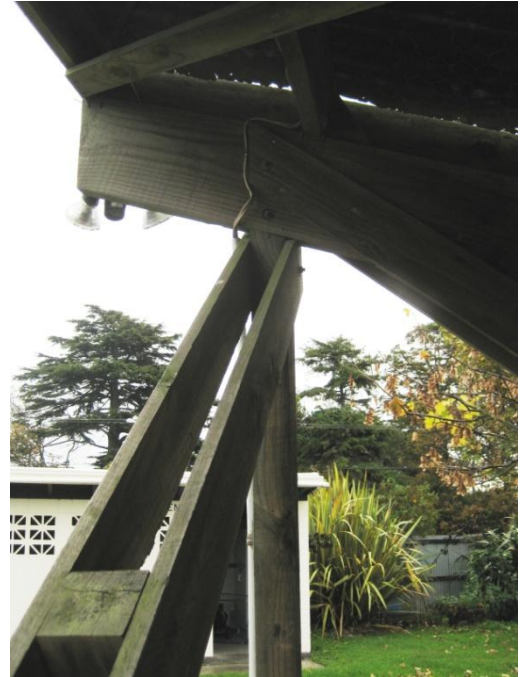
Photo 4: Bracing Connection

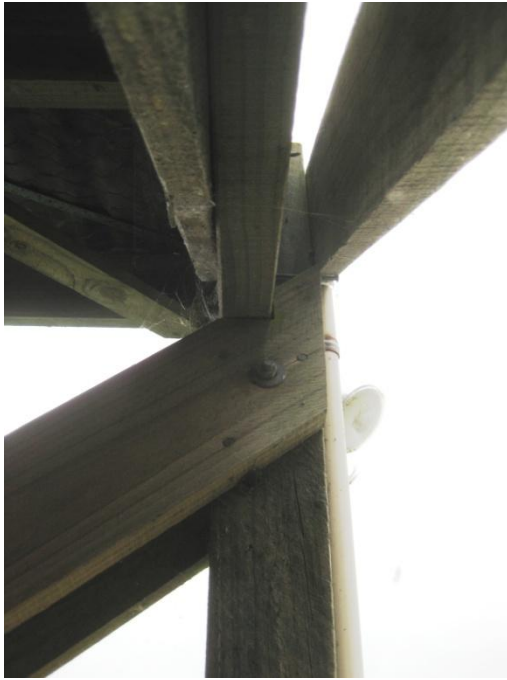
Photo 5: Close up of Bracing Connection

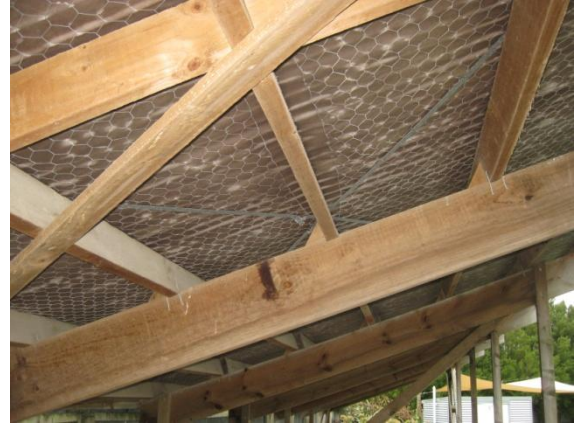
Photo 6: Roof structure

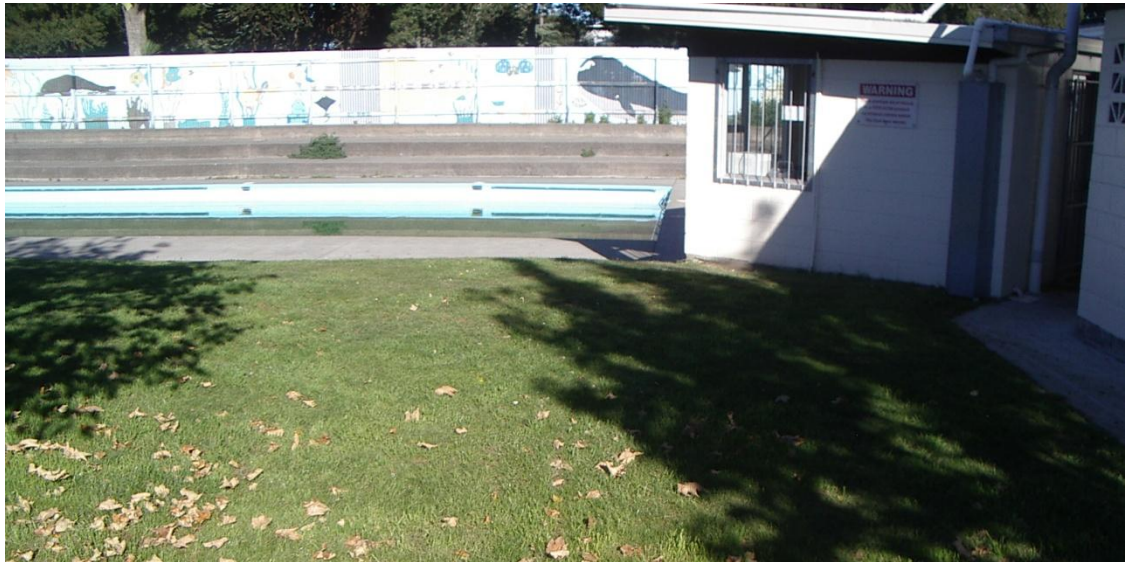
■ **Figure 4 Overview of the pool**

There is no evidence of damage to any of the structures /fences from the external inspection. There is no evidence of any land damage.
