CHRISTCHURCH CITY COUNCIL  
BU 1662-005 EQ2  
Templeton Pool – Toddlers Pool Plant Room  
62 Kirk Road, Templeton

QUALITATIVE ASSESSMENT REPORT

- Rev B
- 23 May 2013

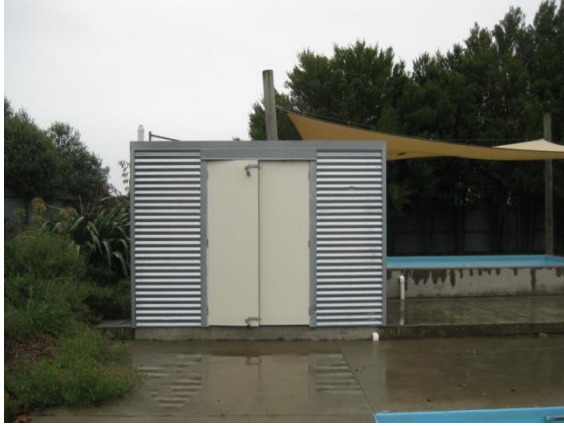
Photo 1: Front Elevation of Building

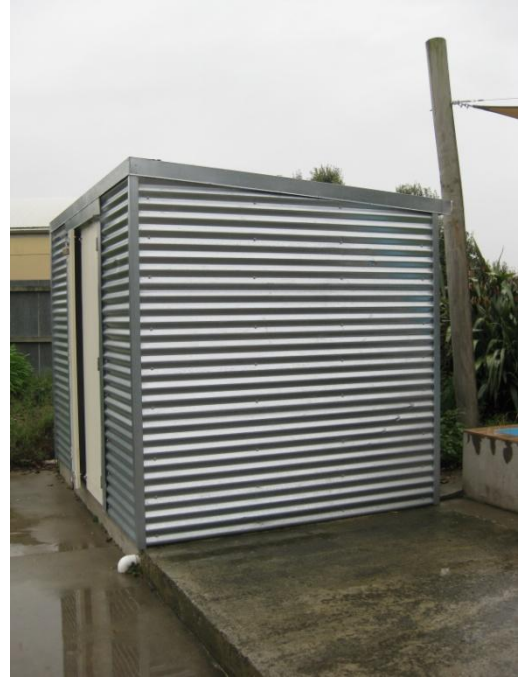
Photo 2: Side Elevation of Building

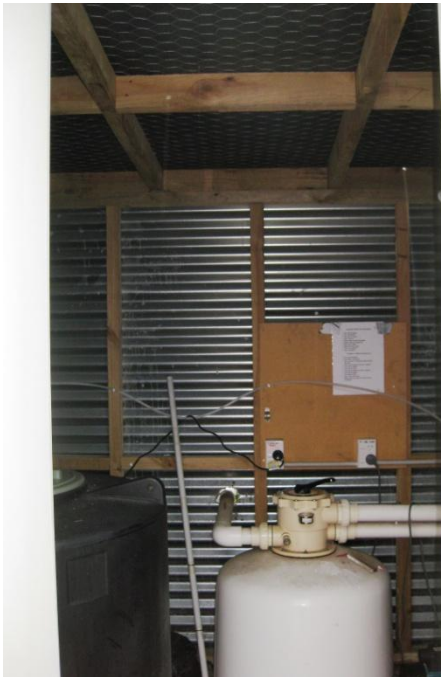
Photo 3: Internal View

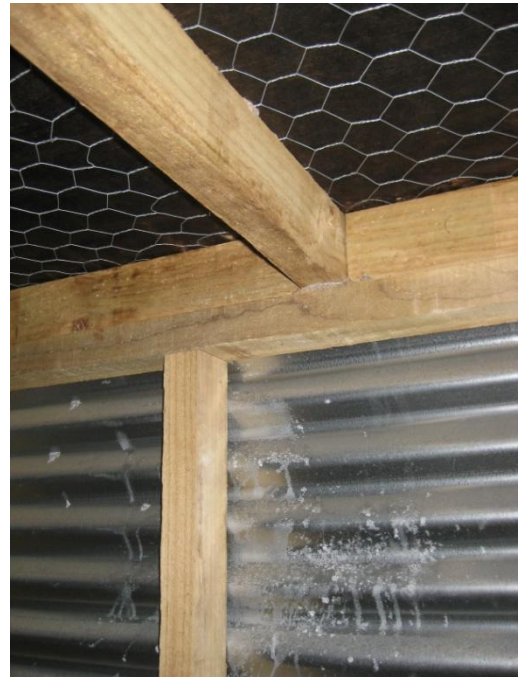
Photo 4: Typical Roof Structure Details

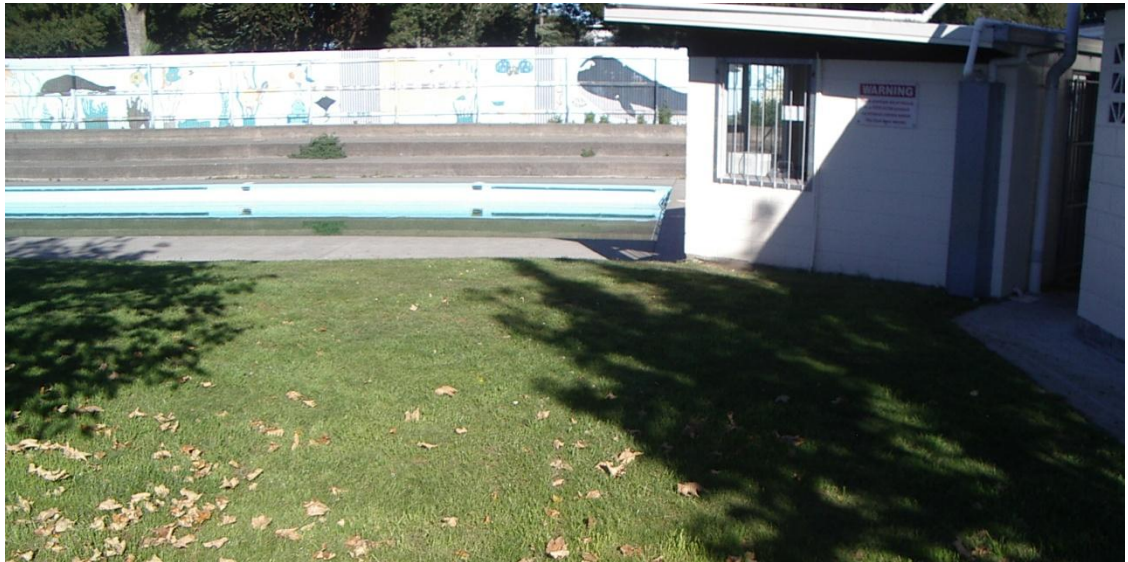
There is no evidence of damage to any of the structures /fences from the external inspection. There is no evidence of any land damage.

■ **Figure 4 Overview of the pool**

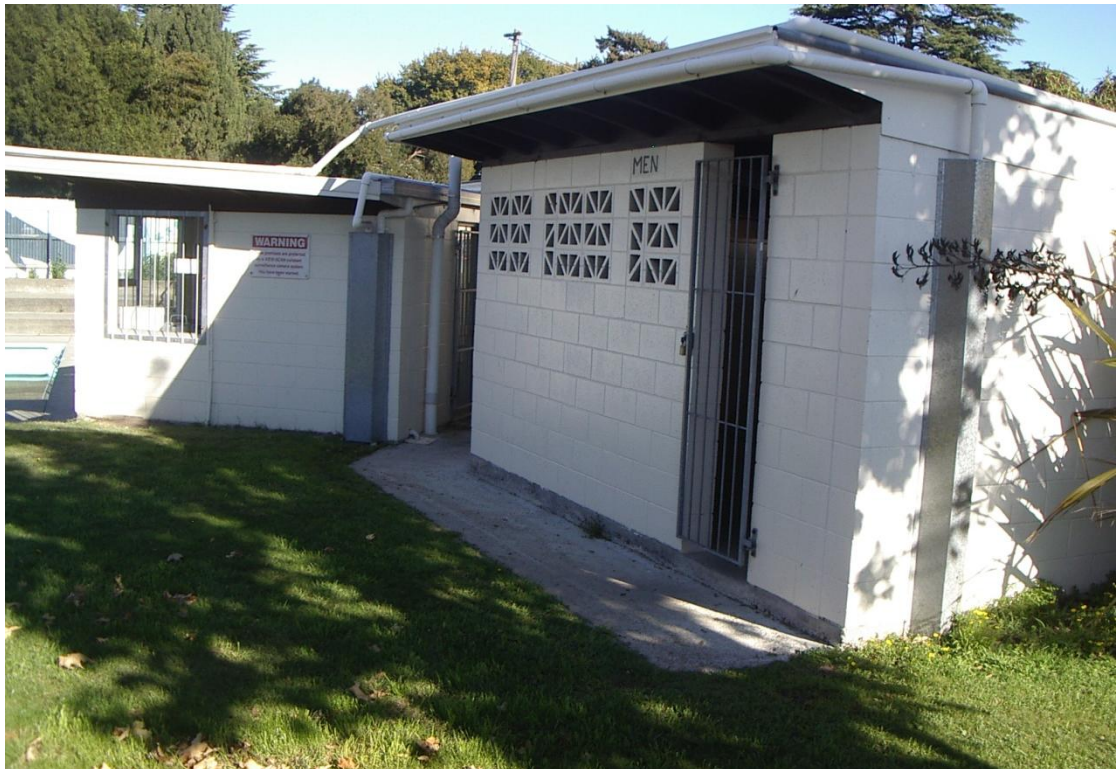
■ **Figure 5 Overview of Toilet block and changing rooms**
