Thames Courts Housing Complex PRO 2156

**Detailed Engineering Evaluation
Quantitative Assessment Report**

Thames Courts Housing Complex Quantitative Assessment Report

Date: February 2014
Reference: 6-QC405.00
Status: Final

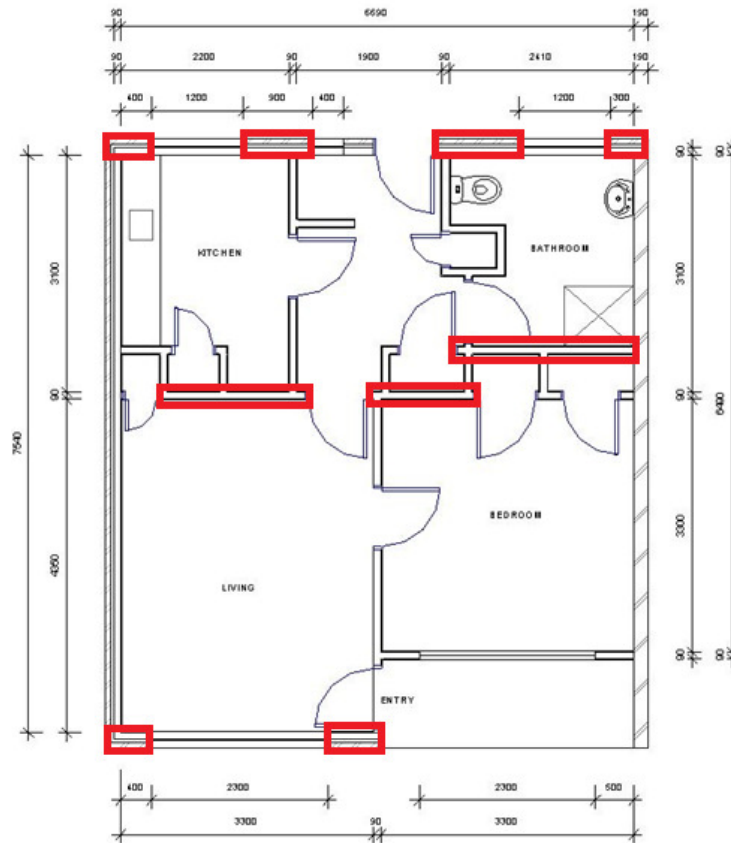
Figure 6: Walls used for bracing in the longitudinal direction.

The residential units have a capacity of 46% NBS as limited by the in-plane shear capacity of the timber-framed shear walls in the longitudinal direction. They are deemed to be a 'moderate risk' in a design seismic event according to NZSEE guidelines.

- Strengthening schemes be developed to increase the seismic capacity of all units to at least 67% NBS.
- Cosmetic repairs be undertaken as required.

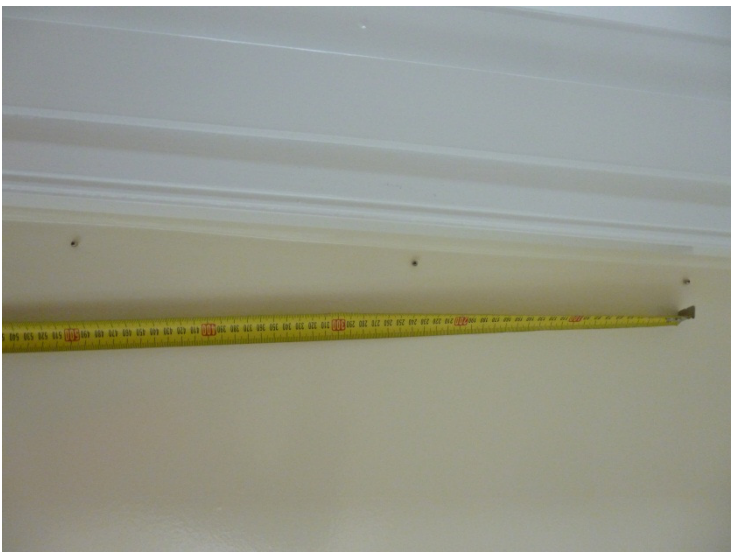
9.	GIB nail spacings (250mm)

Increasing the number of nails in the plasterboard will not significantly improve the strength of the buildings.

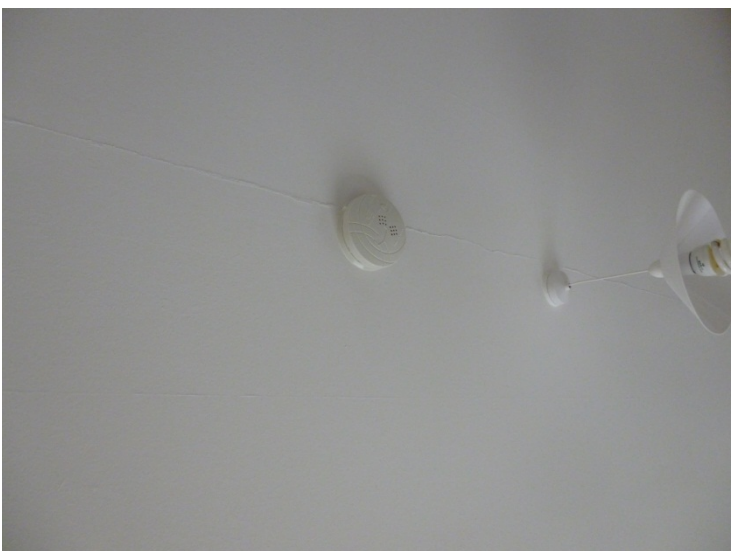
Minor cracking was also observed to some internal linings, mainly around the doors and windows and in several units across the ceiling in the living room (photos 10 and 11). This damage is deemed low and not to affect the lateral-resistance structure.

10.	Crack through centre of lounge ceiling

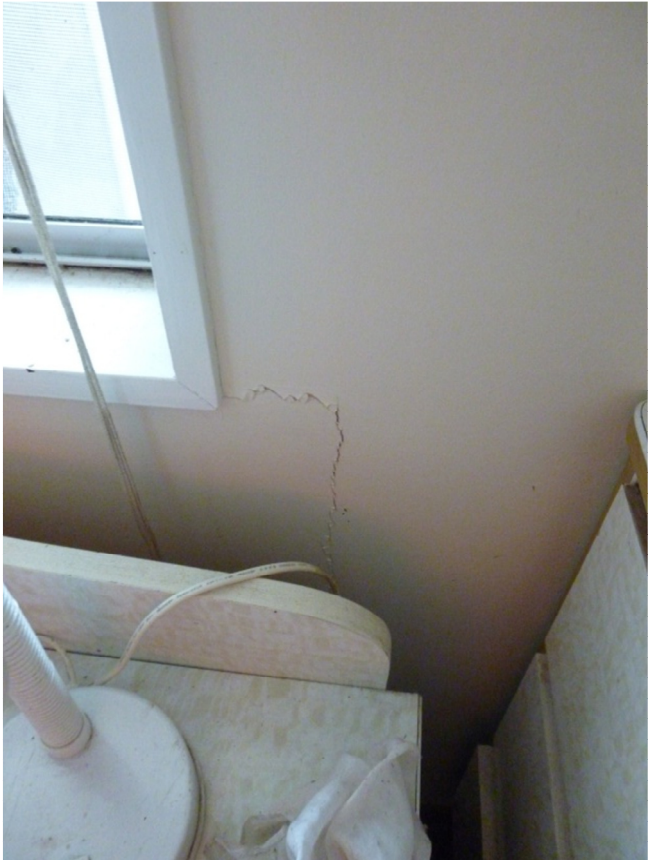
<p>11.</p>	<p>Typical cracking from windows observed in all units</p>

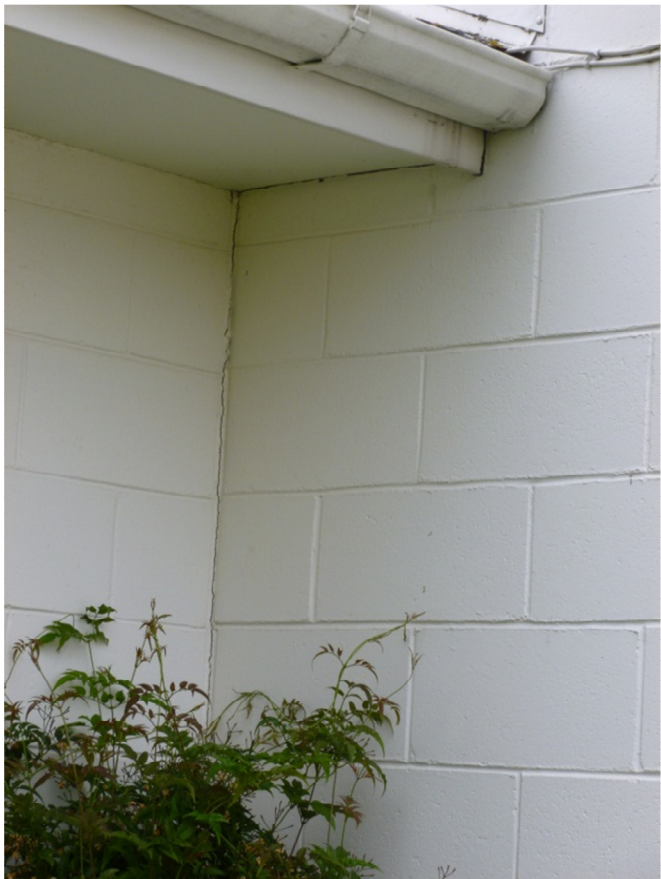
Minor damage was observed to non-structural elements. This included small amounts of cracking to paths around the complex. Non-structural damage observed to the exterior veneers of the units included minor stepped cracking (photo 13) to most units particularly under windows and a vertical crack between the fire wall of Unit 6 and Unit 7 (photo 12).

A photograph showing a white wall with a window above. There is a significant vertical crack in the wall, extending downwards from the window frame. The wall appears to be made of a light-colored material, possibly plaster or concrete. A white pipe or cable runs down the wall to the left of the crack. In the foreground, there is a white circular object, possibly a lamp base, and some other items on a surface.
<p>12.</p>	<p>Separation of Unit 7 from Unit 6 fire wall (observed front and back)</p>

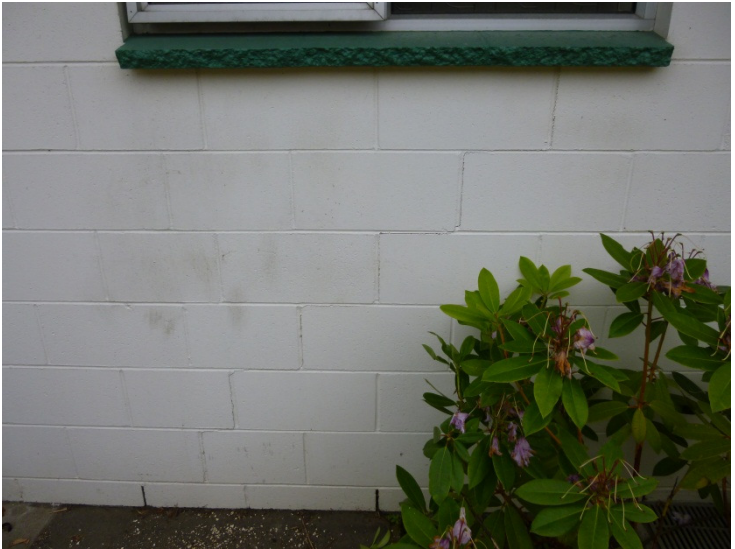
13.	Stepped cracking in veneers of units
