**CHRISTCHURCH CITY COUNCIL**  
PRK\_2347\_BLDG\_003 EQ2  
Travis Wetlands – Information Kiosk  
280 Beach Road, Parklands

QUALITATIVE ASSESSMENT REPORT

FINAL

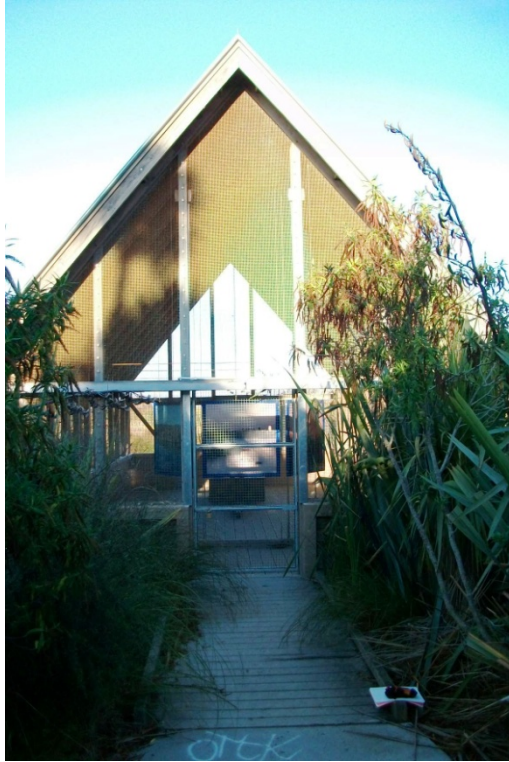
Photo 1: Information Kiosk - Eastern Elevation

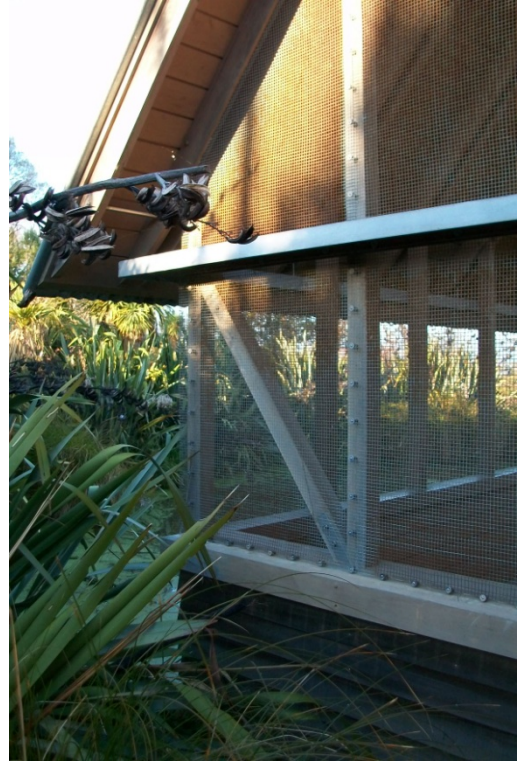
Photo 2: SE Corner Details

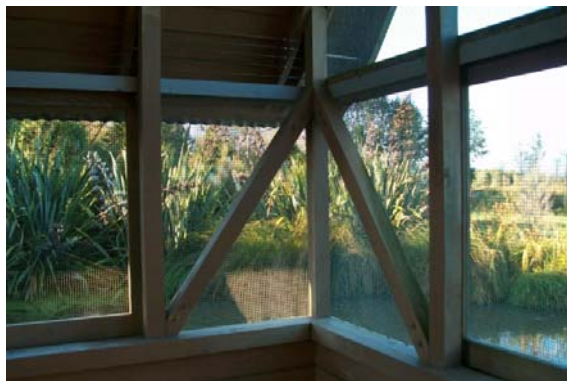
Photo 7: Corner Bracing -Typical

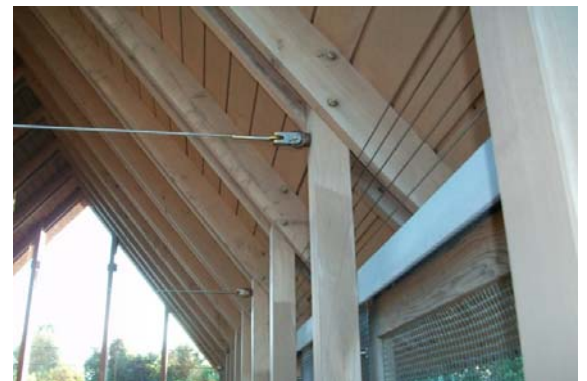
Photo 8: Wall Tie Detail

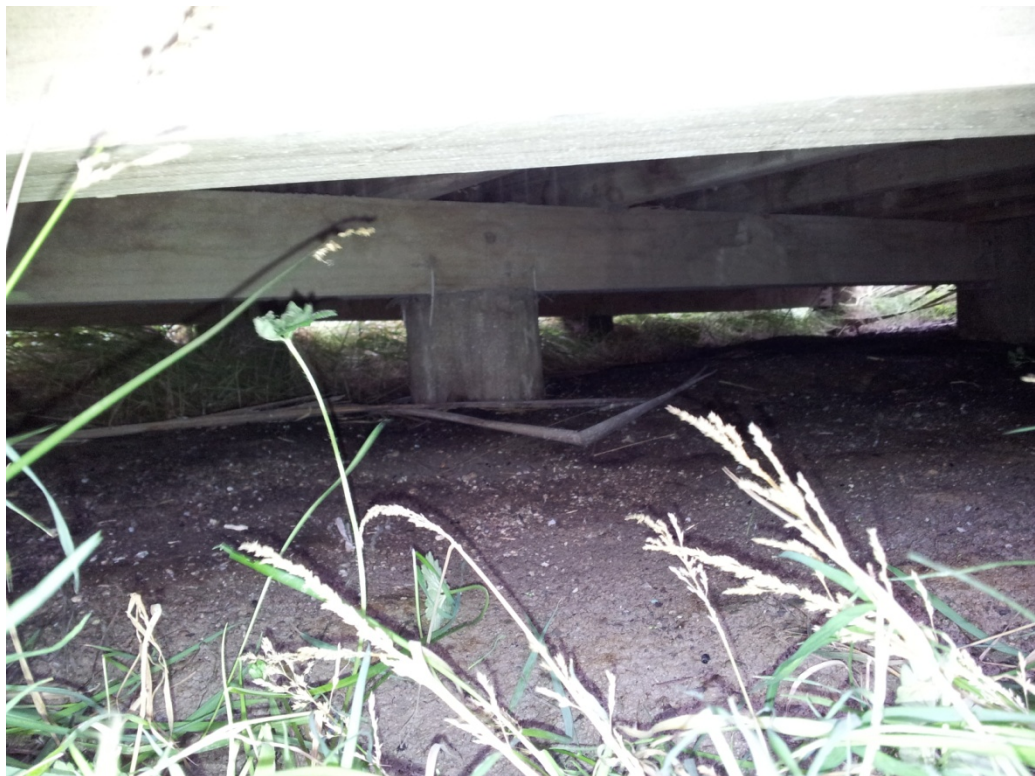
■ **Figure 13 – Foundation details of the bird hide**

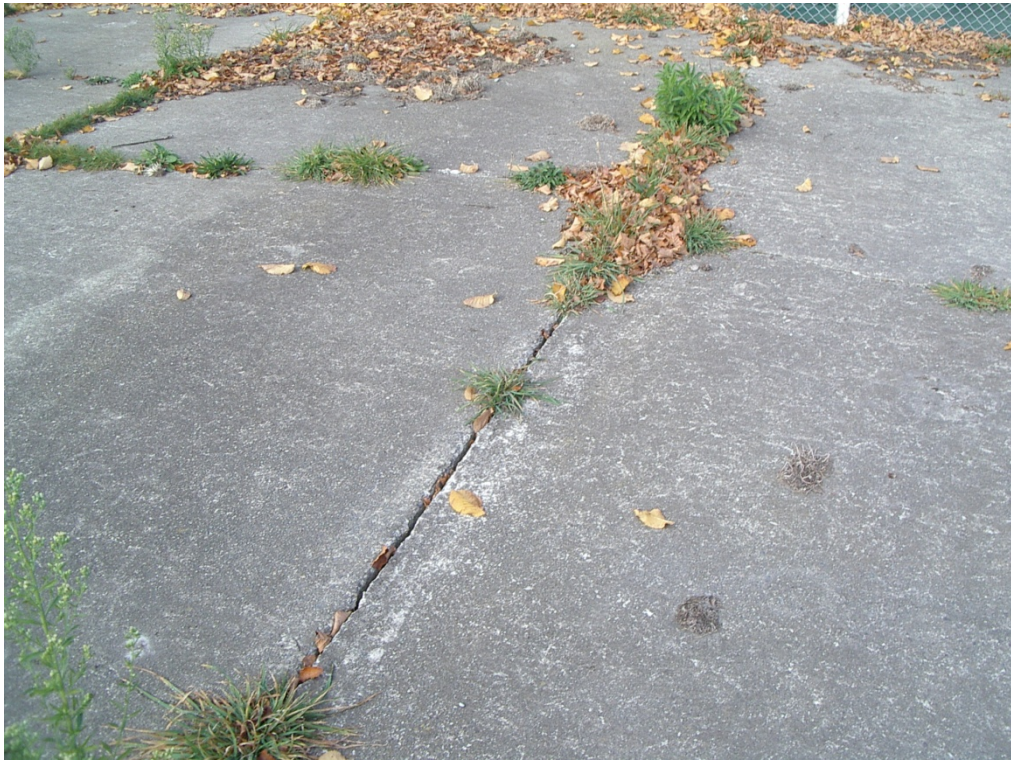
■ **Figure 16 - Noted damage to the concrete paving**

The performance to date suggests that in general the existing foundations are adequate for their current purpose. However some damage to the concrete slab supporting the barn structure was noted. From the site walkover it was noted that the shallow piled foundations in general performed better than the slab foundations.

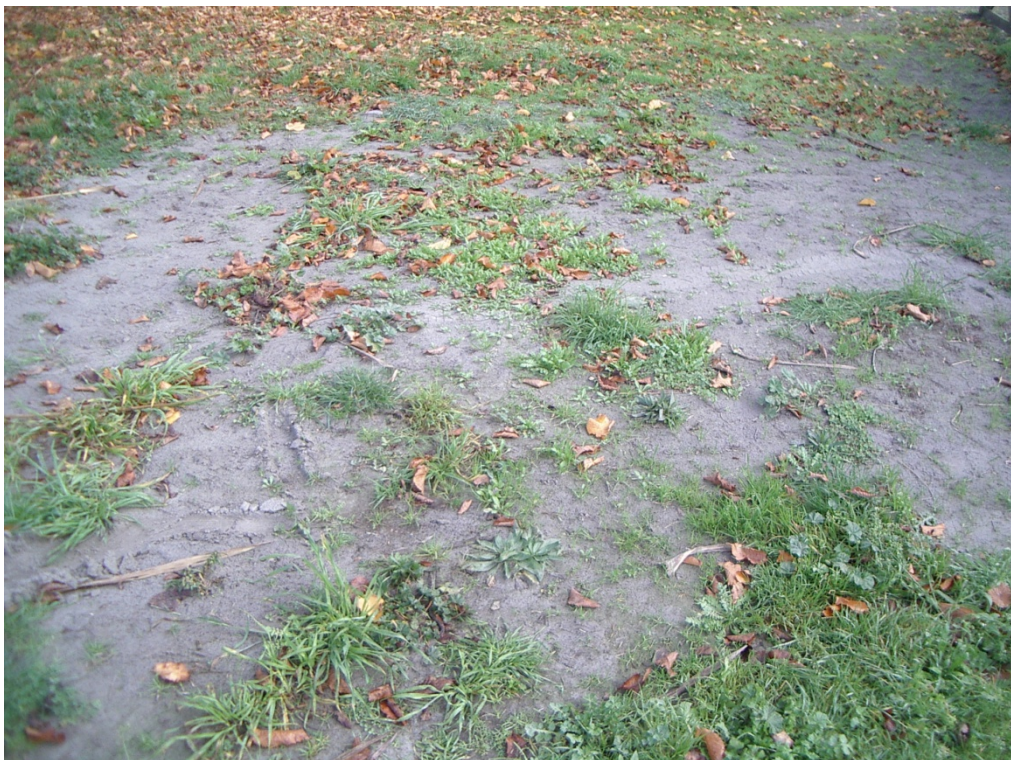
■ **Figure 17 - Ejected sand**
