CHRISTCHURCH CITY COUNCIL
PRK_2347_BLDG_004 EQ2
Travis Wetland Toilets
280 Beach Road, Burwood

QUALITATIVE ASSESSMENT REPORT
FINAL

- Rev B
- 23 May 2013

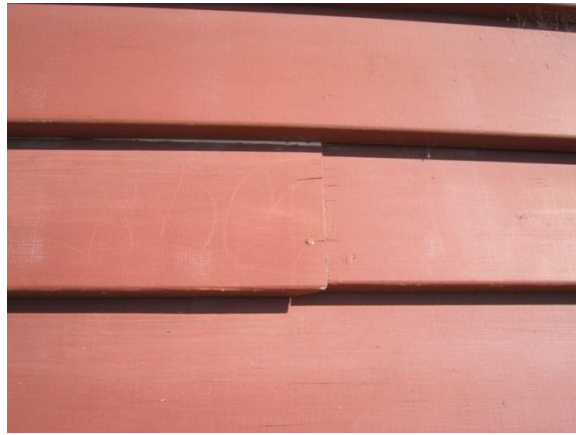
- 1) Hairline cracks in concrete ground slab in male toilet (see Photos 11 & 12), however it is not clear whether this is a result of earthquake damage.
- 2) Slightly dislodged weatherboard on east wall (see Photo 5). This is very minor non-structural damage therefore a repair solution will not be recommended.
- 3) Plant material was observed growing inside the male toilets at gutter level (see Photo 10). This is not earthquake damage, but indicates weather-tightness is not achieved.

Photo 5: Dislodged weathboard on east wall

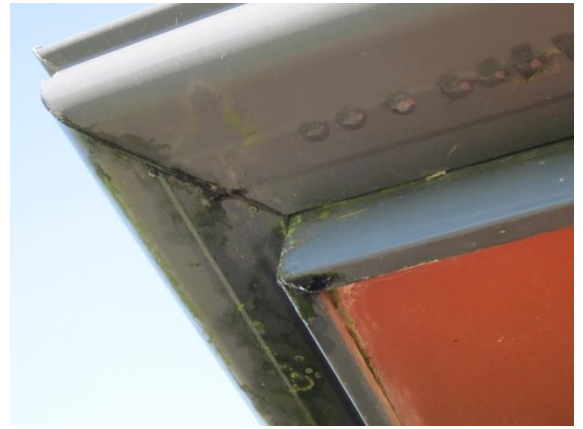
Photo 6: Water damage to underside of gutter (typical)

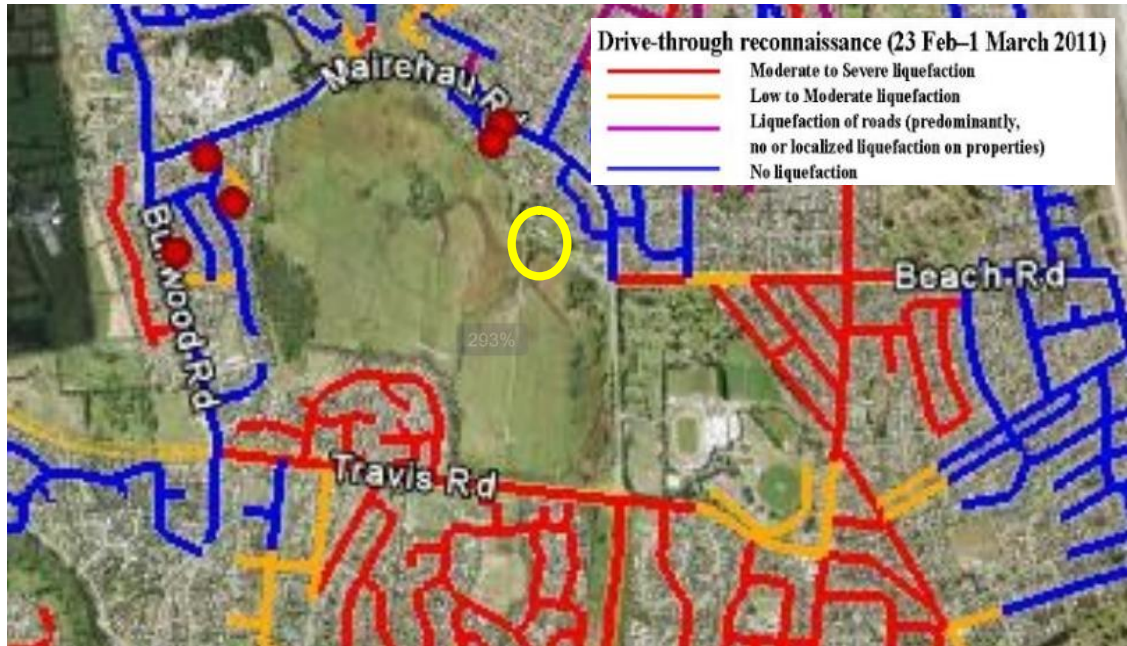
■ **Figure 4 – Liquefaction map (Cubrinovski & Taylor, 2011). Site marked in yellow.**

Following the 22 February 2011 event drive through reconnaissance was undertaken from 23 February until 1 March by M Cubrinovski and M Taylor of Canterbury University. Their findings show no liquefaction on Mairehau Road and Medina Crescent to the north east and moderate to severe liquefaction on Beach Road to the east.

However, as the drive through reconnaissance did not continue to the immediate location of the site and as the site is inferred to be underlain by a different geological formation, the level of liquefaction noted above may not be relevant for the site itself.

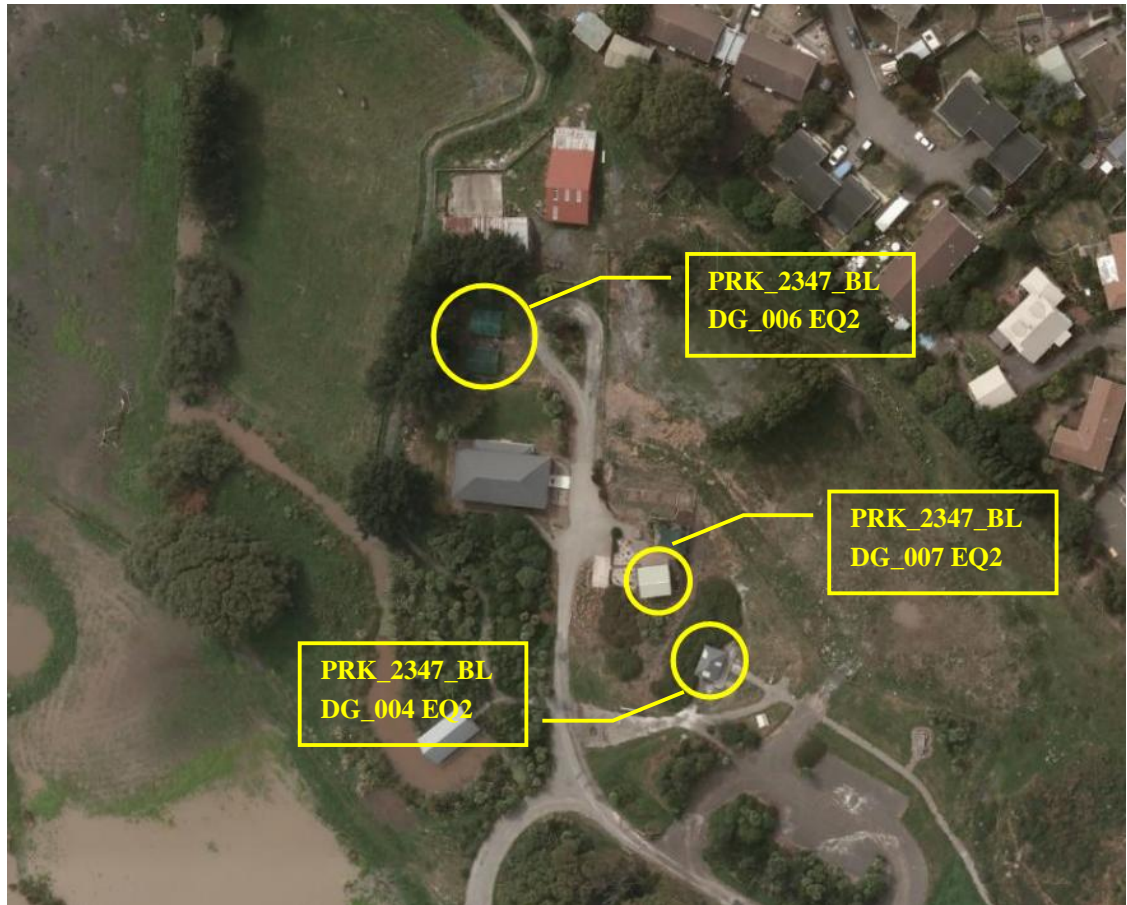
■ **Figure 5 – Aerial photography from 24 Feb 2011 (<http://viewers.geospatial.govt.nz/>)**

A reasonably significant amount of liquefied ejecta could be seen on Beach Road and in land areas around the structures. Due to the presence of the lake to the west, it is expected that ground water level would be shallow beneath the site. This may explain the level of liquefaction noted. From the aerial photograph, no clear evidence of tension cracks or lateral movement towards the lake could be seen.

Additionally, from high level view of the structures there appears to be no catastrophic damage of the surrounding structures as a result of the seismic shaking and land damage caused by the earthquake event.

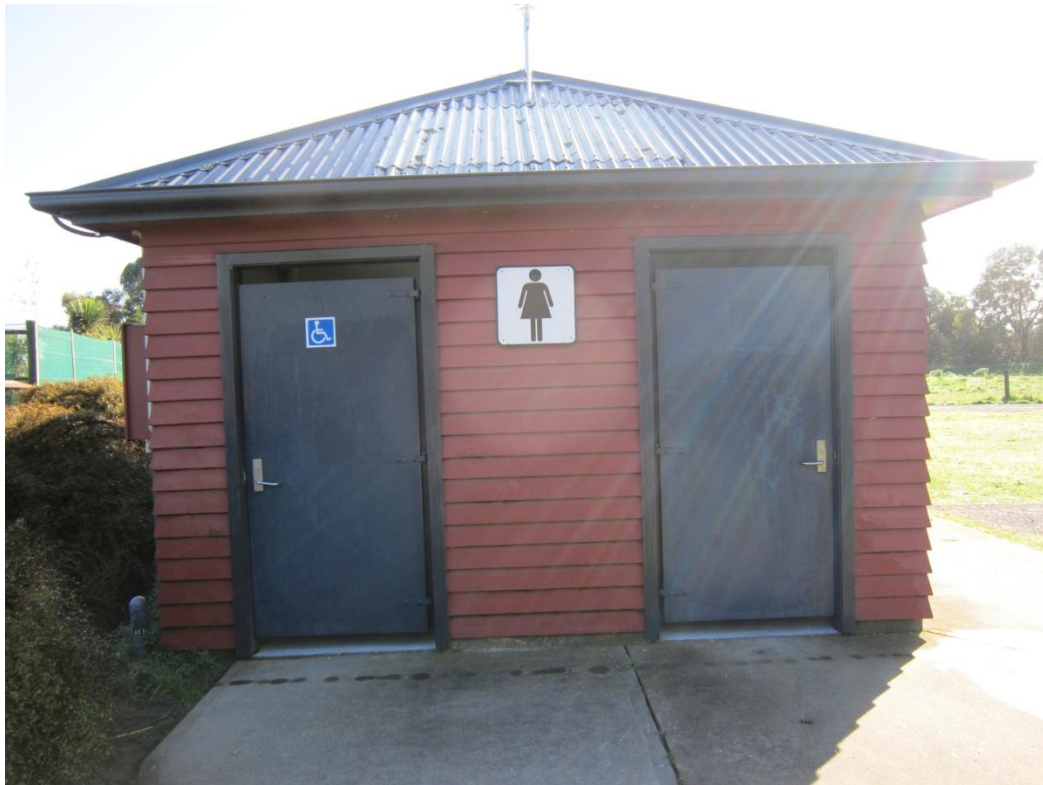
Additionally, hair line cracks were in the floor slab and some separation of the outside pavement slabs was noted. No significant evidence of settlement due to liquefaction was noted. Therefore, the above separation and settlement may have been caused by ground shaking.

■ **Figure 8 - Small separation of the pavement slabs**

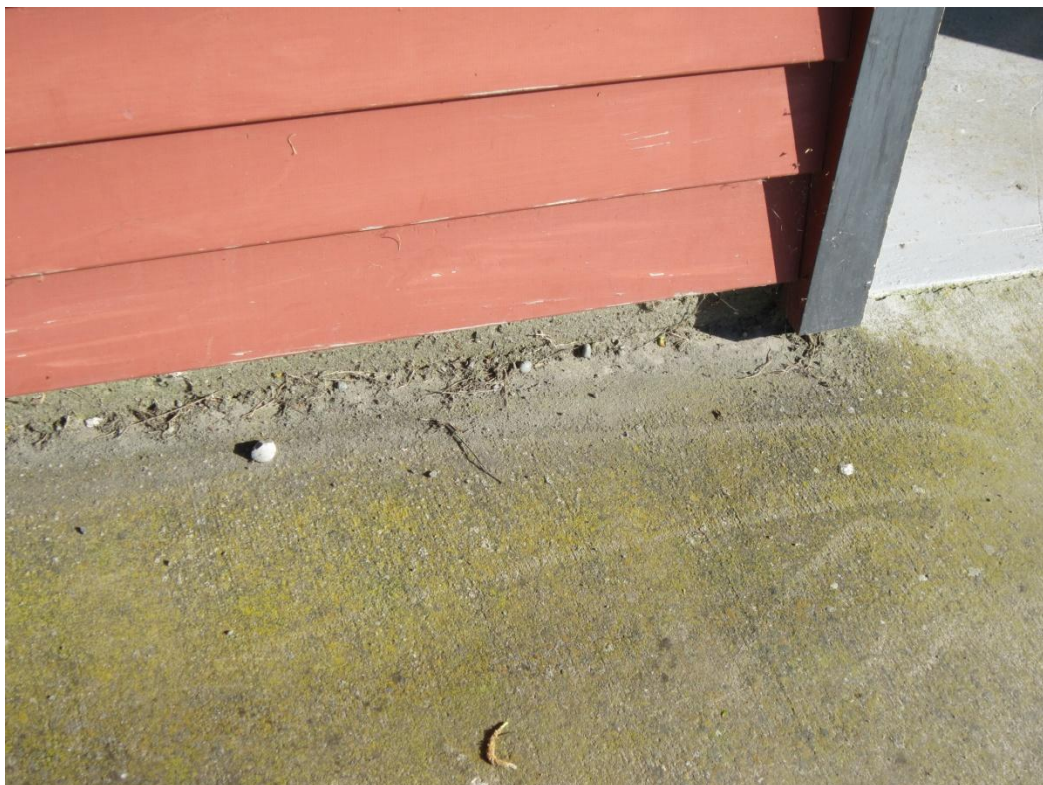
■ **Figure 9 - Remaining silt ejecta from the earthquake event**

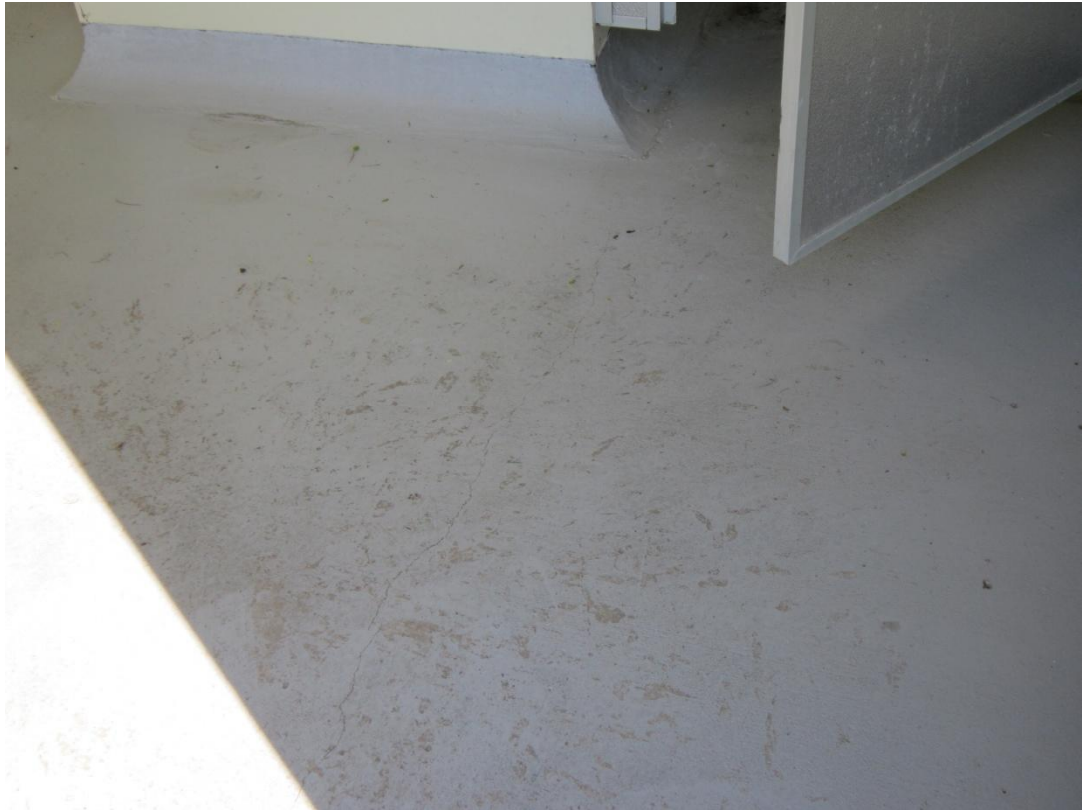
■ **Figure 10 - Hair line cracks in the floor slab**

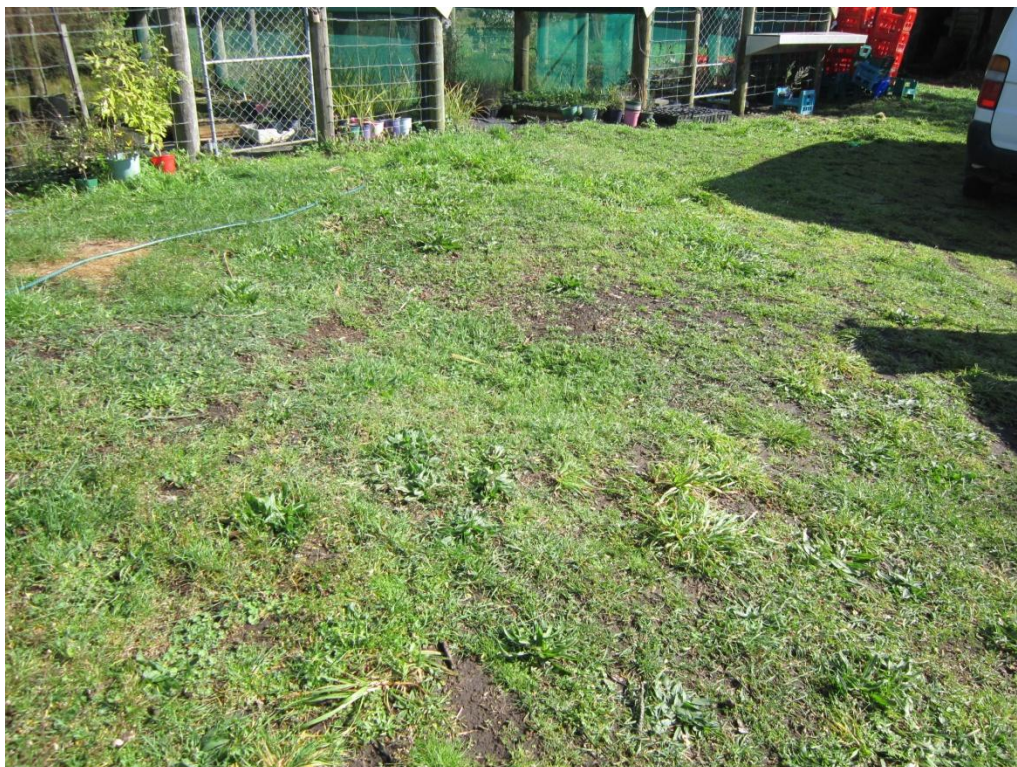
Undulating ground was noted around the structure. However, this topography is expected to have existed before the earthquake. Some loose silt and sand material at ground surface was noted, which may be remnant ejecta from the earthquake event. However, other than for this no other significant land damage was noted during the site walkover.

■ **Figure 12 - Patches of remnant silt ejecta**

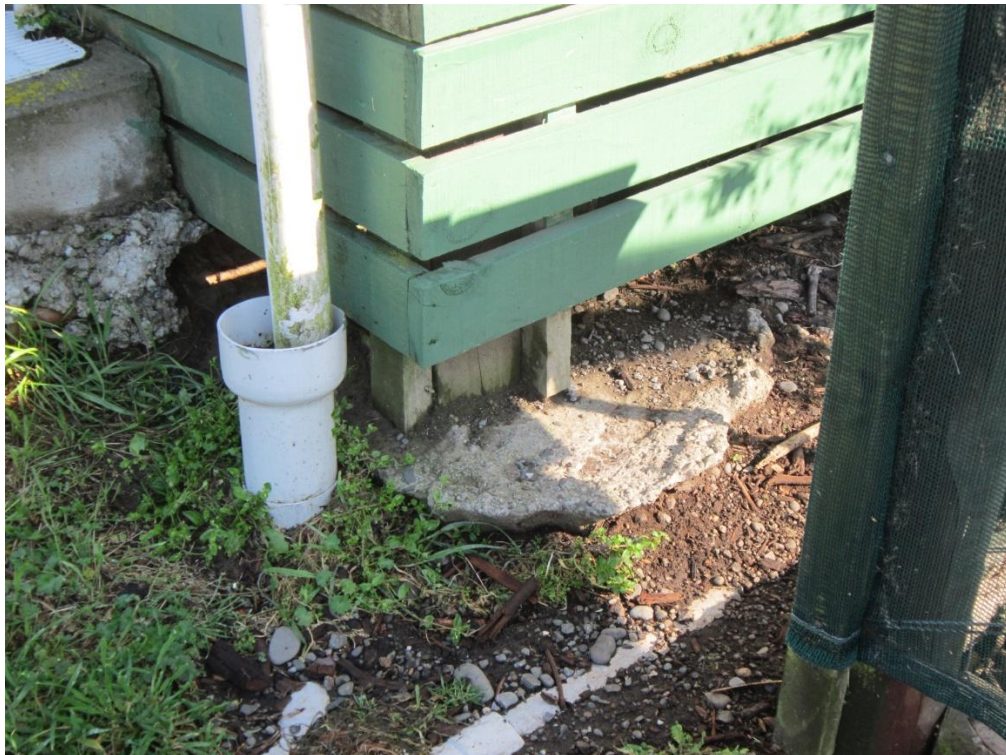
Some separation of the concrete block encasing the piles and adjacent ground was noted. This may indicate some differential settlement between adjacent ground and the respective posts. Significant amount of cracking (up to 10 mm wide) was also observed in the concrete slab west of the structure. However, the level and nature of this damage indicates that it is likely to have been a result of vehicle or other repeated loading on the unreinforced concrete slab rather than damage caused by the earthquake event.

■ **Figure 15 - Concrete encased piles some separation between the block and adjacent ground**

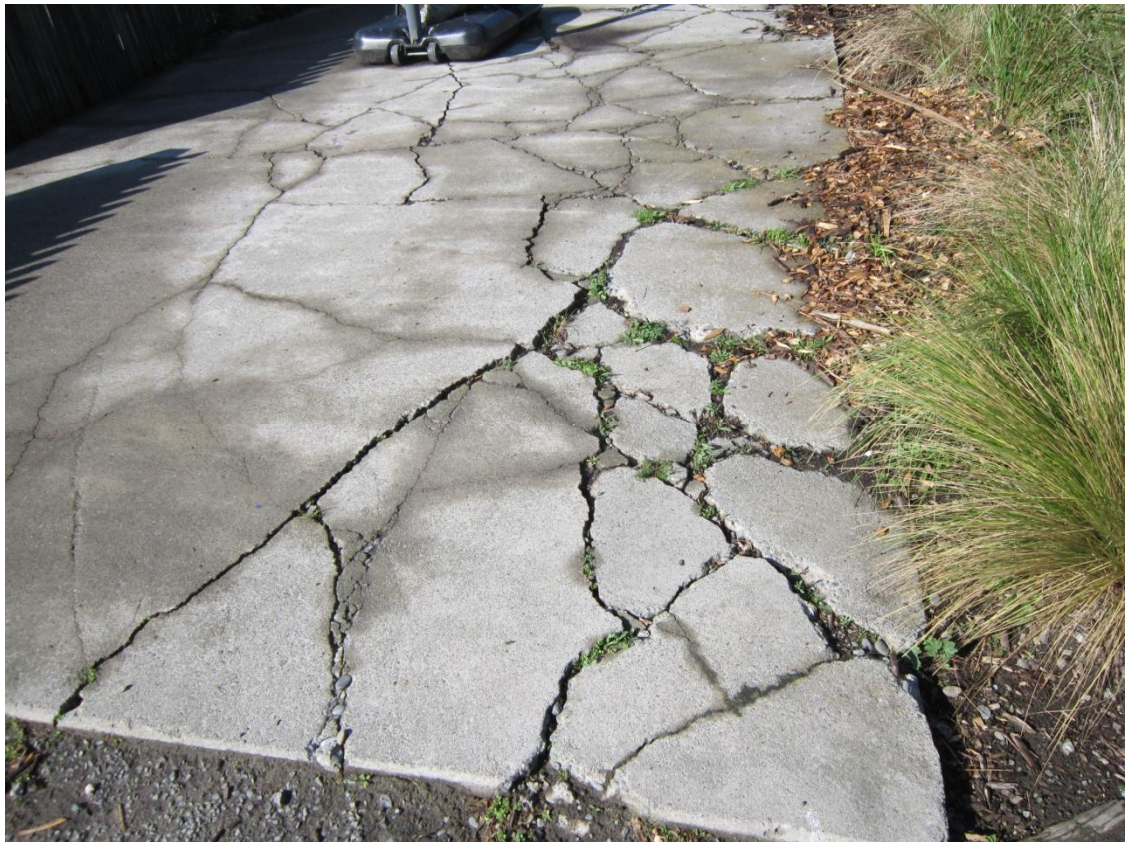
■ **Figure 16 - Significant cracking of the slab west of the building**
