Victoria Park – Dangerous Goods
Shed
Qualitative Engineering Evaluation

Reference: 228663
Prepared for:
Christchurch City
Council

Functional Location ID: PRK 1829 BLDG 010

Date: 9 April 2014

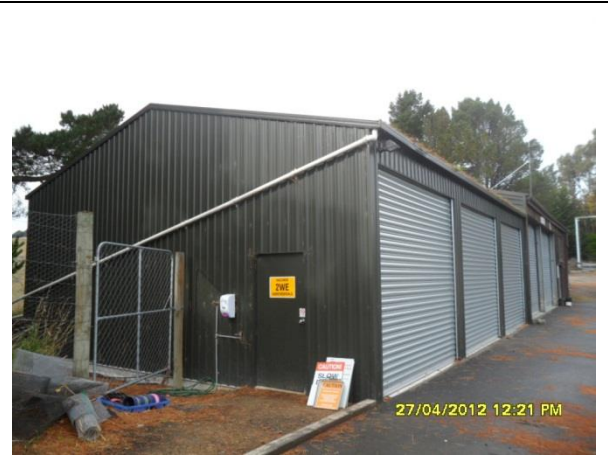
Northwest view of the building.

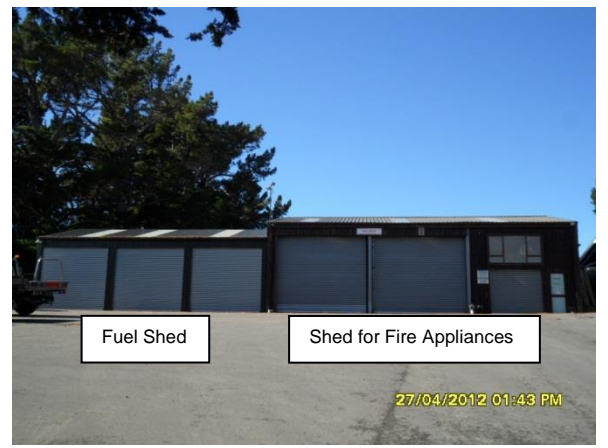
West view of the building.

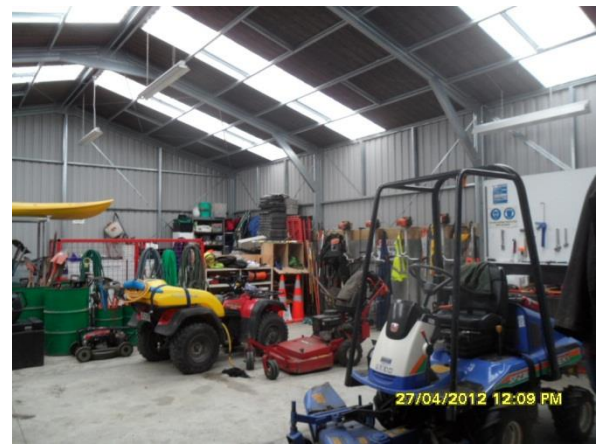
Internal northeast side of the building.

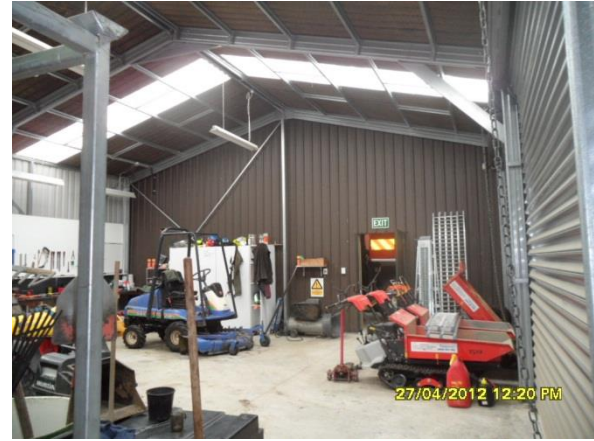
Internal south side of the building.

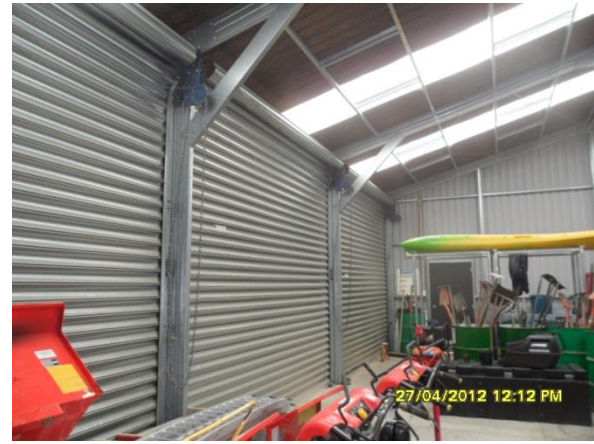
Internal west side of the building.

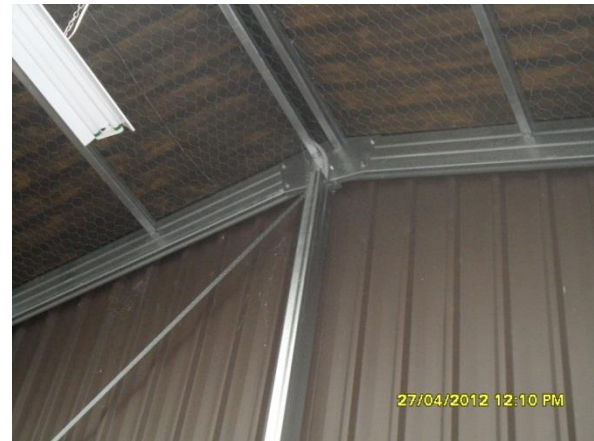
Typical purlin connection detail at ridge.
