Victoria Park – Garage
Qualitative Engineering Evaluation

Reference: 228902

Prepared for:
Christchurch City
Council

Date: 25 February 2013

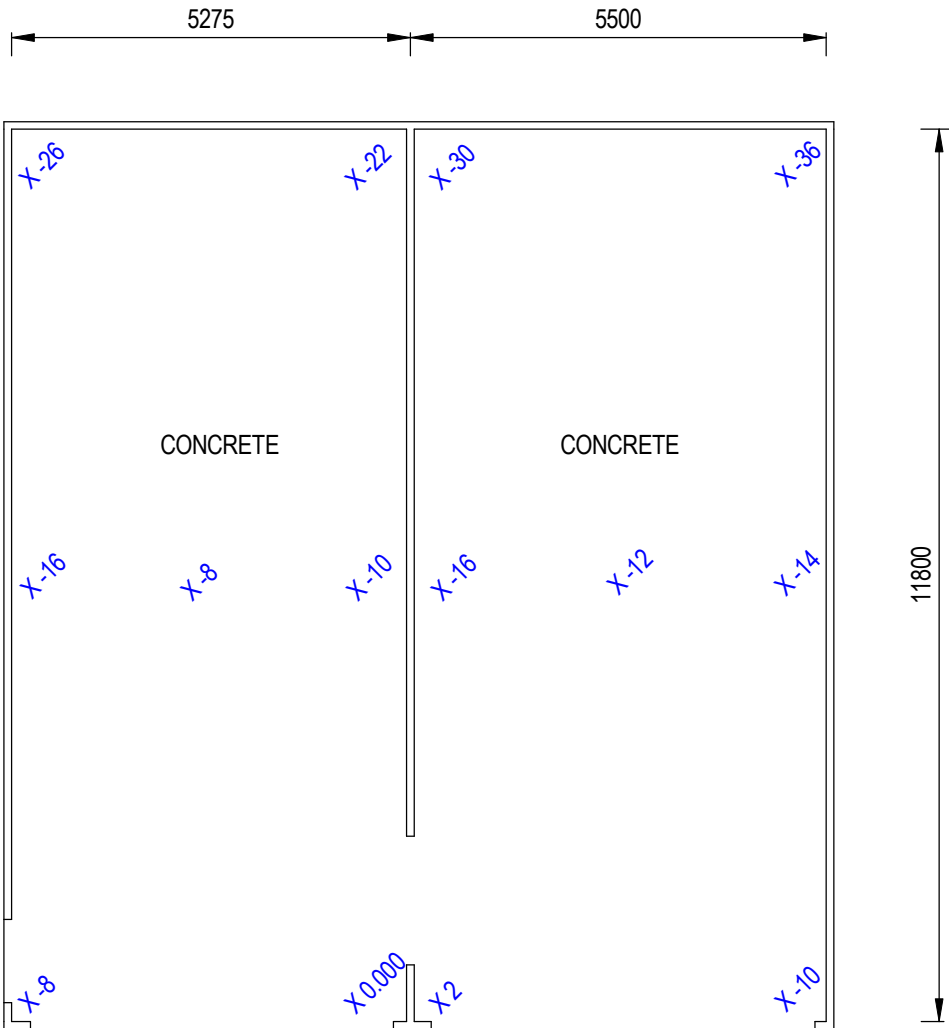
PROJECT
VICTORIA PARK GARAGE
TITLE
LEVEL SURVEY

The floor levels for the Victoria Park – Garage were found to be within the recommended tolerances.
