Victoria Park – Rangers House
Qualitative Engineering Evaluation

Reference: 228903
Prepared for:
Christchurch City Council

Functional Location ID: PRK 1829 BLDG 008

Date: 5 July 2013

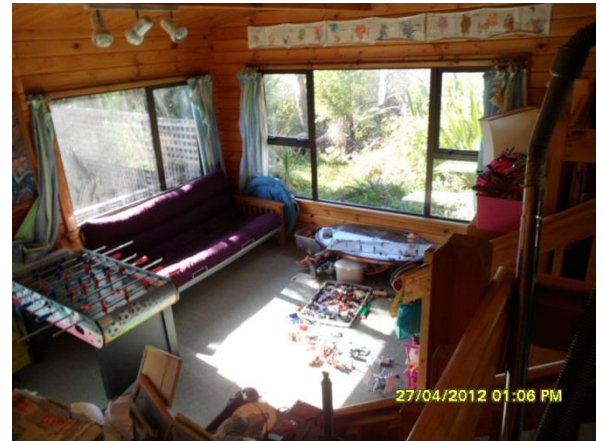
Internal view from the play area and looking up towards the lounge area.

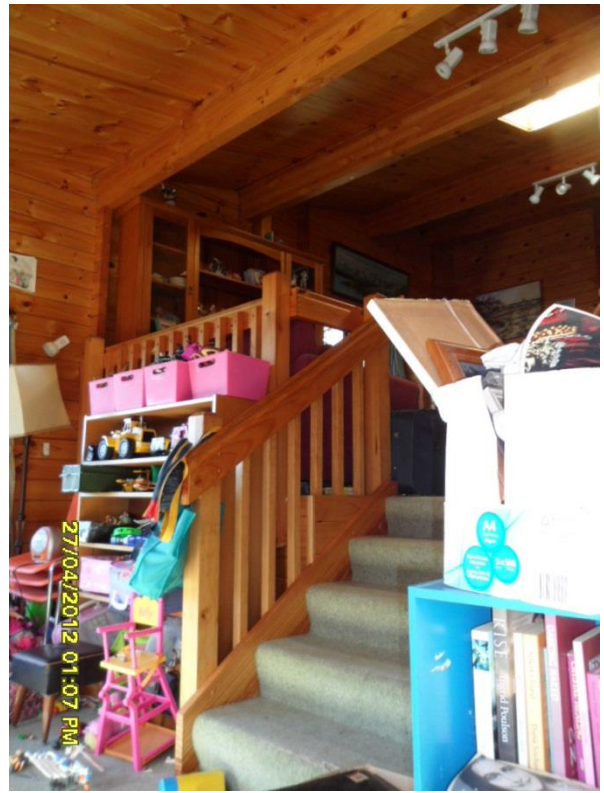
Internal view of the lounge area.

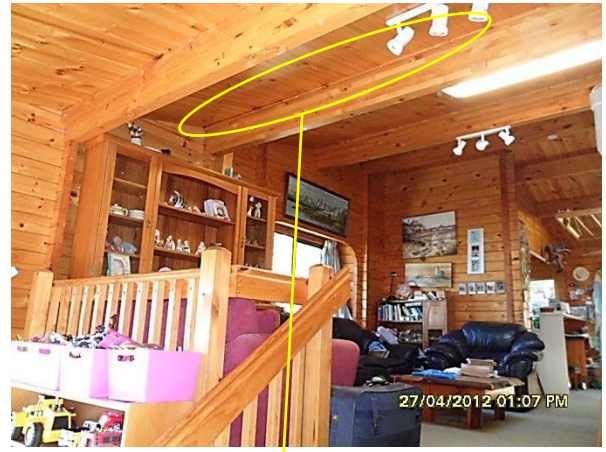
- Cracking to plasterboard in the west end bedroom; and
- The sloping laminated ceiling appears to have been dislodged at the end of one of the laminated beams in the lounge area.

The dislodged laminated ceiling in the lounge area may be due to lack of connection between the beam and the ceiling. Damage to the plasterboard wall linings is a common occurrence in this type of construction and occurs as plasterboard is relatively brittle causing cracks to develop under a limited amount of movement.

Dislodged ceiling.

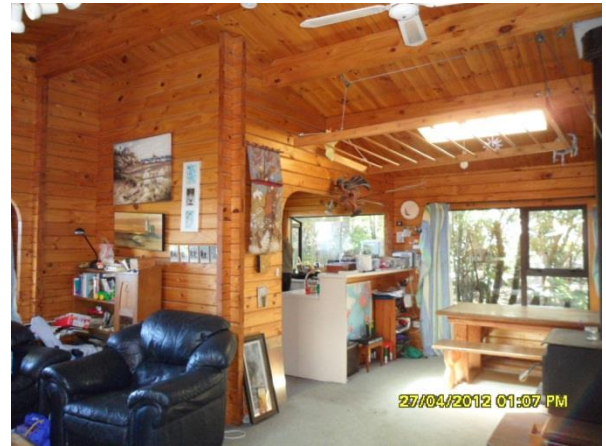
View from the play area and looking up towards the lounge and kitchen areas.

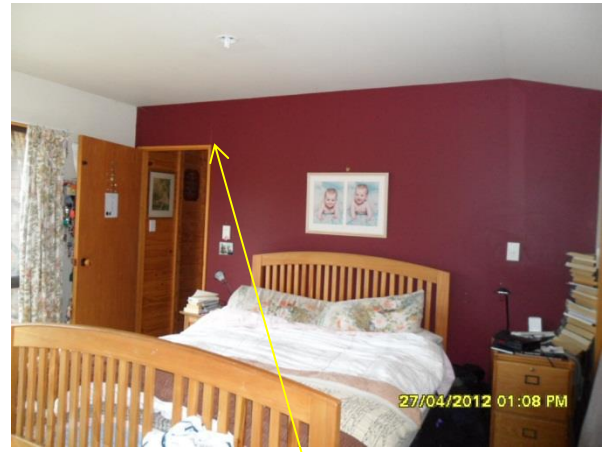
Cracking to plasterboard in the west end bedroom.

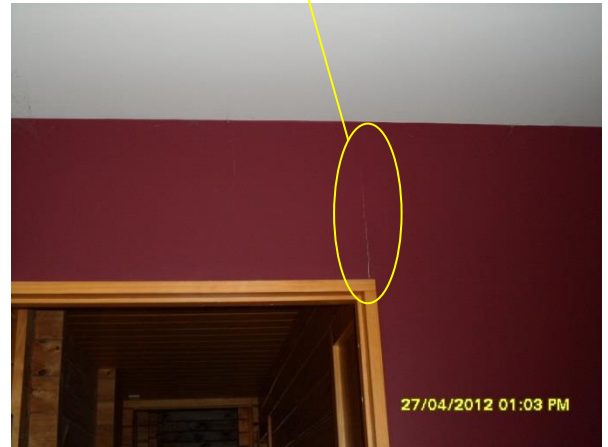
West end bedroom looking towards south west.

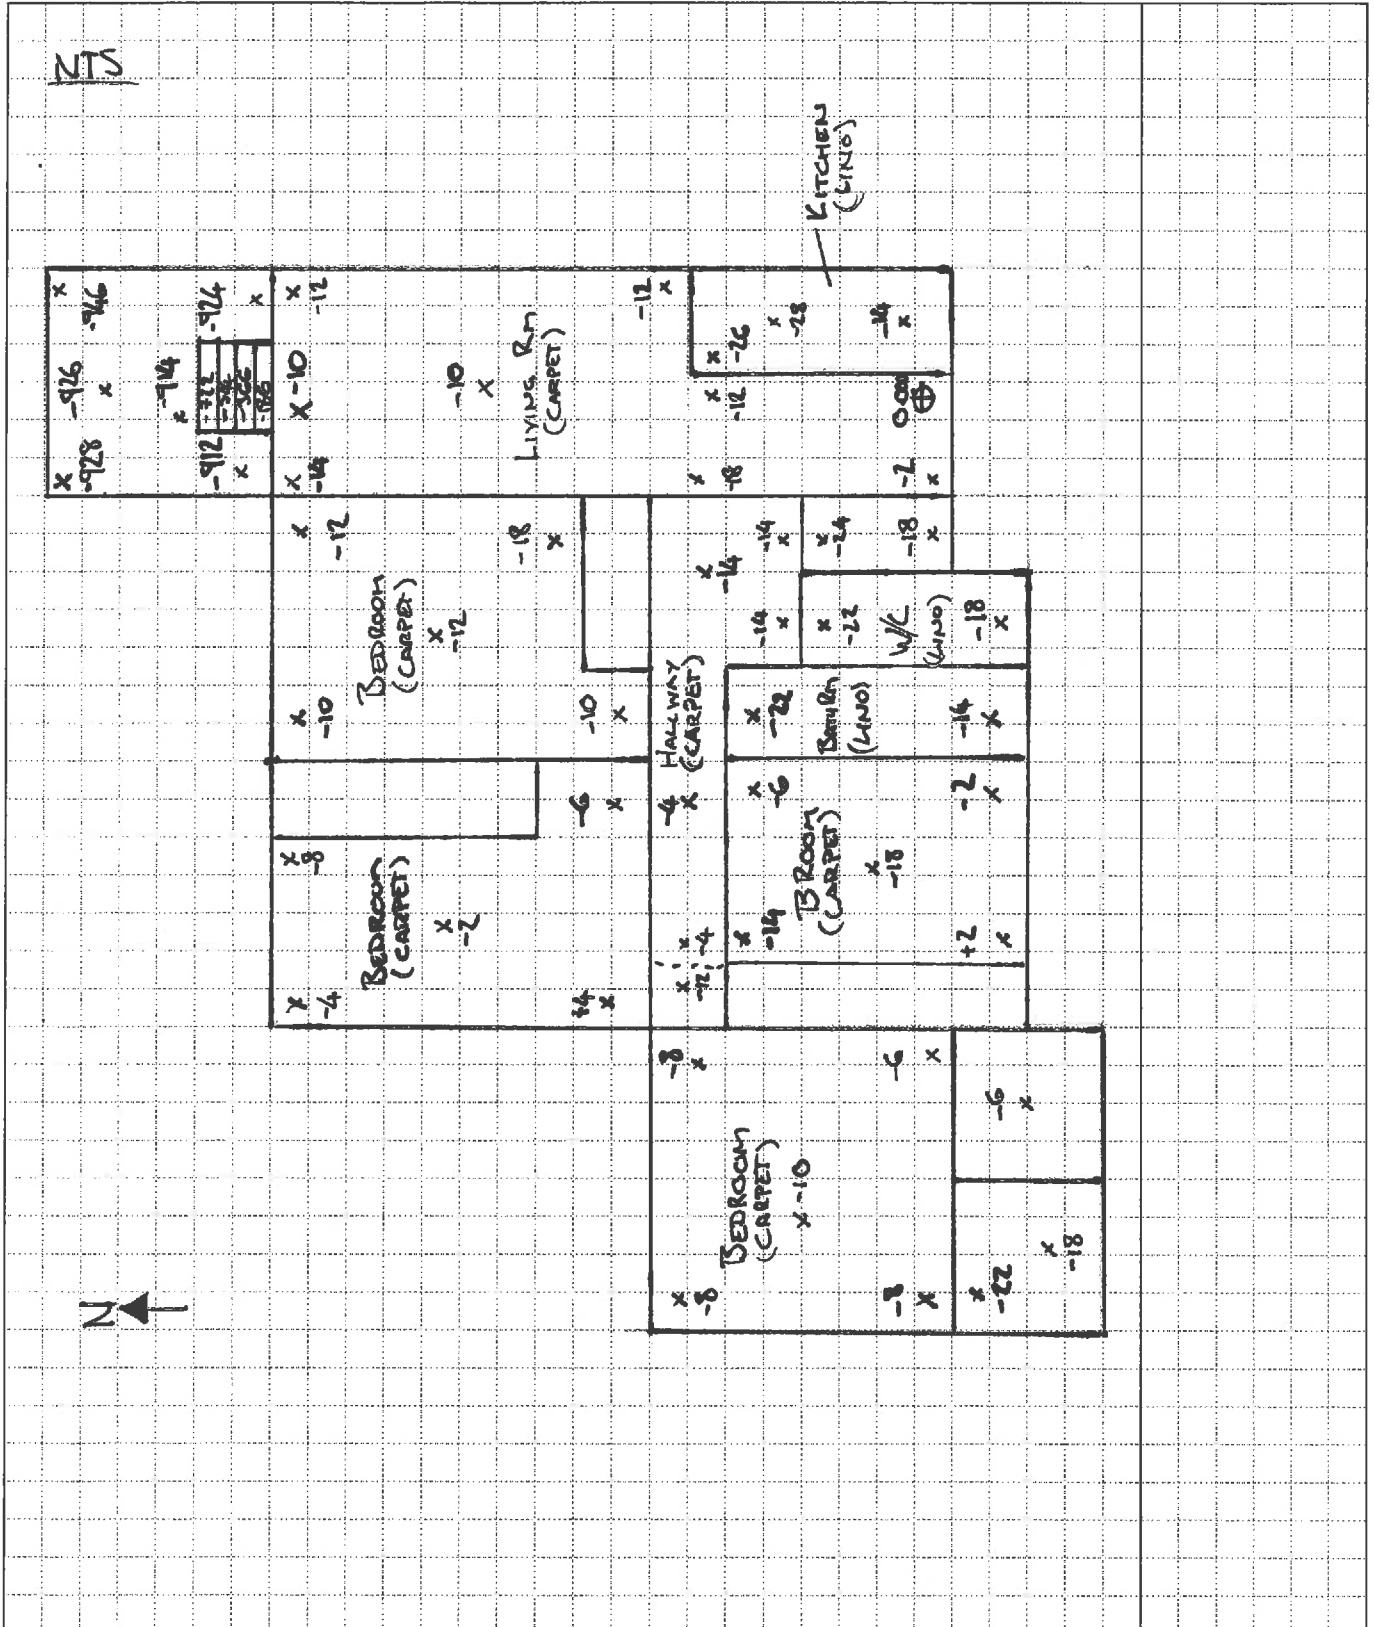
Client: CHRISTCHURCH CITY COUNCIL		Date: 13.6.12	
Project/Job: VICTORIA PARK - RANGERS HOUSE		Job No: 228903	
Subject: LEVEL SURVEY		Sheet No: 1-1	By: DH

A floor level survey was undertaken to establish the level of unevenness across the floors. The results of the survey are presented on the attached sketch in Appendix A. All of the levels were taken on top of the existing floor coverings which may have introduced some margin of error.

1. Floor slopes down 34mm (approximately 0.85%) in the northeast corner of the house; and
2. Floor slopes down 20mm (approximately 0.70%) in the south end bedroom towards the hallway.

The room in the south end of the house is on timber piles. Therefore, to re-level the floor, we recommend disconnecting all existing piles from the bearers and plates. For lifts up to 50mm at any pile, fit H5 treated timber packing (preferably as a single thickness piece) and connect to the existing pile top and the underside of the bearer.

The room in the northeast corner of the house is on concrete floor slab on grade. Therefore, to re-level the floor, we recommend a company that specialises in levelling concrete floor slabs using grout injection techniques should be engaged.
