**Victoria Park
Resource Building
PRK 1829 BLDG 013**

**Detailed Engineering Evaluation
Qualitative Assessment Report**

Date: December 2013
Reference: 6-QC158.00
Status: Final

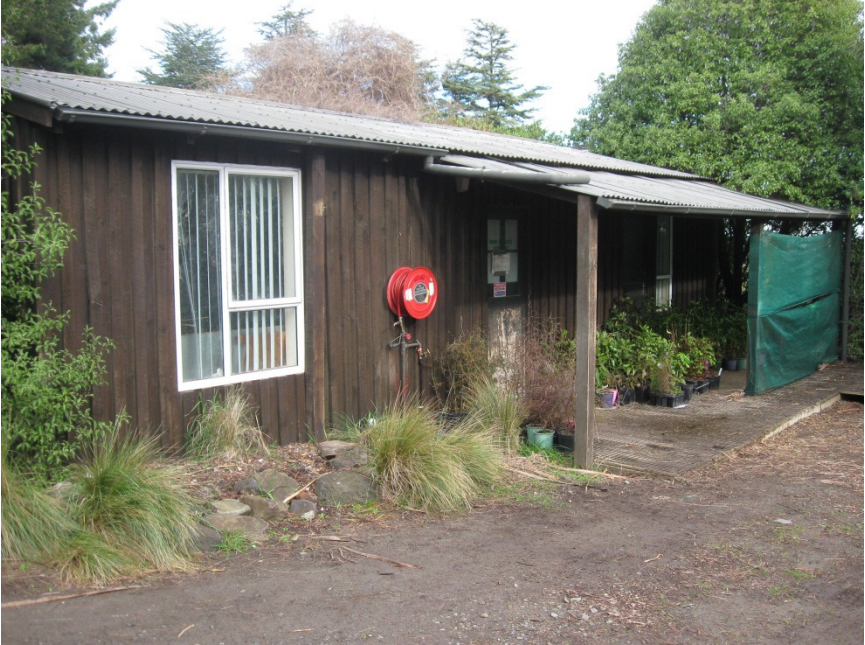
| Victoria Park Resource Building | | |
|---|---|--|
| 1. | Front view of the building | A photograph showing the front view of a single-story building with dark brown vertical wood siding and a corrugated metal roof. A white-framed window with vertical blinds is visible on the left. A red fire hose reel is mounted on the wall to the right of the window. The building is surrounded by greenery, including tall grasses and trees in the background. A green tarp is visible on the right side of the building. |

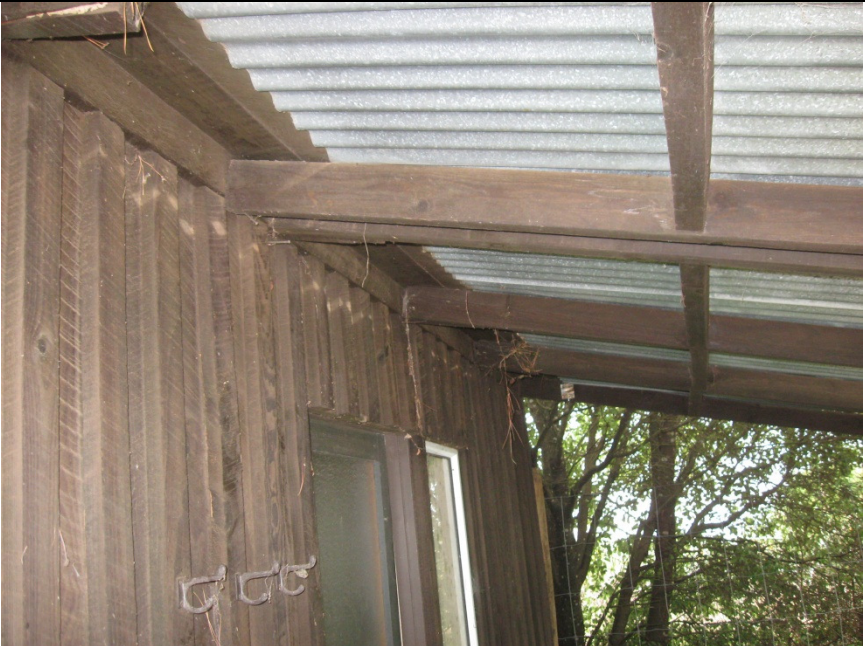
| Victoria Park Resource Building | | |
|---|---|--|
| 2. | Veranda roof attached to building | A close-up photograph of the veranda roof structure. The roof is made of corrugated metal and is supported by dark wooden beams. The building's exterior wall, made of dark brown vertical wood siding, is visible on the left. A window with a white frame is partially visible below the veranda. The background shows green trees. |

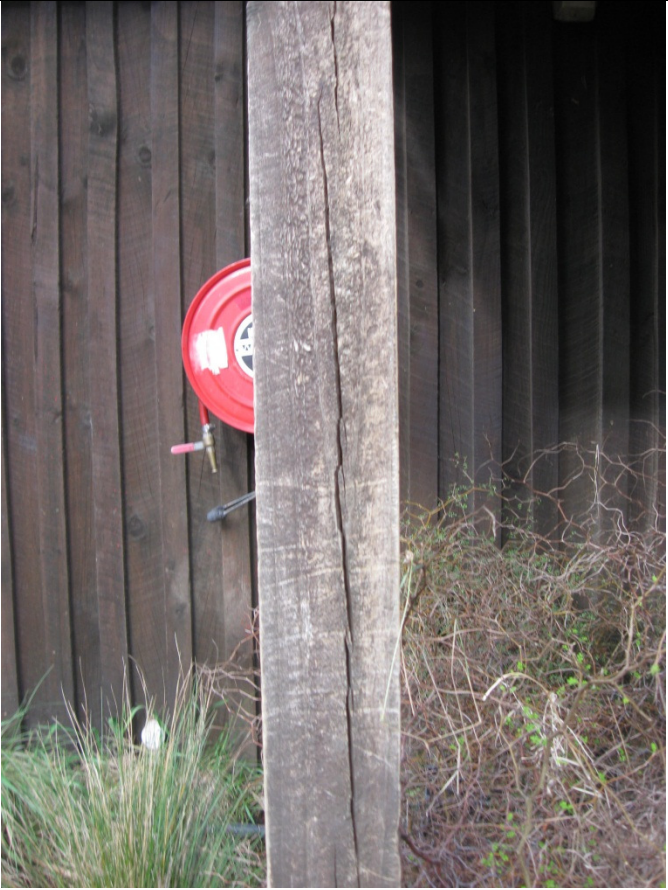
| <p>3.</p> | <p>Cracked verandah post</p> | |

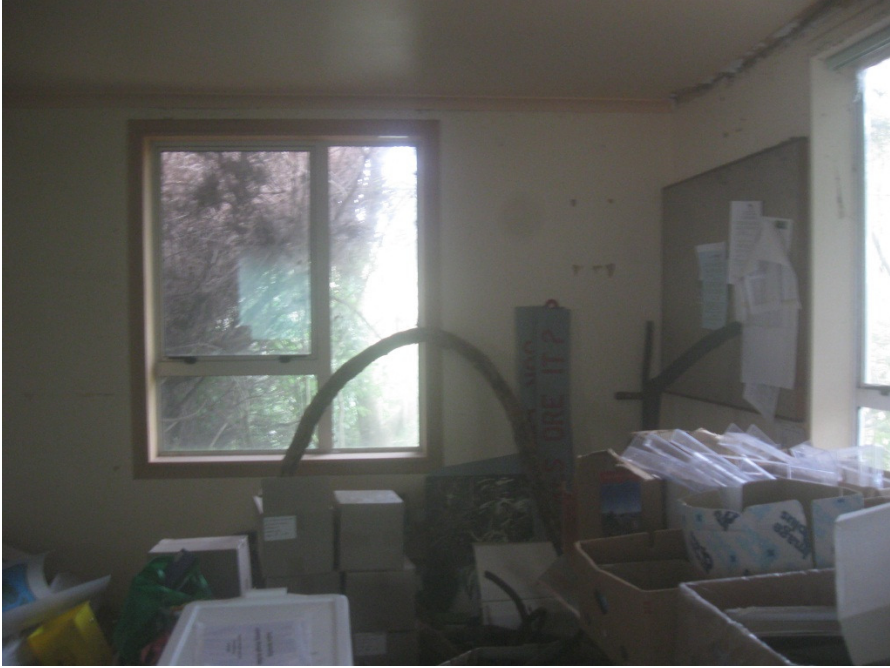
There was no observed damage although access to the inside was not available at the time. Views through the windows did not reveal any interior damage, other than a missing architrave moulding.

| <p>4.</p> | <p>Inside view of wall and ceiling. Side architrave is missing</p> | |
