Christchurch City Council  
PRK\_2204\_BLDG\_001 EQ2  
Washington Reserve - Toilet  
Washington Way/ Waltham Rd

QUALITATIVE ASSESSMENT REPORT  
FINAL

- Rev B
- 23 May 2013

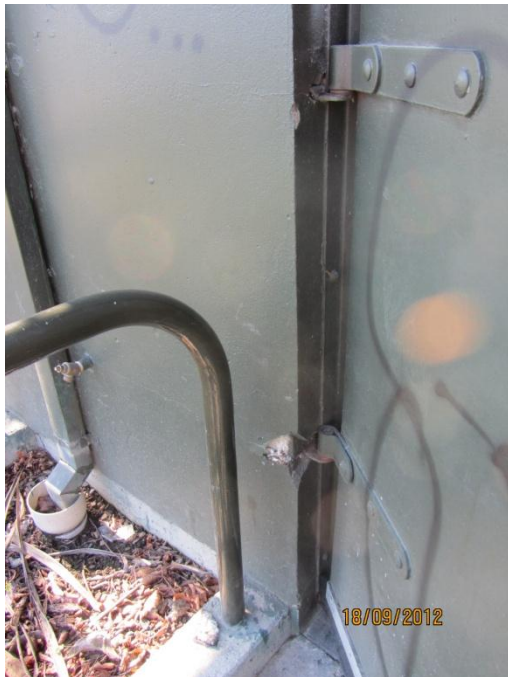
Photo 7: Hinges for the womens toilet door

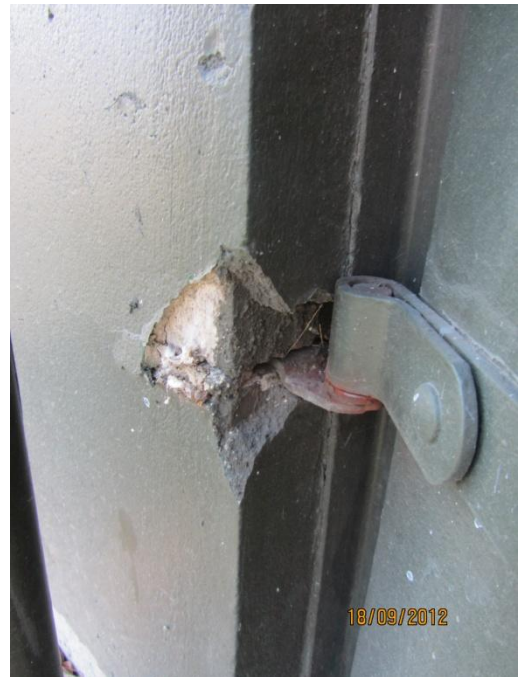
- Plaster material surrounding the bottom door hinge for the women's toilet has broken off  
See section 6 for the damage summary.

- 1) Plaster material surrounding the bottom door hinge for the women's toilet has broken off (see photo 8)

Photo 8: Close up view of the bottom hinge for the womens toilet door showing the missing plaster material

- a) There is no damage to the building that would cause it to be unsafe to occupy.
- b) We consider that barriers around the building are not necessary.
