Whakahoa Village Units Block B
BU 2680-002 EQ2
Detailed Engineering Evaluation
Quantitative Report
Christchurch City Council

Detailed Engineering Evaluation Quantitative Report

Detailed Engineering Evaluation
Quantitative Report - SUMMARY
Final

Gowerton Place, Richmond

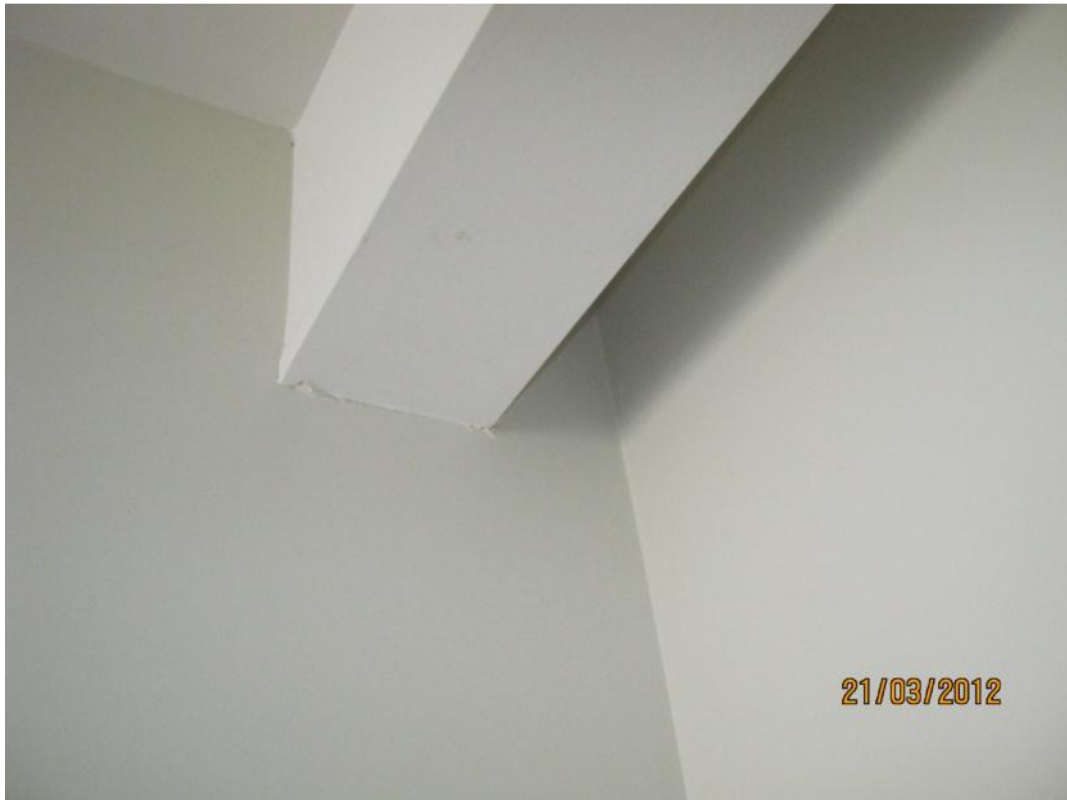
The majority of the damage has occurred in Unit 50, with cracks in walls over door openings, a crack in the garage floor, cracks in the corner of the bathroom wall and along the ceiling, cracks around the bathroom door and slight nail popping in lounge wall linings. There is a dislodged block at the top corner of the patio and the patio slab has lifted from liquefaction.

Photo 1: Crack in Unit 50 wall – beam joint.

- (a) The building damage relating to cracking of wall or ceiling linings, and out-of-plumb windows and doors should be repaired. Repair dislodged or damaged block veneer.
- (b) Remove carpets and investigate ground floor slab for cracking and assess and undertake crack repairs where necessary.
- (c) Six (6) Cone Penetrometer Tests to a depth of 25m be undertaken to enable a site wide liquefaction assessment.

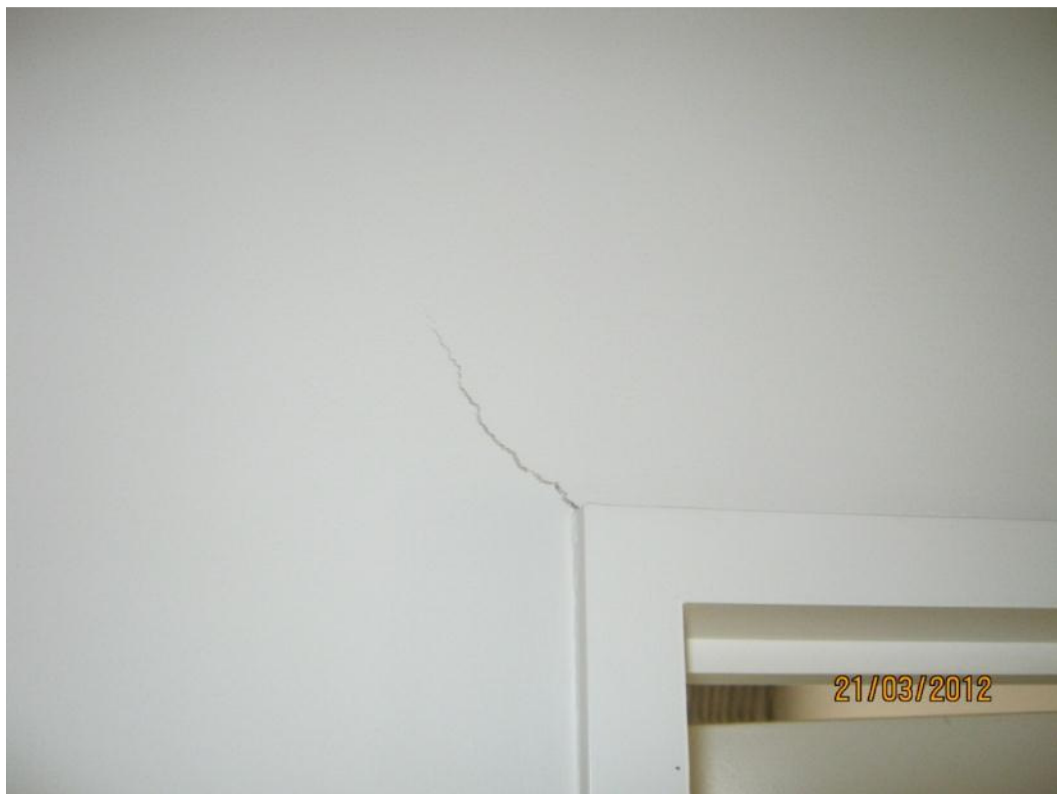
In Unit 49 there are minor cracks over bedroom doors and a crack along the garage wall and the edge of slab.

Photo 2: Crack in wall over bedroom doors.

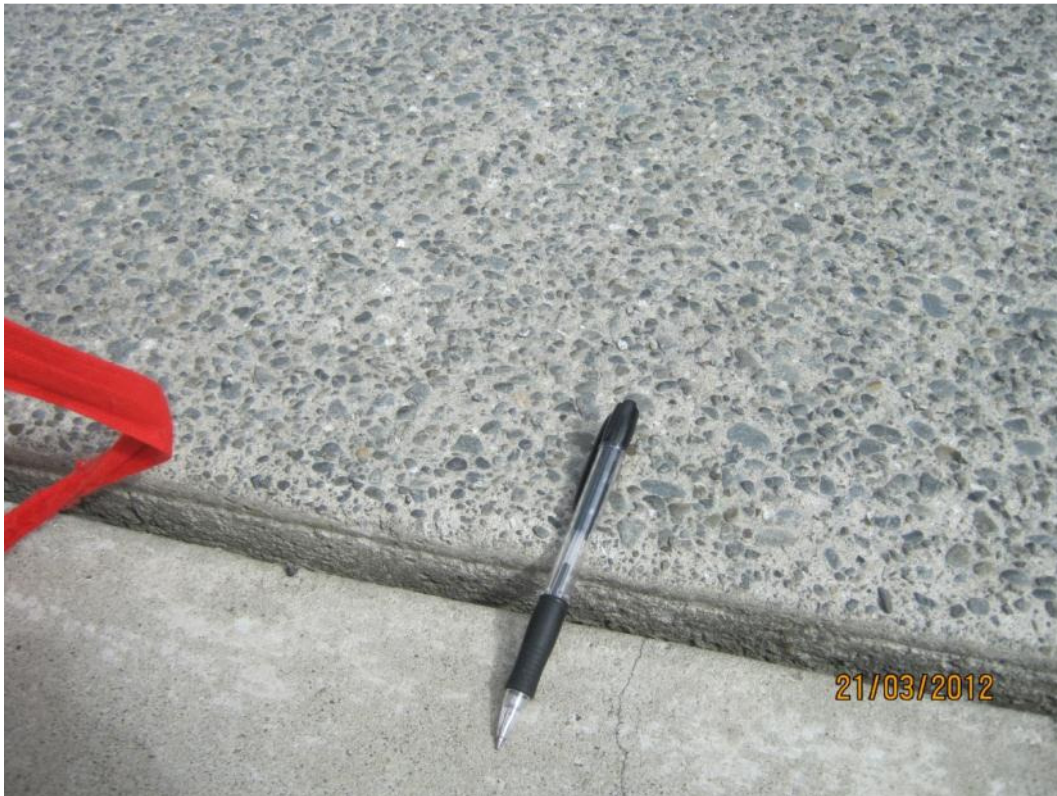
Photo 3: Separation and settlement of patio slab.
