# **Whakahoa Village Block C**

## **Detailed Engineering Evaluation Quantitative Report**

Whakahoa Village Block C  
BU 2680-003 EQ2

Gowerton Place, Richmond

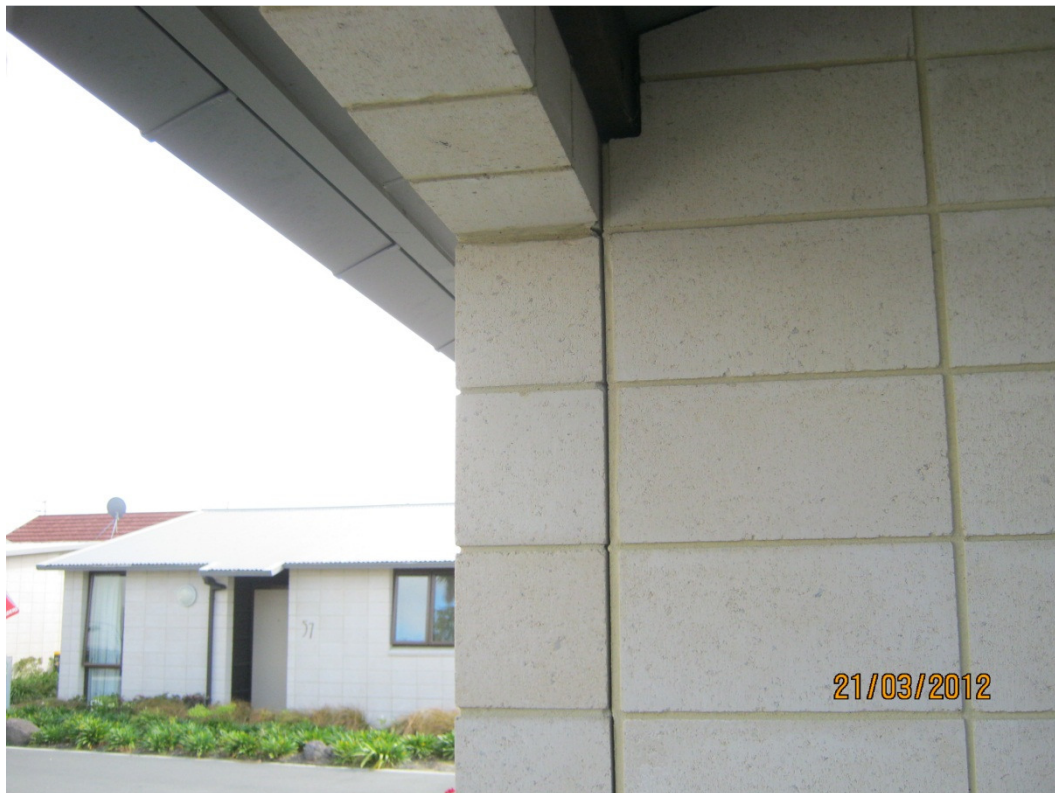
Photo 1 – Block veneer supporting block lintel and veneer separation at entry

- (c) The building damage relating to cracking of wall or ceiling linings, and out-of-plumb windows and doors should be repaired.
- (d) The entry lintels should be secured at the wall ends. A structural investigation should be undertaken to determine the adequacy of support to the entry block lintels and remedial work undertaken if necessary.
- (e) The carpets should be removed and an investigation undertaken of the ground floor slab for cracking and undertake crack repairs where necessary.

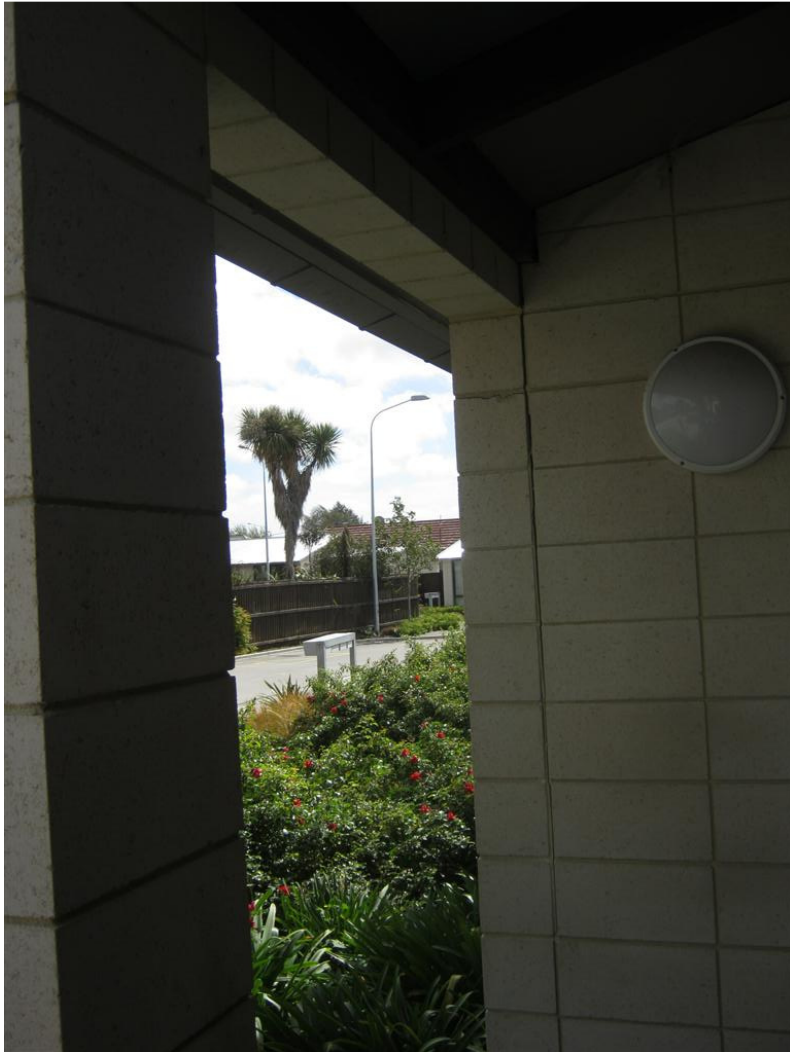
Photo 2 – Block lintel on veneer / separation of veneer at entry

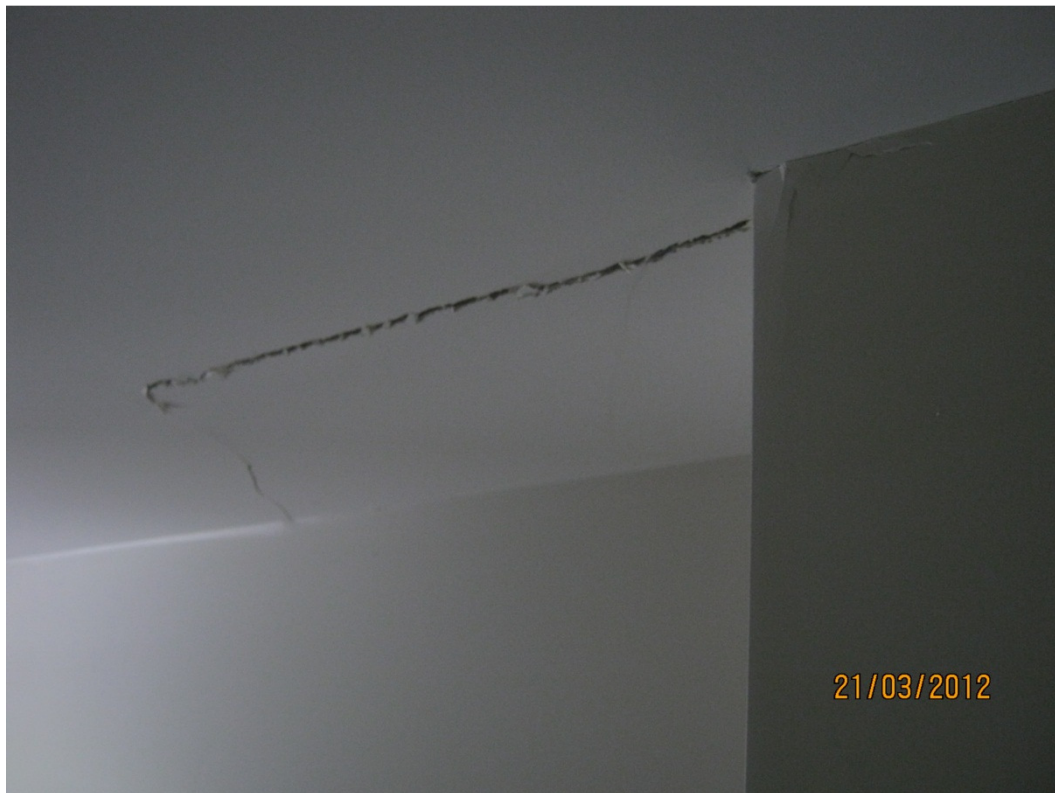
Photo 3 – Crack in ceiling lining

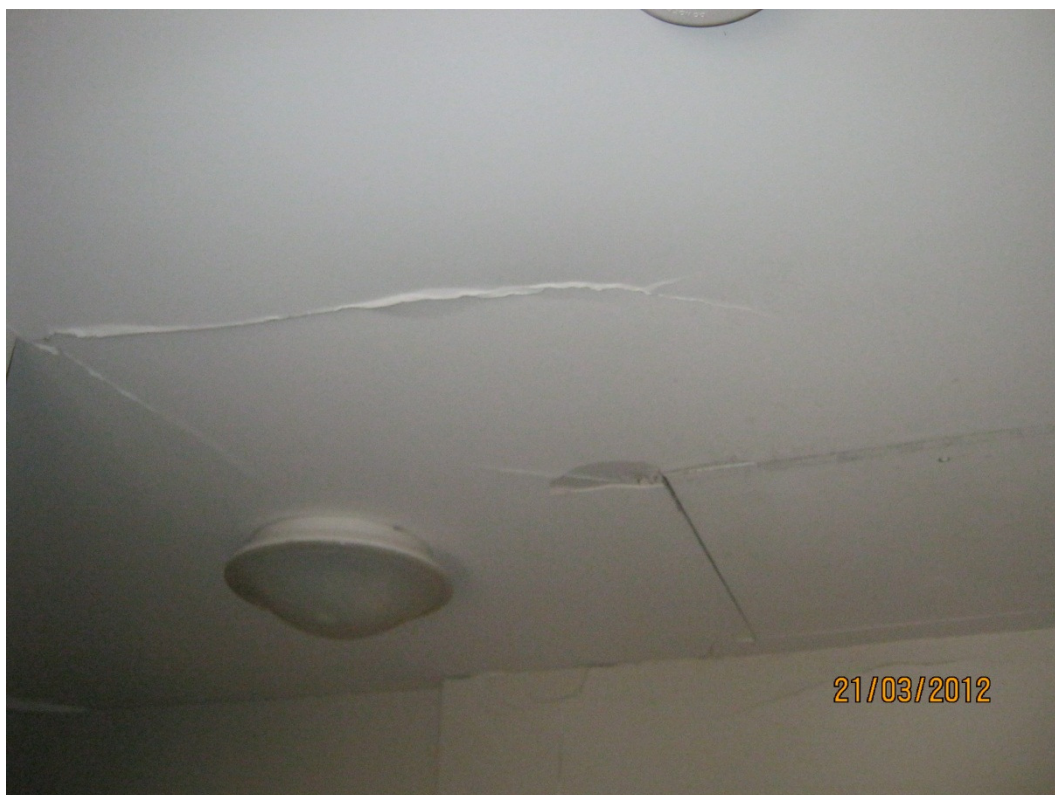
There has been significant ceiling damage in Unit 54 in the small central hall area adjacent to the bathroom and bedrooms – refer photo 4 in Appendix 1. The damage is most likely caused by a combination of differential settlement from liquefaction, and seismic loading. This area creates a pinch-point in the ceiling diaphragm between the patio and the garage, which has dragon tie bracing only (no ceiling), exacerbated by a ceiling hatch opening adjacent to the garage. Similar damage has occurred in Units 52 and 53 with the same configuration, but to a much lesser degree. These ceiling areas should be further investigated for timber framing damage.

Photo 4 –Cracking to ceiling and wall linings

The hall ceiling areas adjacent to the bathroom and bedrooms in Units 52, 53 and 54 should be investigated for strengthening, provision of diaphragm load path to bracing walls, and possible framing repairs.

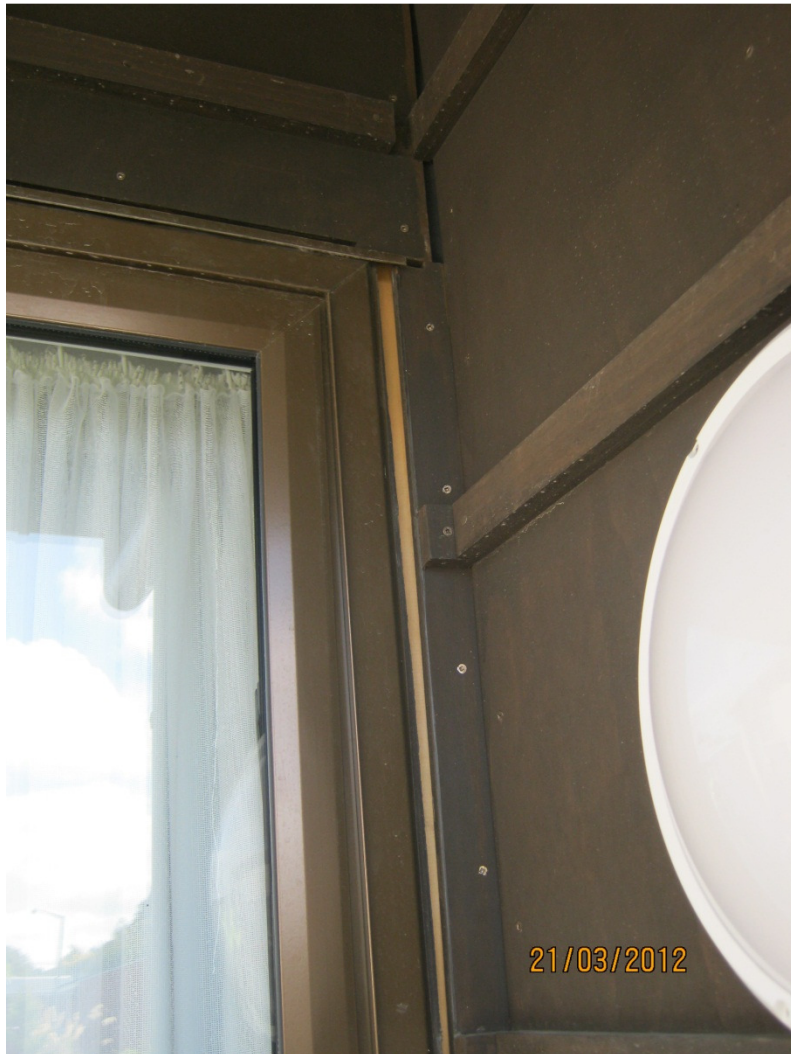
Photo 5 - Separation of wall framing and window frame

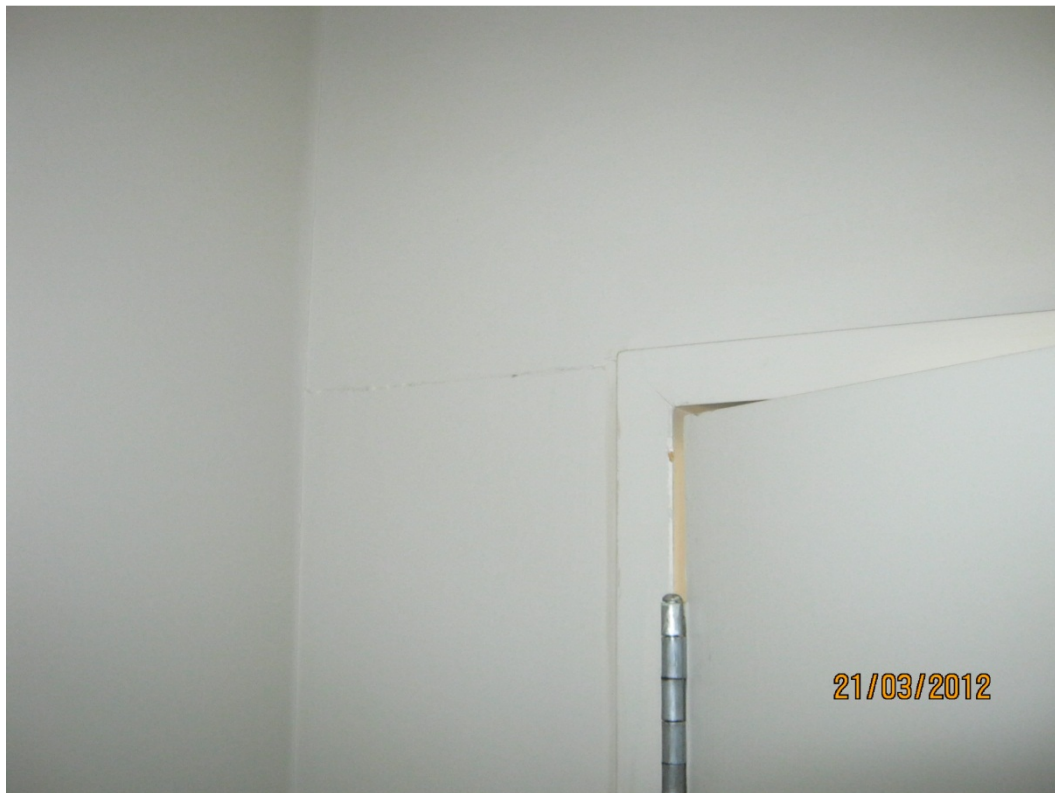
Photo 6 – Crack in wall lining at door opening

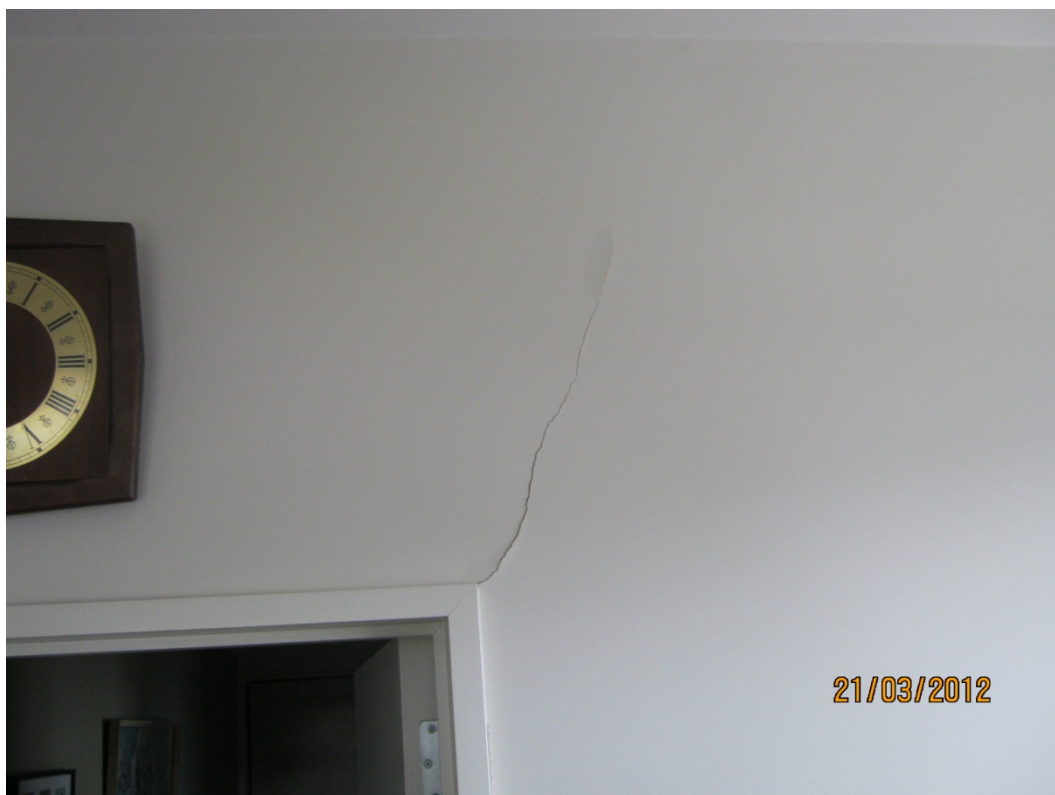
Photo 7 – Crack in wall lining at door openings

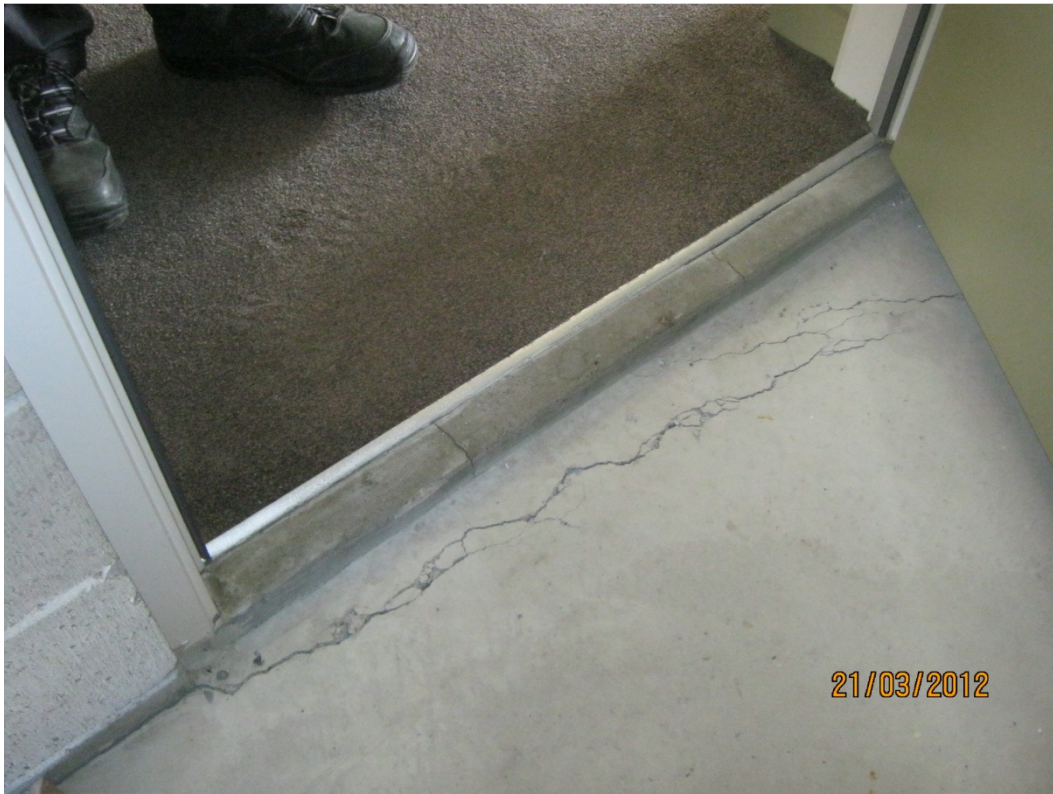
Photo 8 – Crack in garage floor

The floor slabs should be fully investigated for cracking and repaired where necessary.

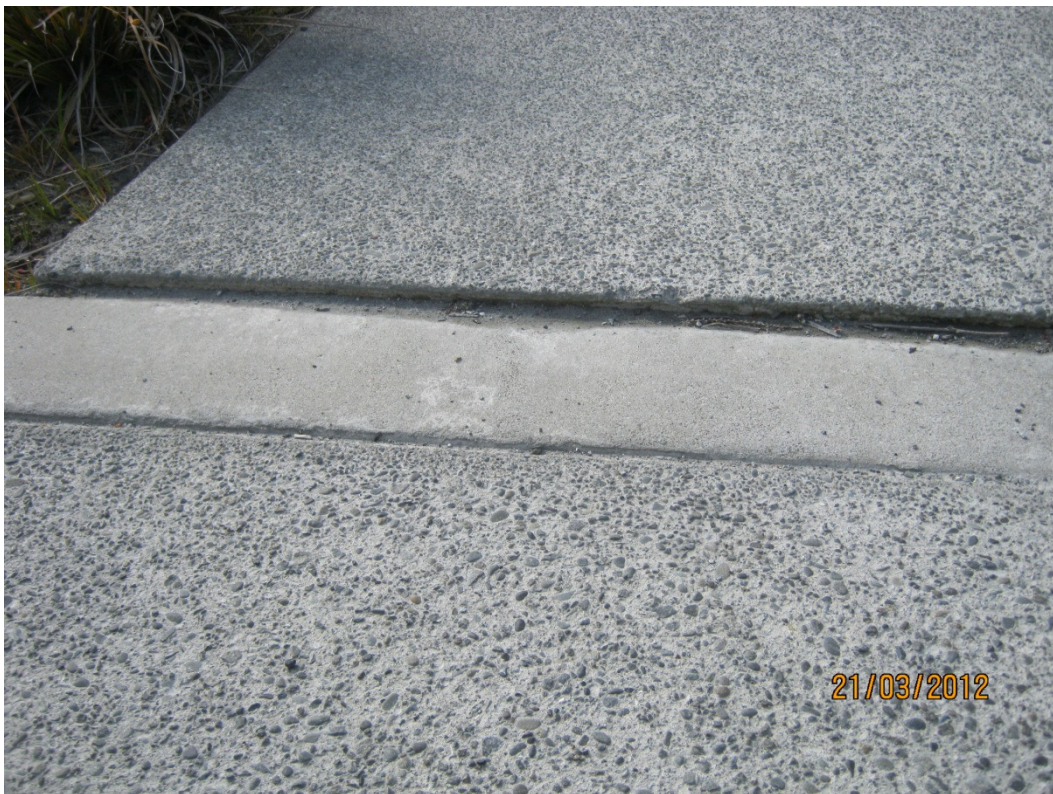
Photo 9 – Differential settlement or heave in patio slab

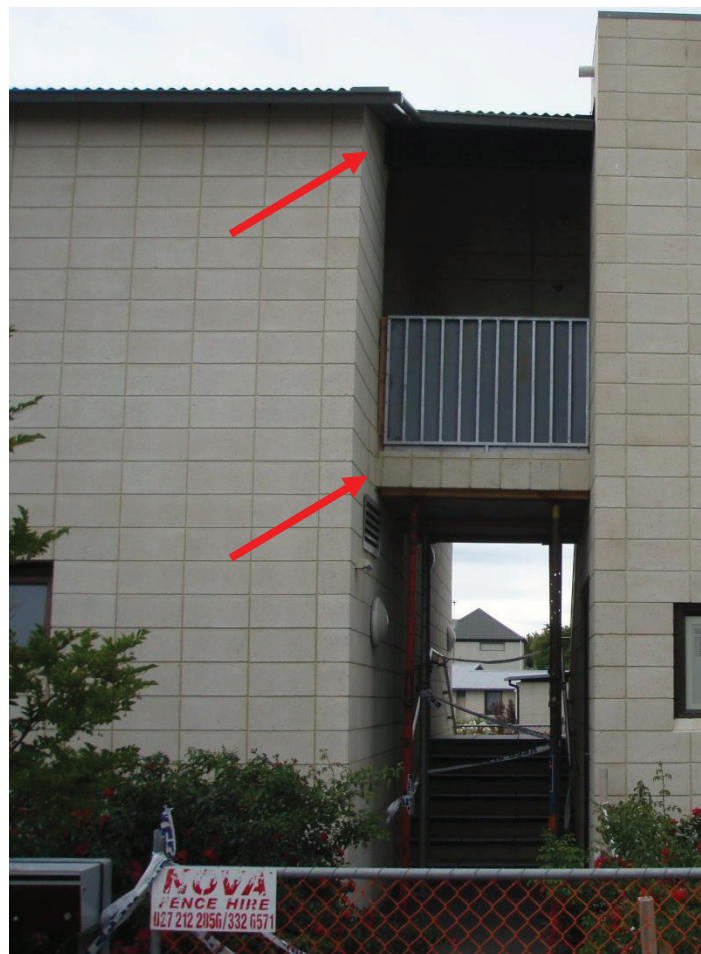
Figure 14: Separation between west side of Block A and the stair well.
