Whakahoa Village Units Block D
BU 2680-004 EQ2
Quantitative Report

Detailed Engineering Evaluation Quantitative Report

Date: September 2012
Reference: 6-QUCCC.93
Status: Final

Gowerton Place, Richmond

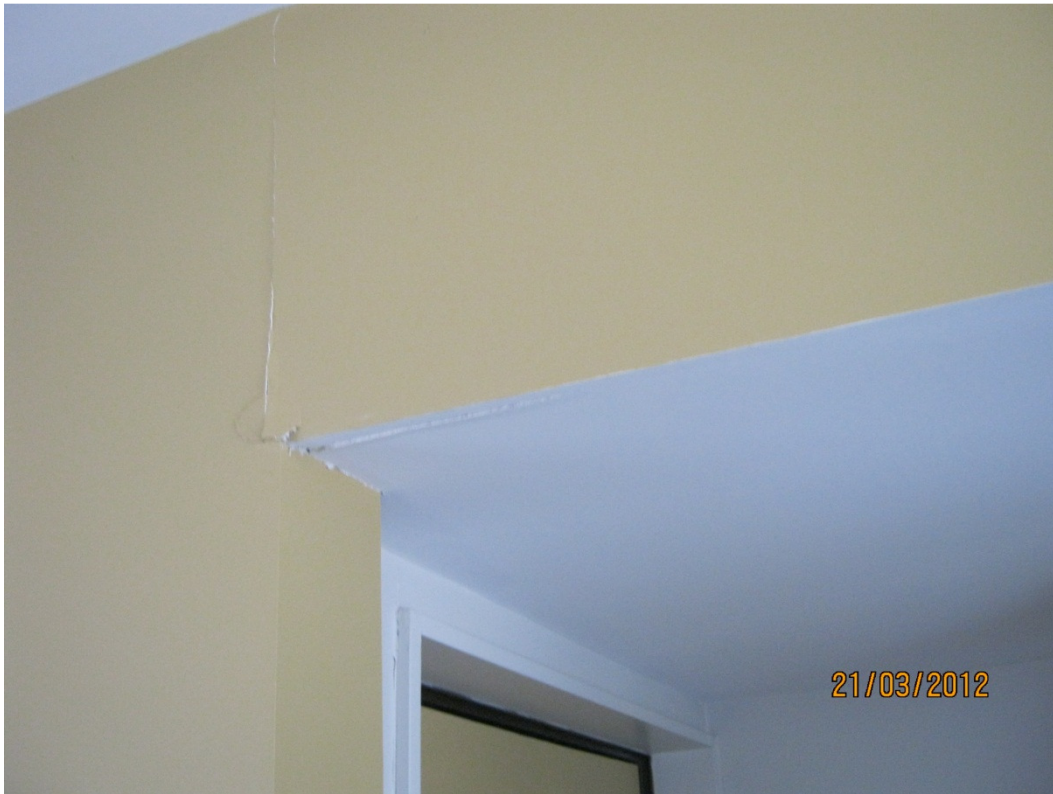
Photo 1 – Plasterboard lining cracking at wall opening.

- (a) The building damage relating to cracking of wall or ceiling linings, and any out-of-plumb windows and doors should be repaired.

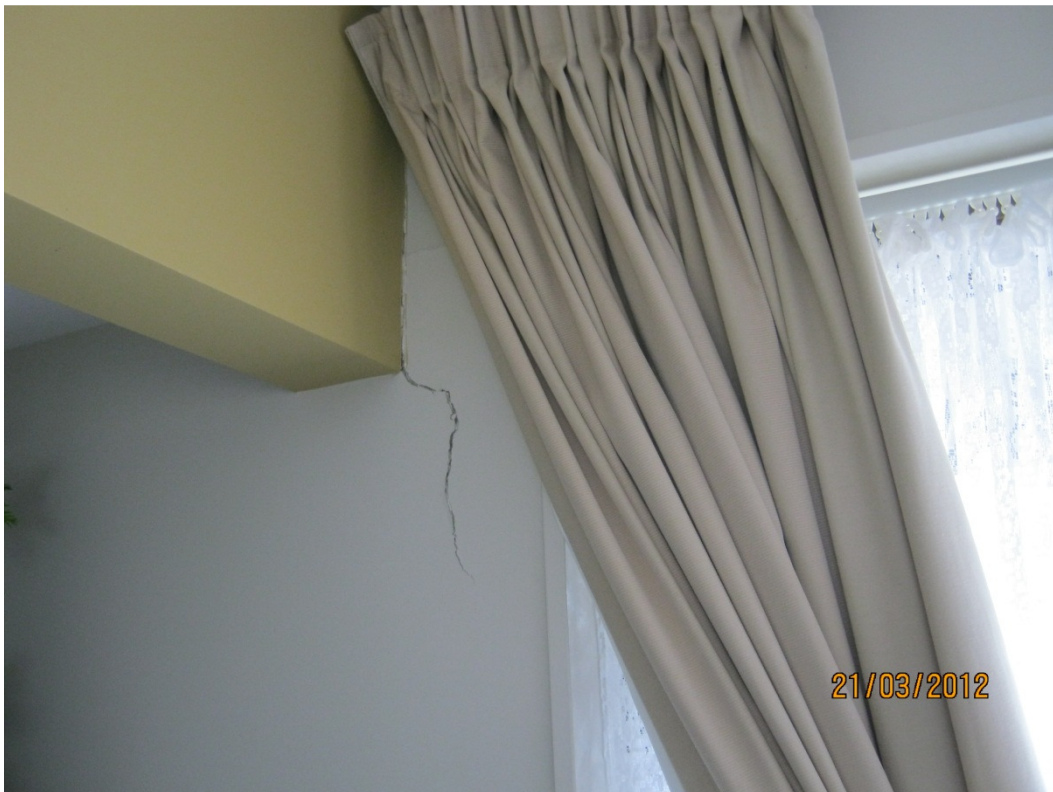
Photo 2 – Wall crack at roof beam and lintel junction

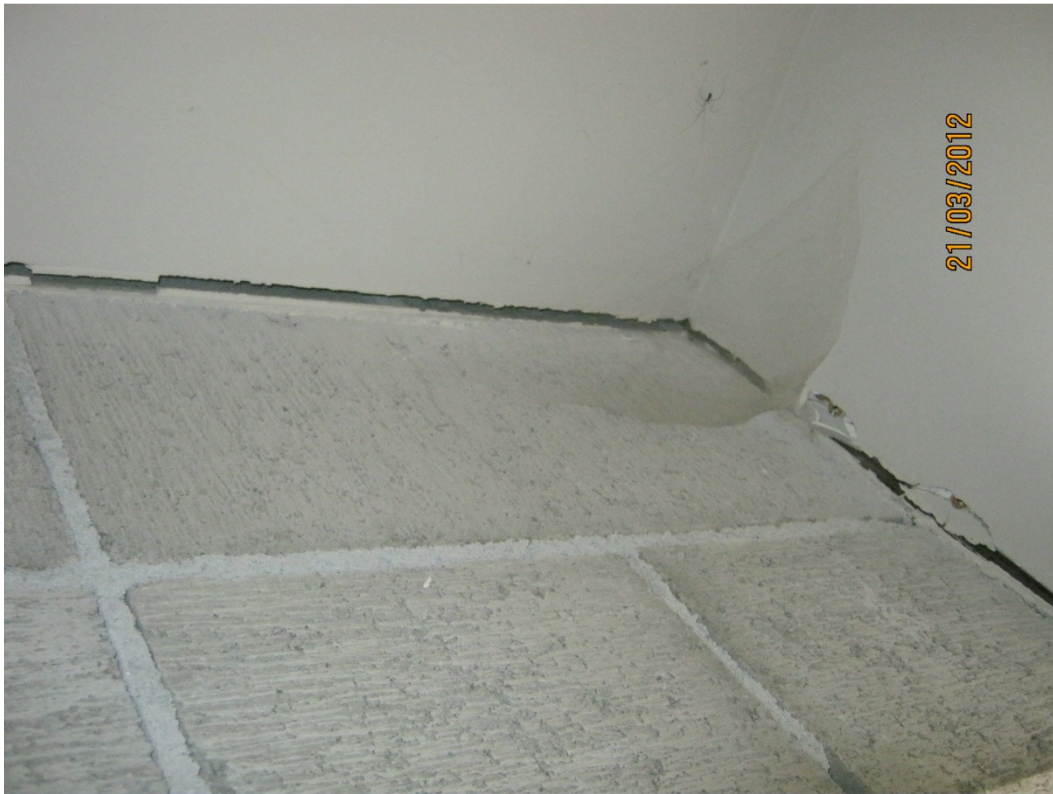
Foundation settlement in Unit 55 has caused separation of the timber wall framing from the garage concrete block walls, refer photo 3. Further investigation should be made of the timber framing and connections to assess the extent of repairs that may be required.

Photo 3 – Separation of timber framing from garage block wall – Unit 55

An investigation of the separated timber framing at the laundry alcove in Unit 55 garage should be carried out to assess the extent of repairs required.

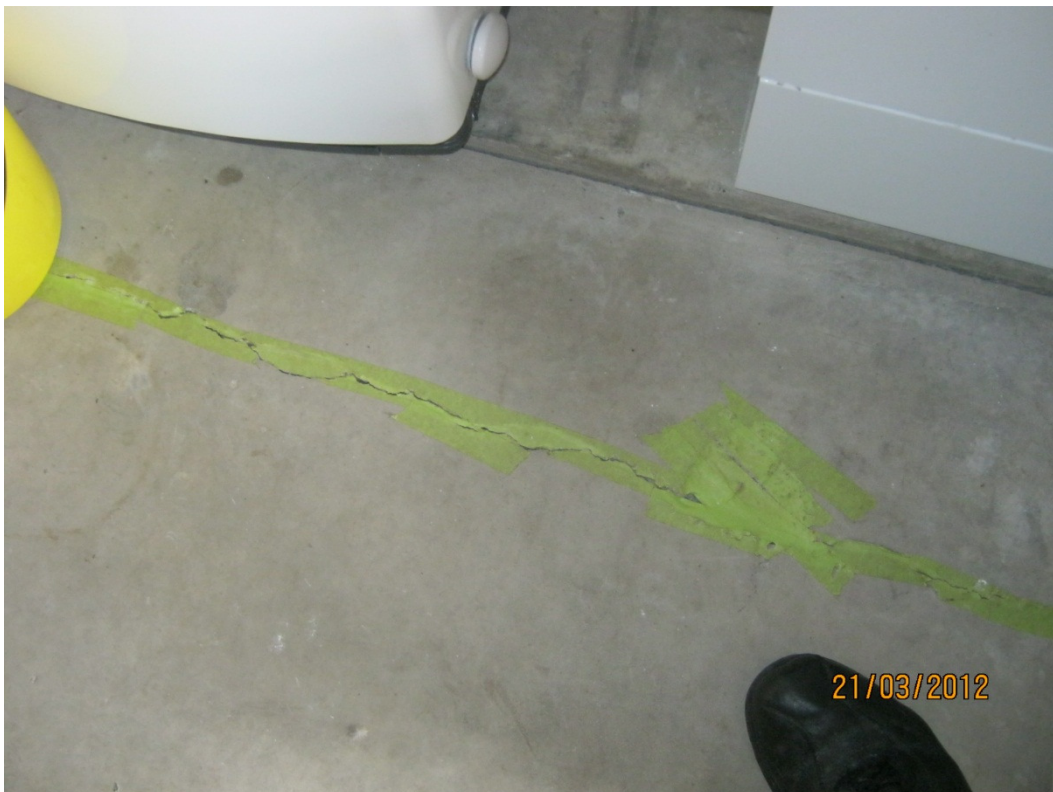
Photo 4 – Crack in garage floor slab

Repairs should be carried out throughout the three units to cracked internal wall and ceiling linings. Floor slabs should be fully investigated for cracking and repaired where necessary.

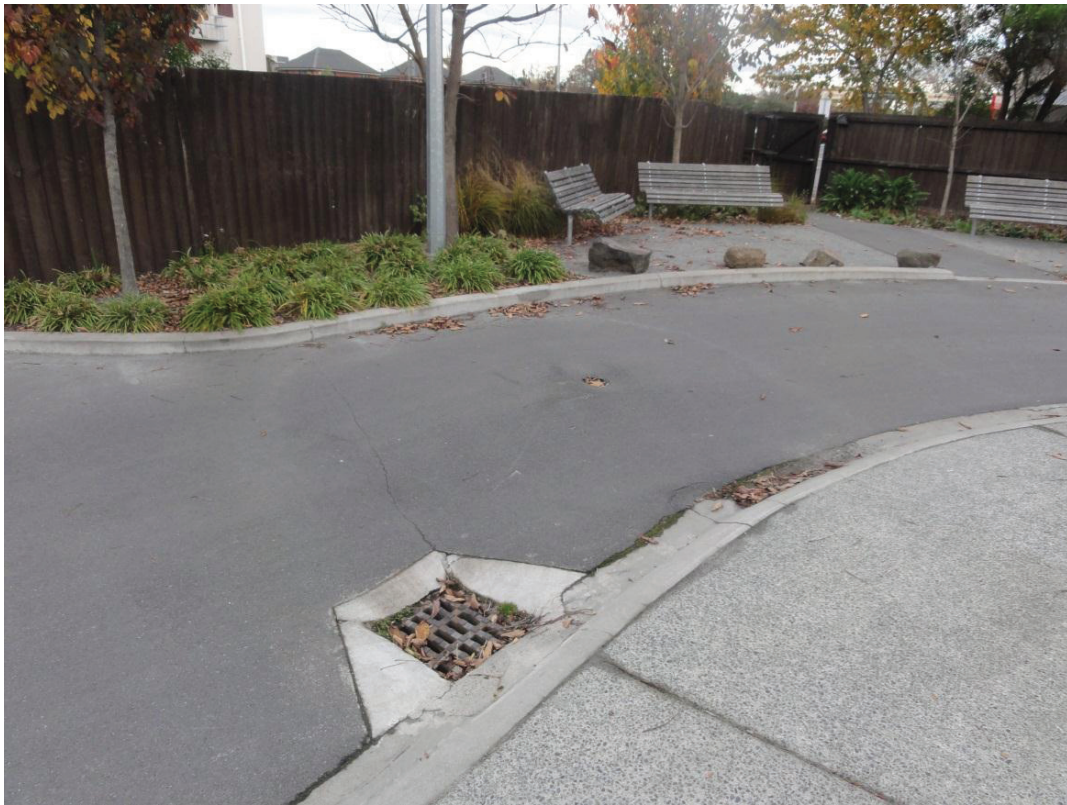
Figure 5: Up to 200mm of heave in pavement south west of Block A.

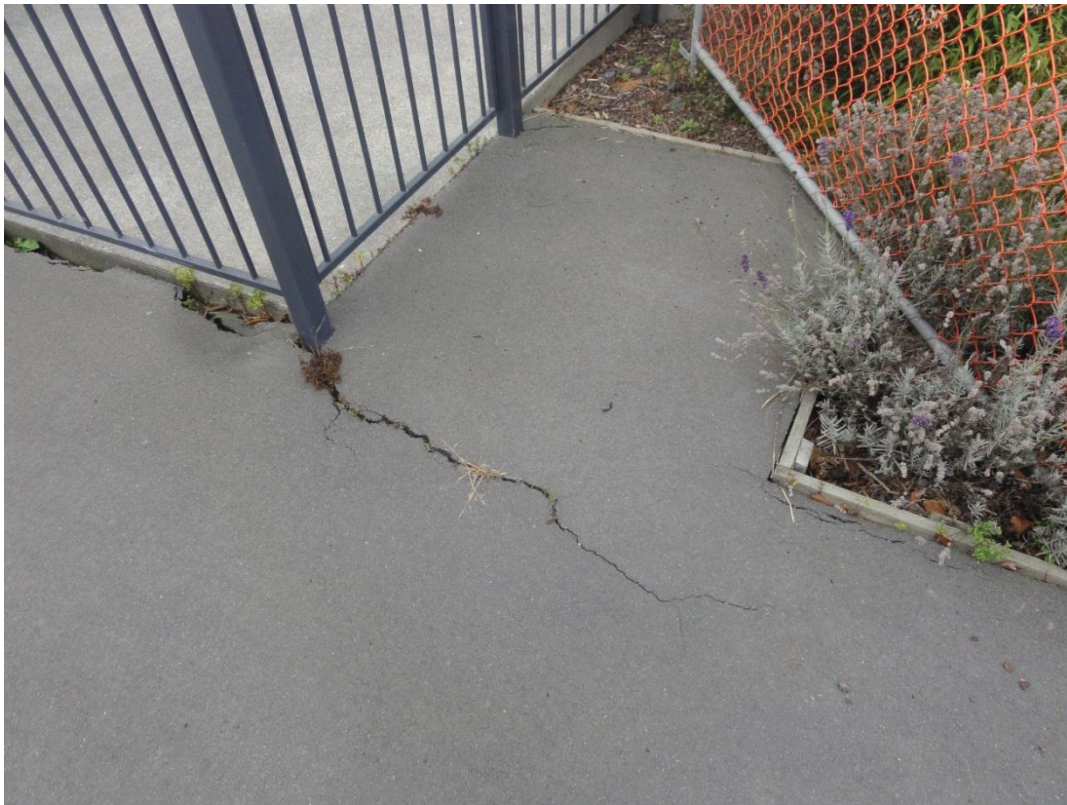
- Cracking and settlement has occurred at several locations in the paved footpath in-between Blocks A, B and C (Figure 11).
- Gaps of up to 50mm wide have formed on the north and south sides of Block A (Figures 4, 11 and 12).

Due to the ground motion during the seismic events, the lateral movement that Block A has undergone may have caused the soils to consolidate resulting in the gaps observed on both the north and south sides of Block A.

Figure 11: A gap up to 50mm is evident between the asphalt and concrete patio north of Block A.

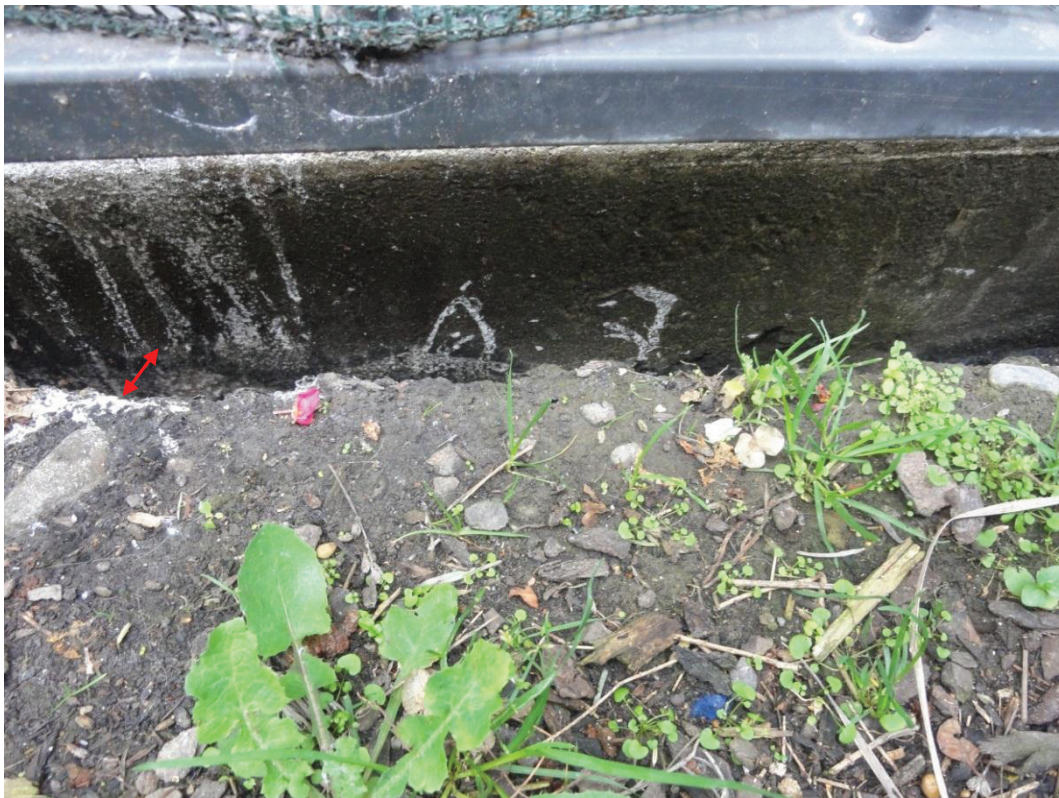
Figure 12: A gap up to 50mm is evident between a garden and concrete patio north of Block A.
