Whakahoa Village Units Block E
BU 2680-005 EQ2
Detailed Engineering Evaluation
Quantitative Report
Christchurch City Council

Detailed Engineering Evaluation Quantitative Report

Date: September 2012
Reference: 6-QUCCC.93
Status: Final

Gowerton Place, Richmond

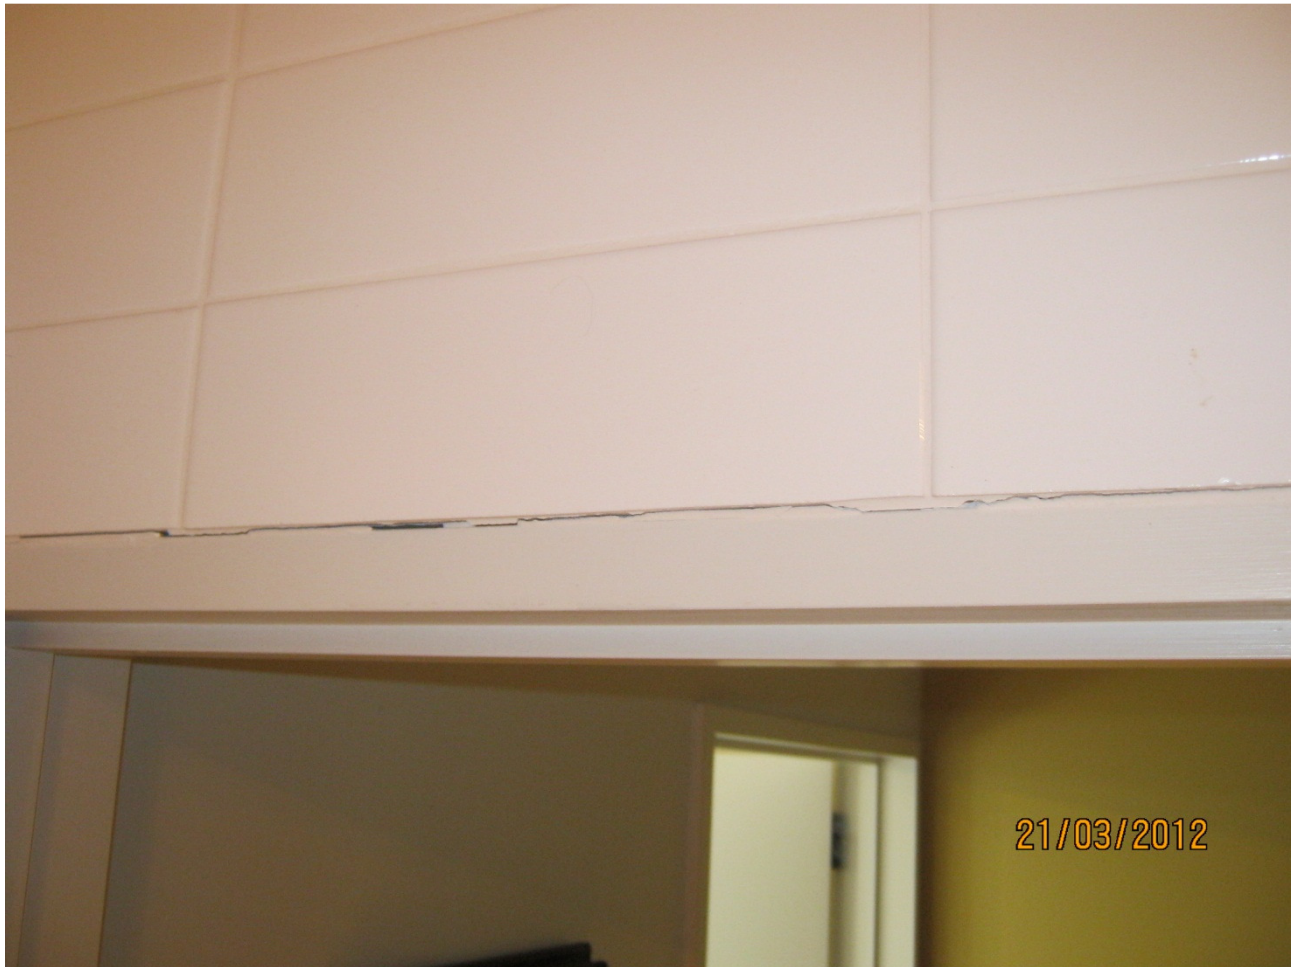
The building has performed well under seismic conditions with only minor localised wall lining damage due to movements of the building from either liquefaction and/or earthquake loading. The most noticeable damage in Unit 59 is the crack over the bathroom door. Cracking in Unit 58 is barely noticeable.

Photo 1: Crack in wall above bathroom door

- (a) The building damage relating to cracking of wall or ceiling linings should be repaired.

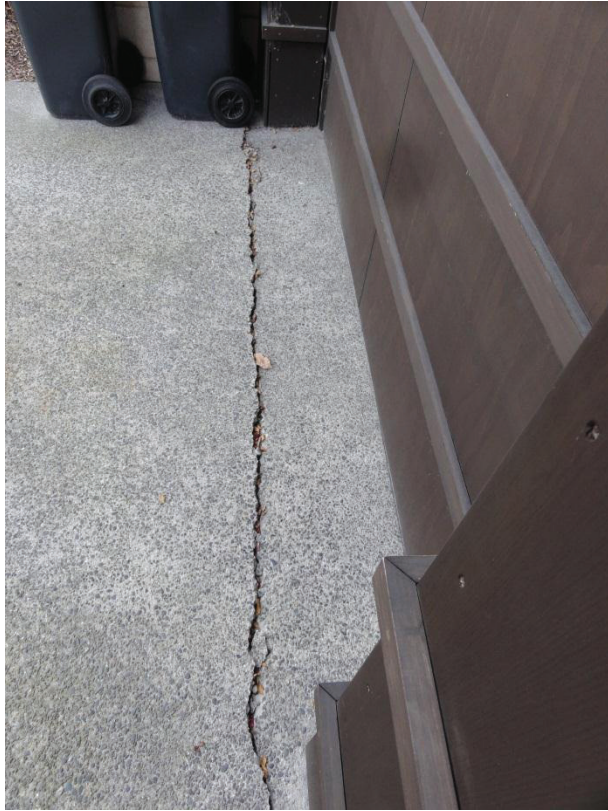
- A door frame in unit 54 (Block C) appears to be skewed by 10mm, likely due to differential settlement of foundations (Figure 7).
- The concrete driveways of unit 43 (west end of Block A) and unit 54 (south end of Block C) have cracked and have been offset vertically by up to 20mm (relative to the driveway) and laterally by 10mm directly outside of the garage doors (Figure 3).

Figure 3: Up to 10mm lateral and 20mm of vertical movement.

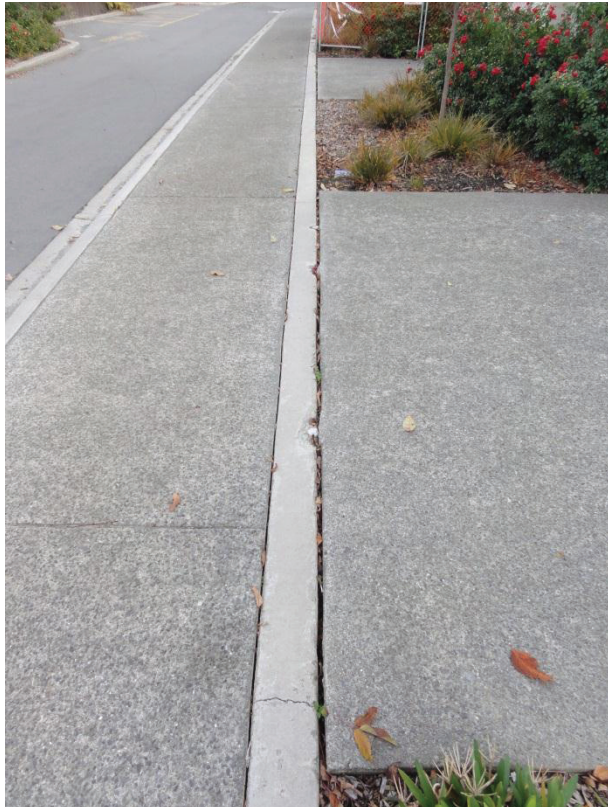
- Cracking and settlement has occurred at several locations in the paved footpath in-between Blocks A, B and C (Figure 11).
- Gaps of up to 50mm wide have formed on the north and south sides of Block A (Figures 4, 11 and 12).

Figure 4: Up to 30mm of lateral movement.

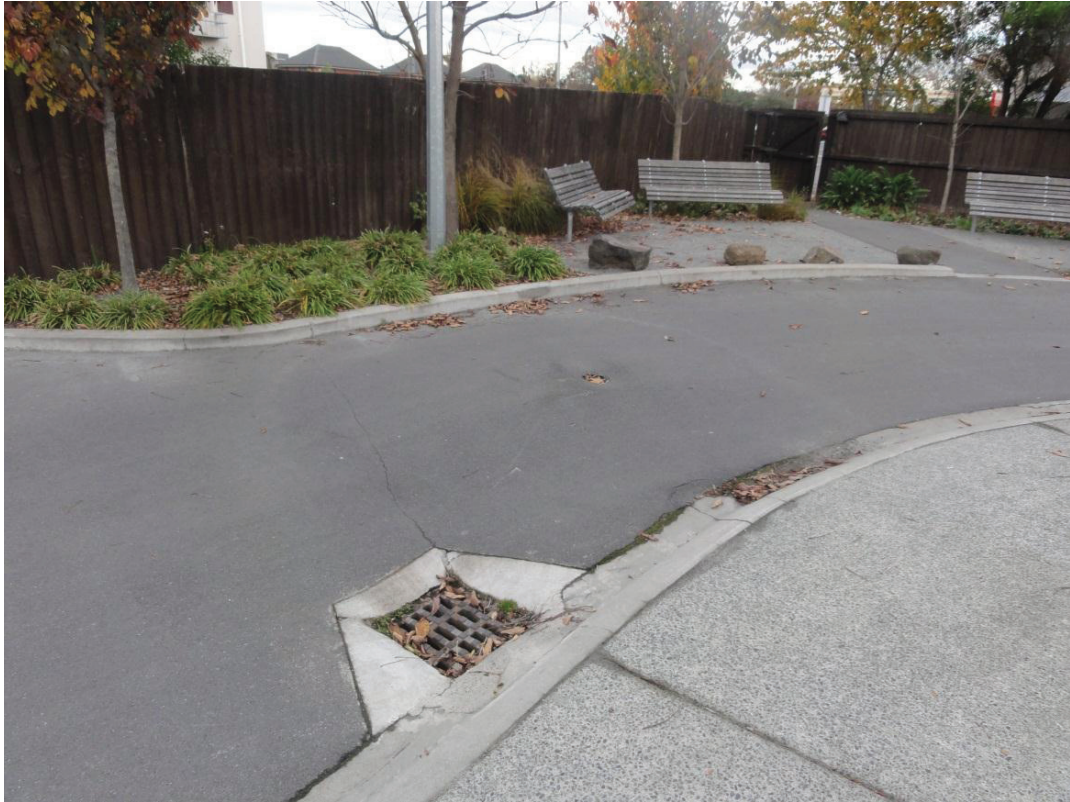
Figure 5: Up to 200mm of heave in pavement south west of Block A.

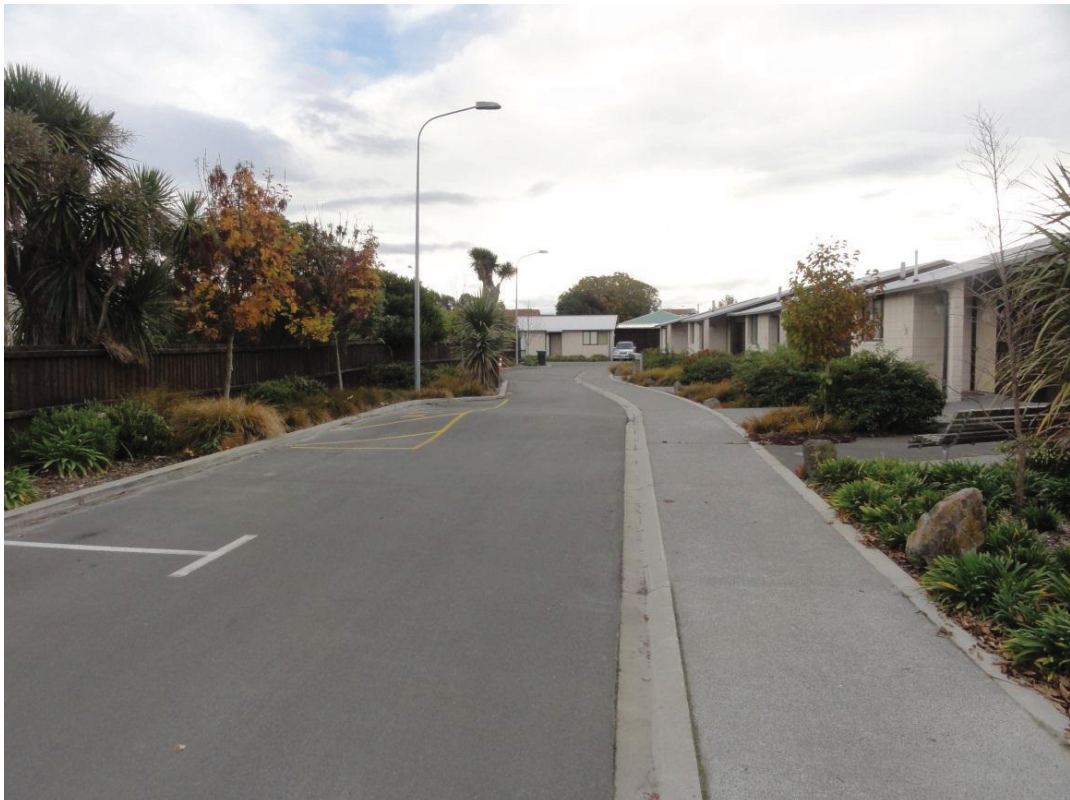
Figure 6: Up to 300mm of heave in the pavement along the western boundary.

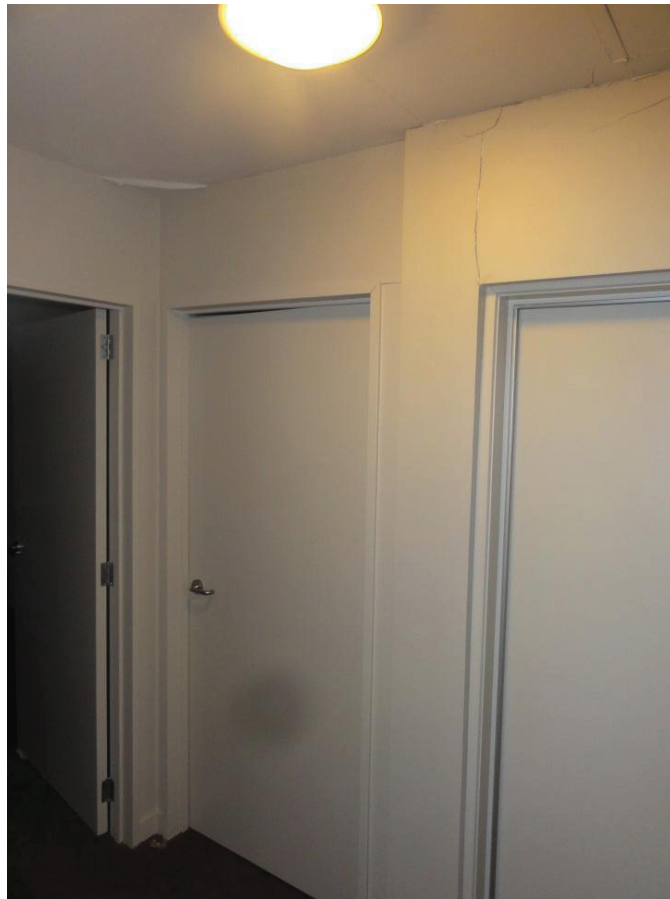
It is unknown whether up to 10mm of vertical skew of the door in Unit 54 (Block C) is attributed to settlement or structural damage due to the shaking. A level survey is recommended of Block C to determine whether differential settlement has occurred.

Figure 7: The bedroom door has skewed by up to 10mm.

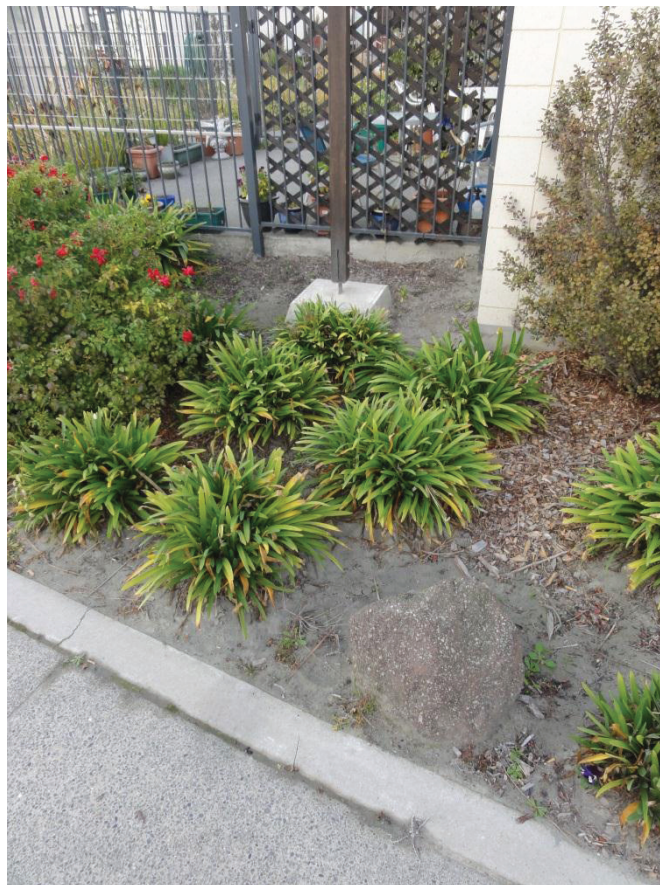
Figure 8: Liquefaction ejected material is evident in gardens around the site.

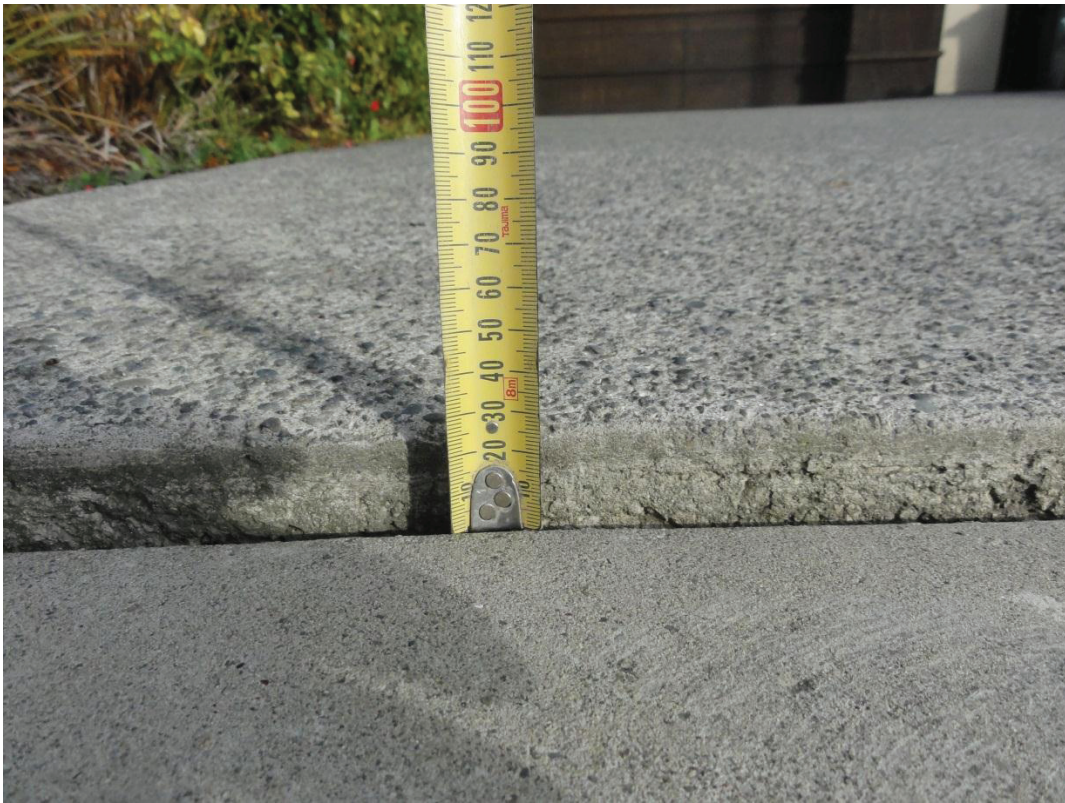
Figure 9: Approximately 20mm of vertical settlement in footpath outside Block B.

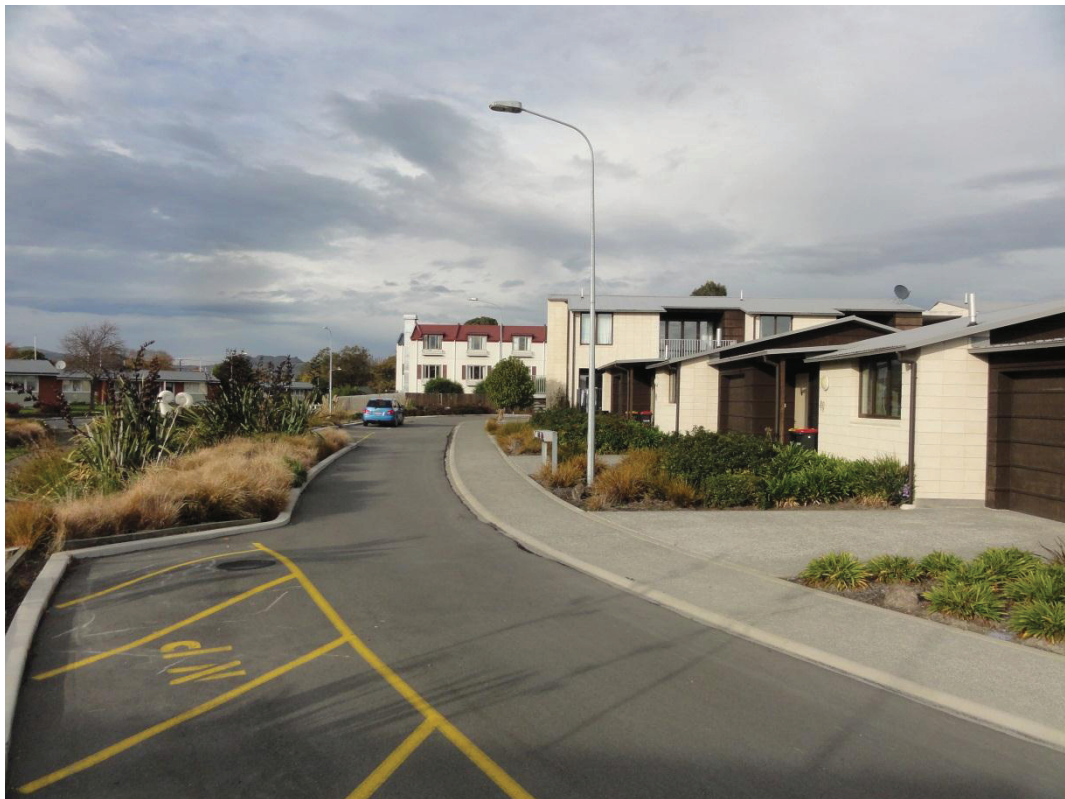
Figure 10: Heave in the pavement along the western boundary.

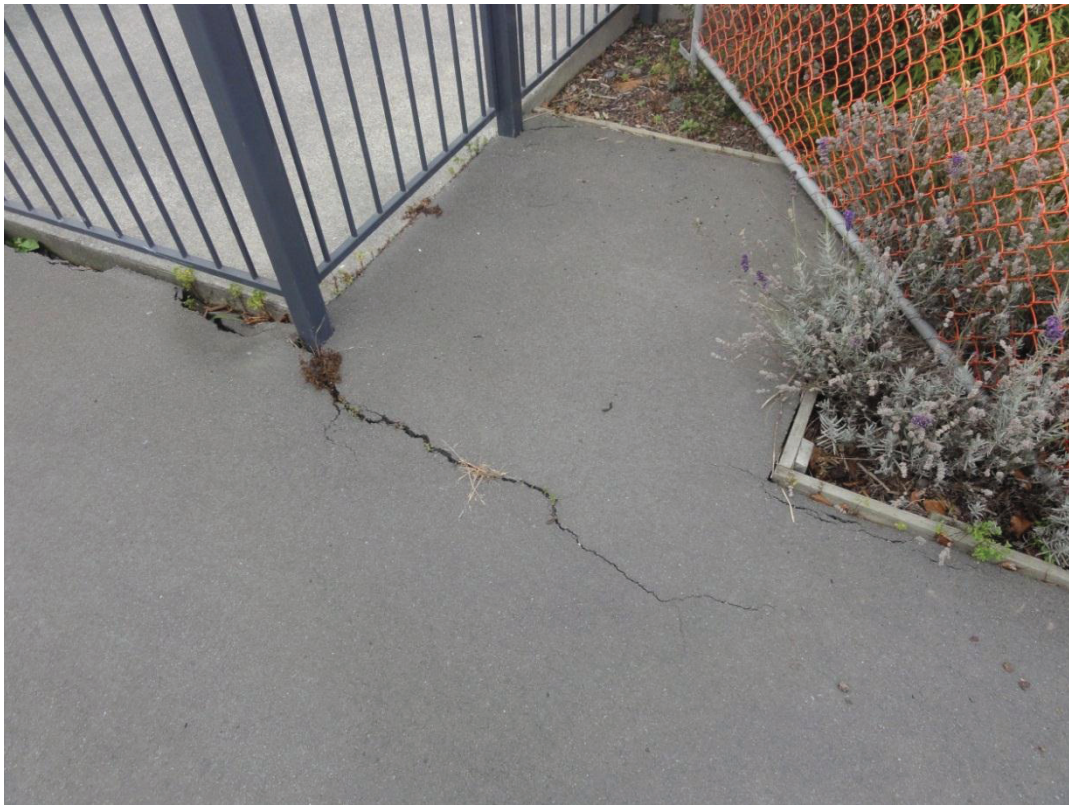
Due to the ground motion during the seismic events, the lateral movement that Block A has undergone may have caused the soils to consolidate resulting in the gaps observed on both the north and south sides of Block A.

Figure 11: A gap up to 50mm is evident between the asphalt and concrete patio north of Block A.

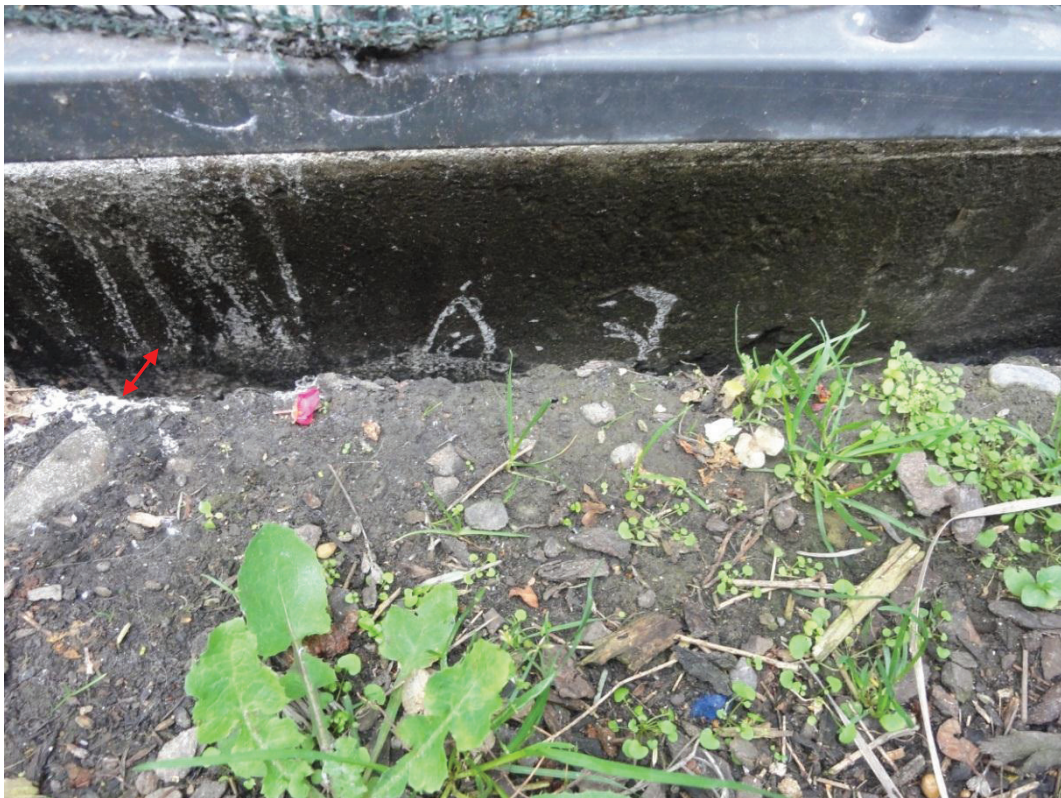
Figure 12: A gap up to 50mm is evident between a garden and concrete patio north of Block A.

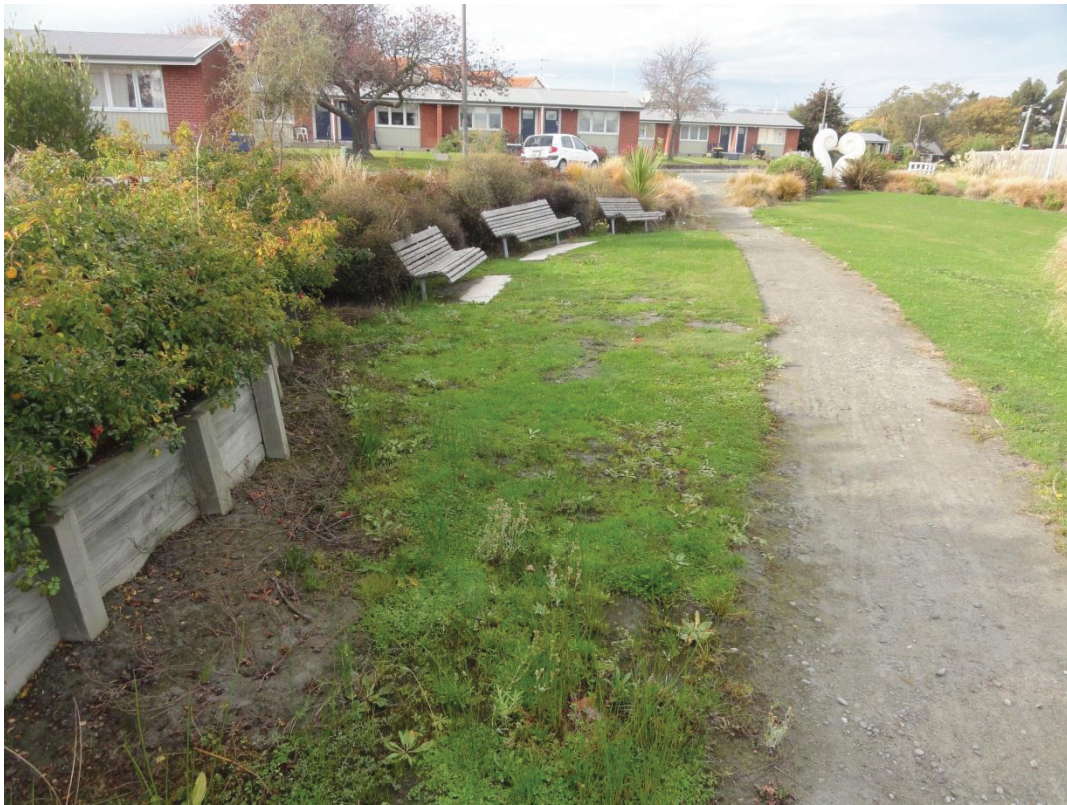
Figure 13: Liquefaction induced settlement of the park benches east of the site.

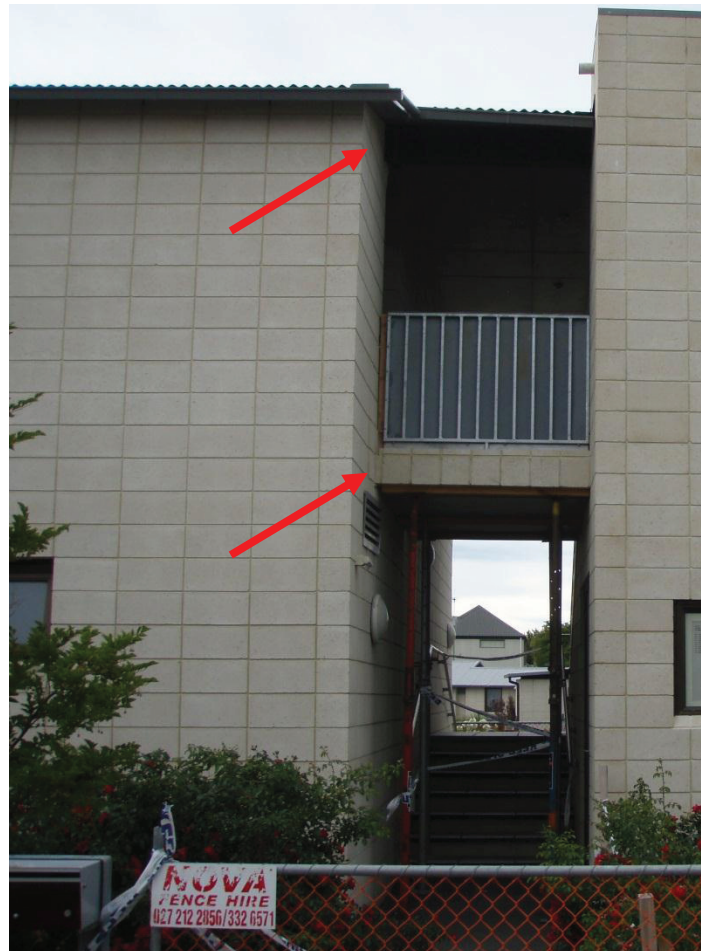
The level survey results are consistent with the observations of differential settlement of the western units of Block A. Observations include pavement cracking of the driveway outside the western most unit (unit 43) separating from the stair well.

Figure 14: Separation between west side of Block A and the stair well.
