Wharenui Pool Building
BU 0533-002 EQ2
Detailed Engineering Evaluation
Stage Two Quantitative Report
Christchurch City Council

Wharenui Pool Building

Detailed Engineering Evaluation Quantitative Report BU 0533-002 EQ2

Date: September 2012
Reference: 6-QUCCC.41
Status: Final

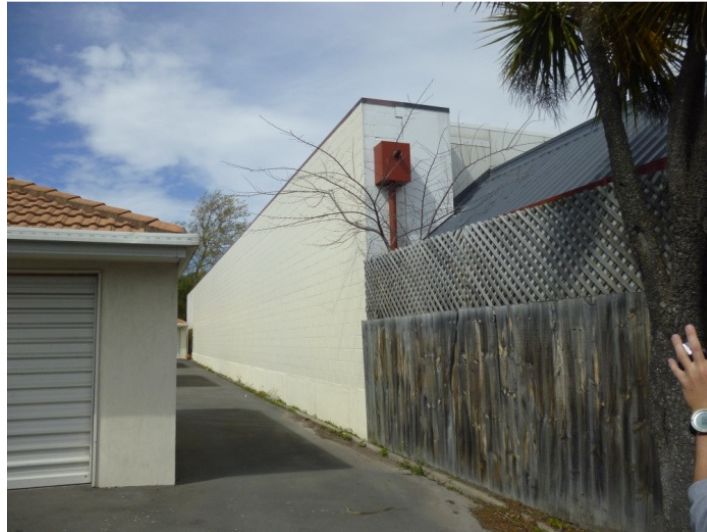
The east wall of the pool building appears to be out of plumb but there are no signs of cracking or other damage.

Photo 1 – Eastern perimeter wall

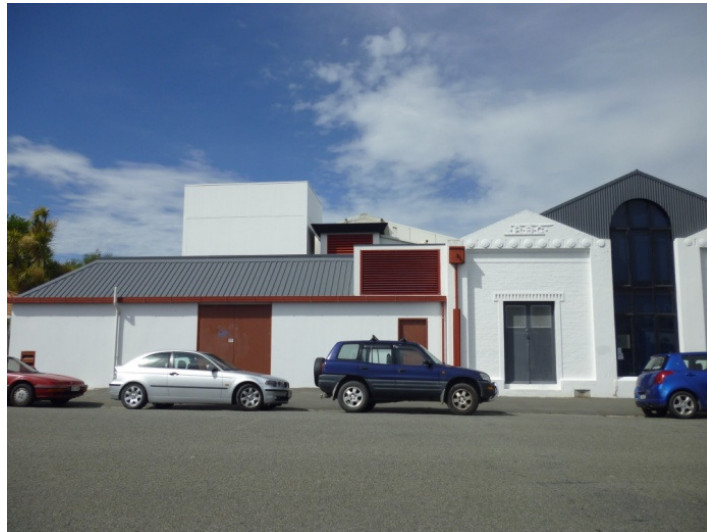
Photo 2 – North elevation (east end)

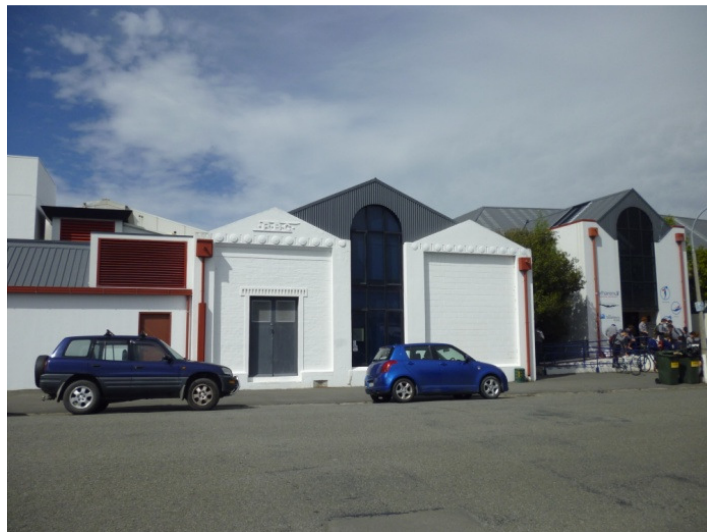
Photo 3 – North elevation (west end)

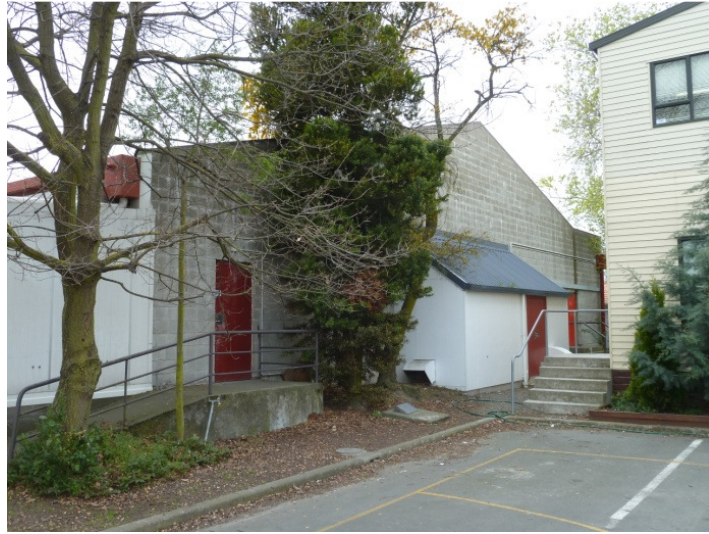
Photo 4 – South elevation

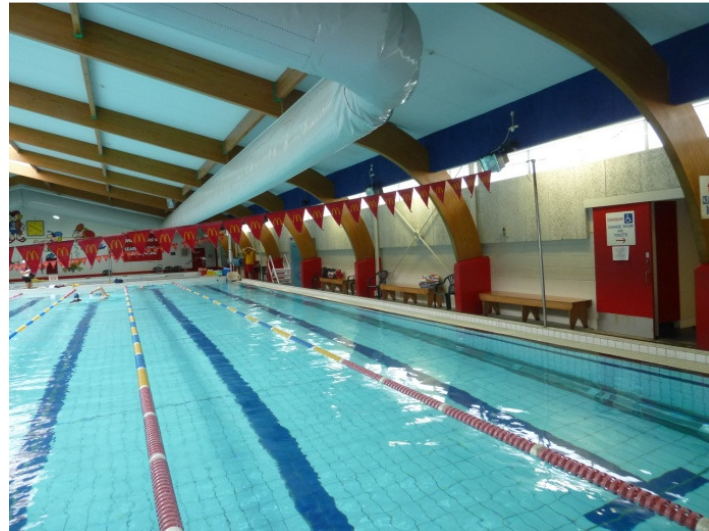
Photo 5 – Internal view of portals frames and cross bracing elements on western wall

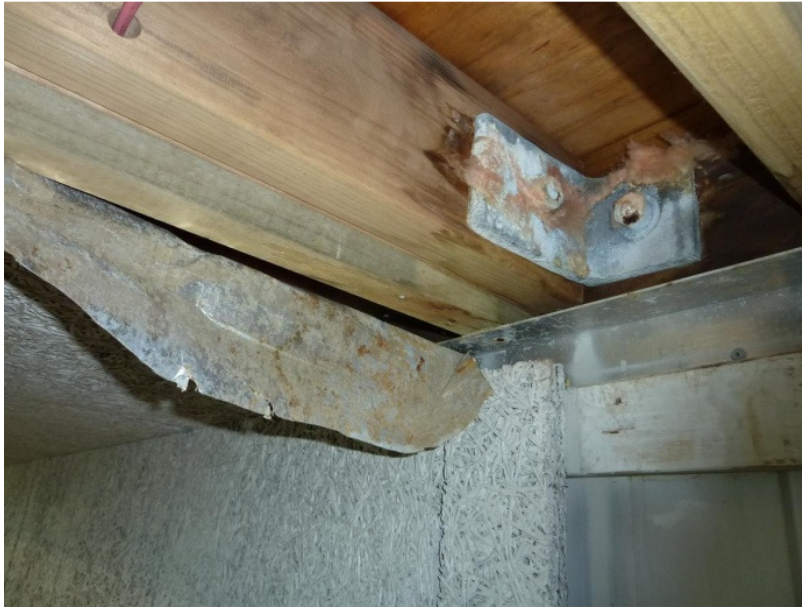
The box gutter appears to be formed from plywood which could potentially provide some diaphragm action between the masonry wall and the longitudinal steel beam supporting the box gutter, however the bolted connections between the timber runner and masonry wall are extremely corroded and have limited capacity.

Structural Element/System	Failure mode and description of limiting criteria	Critical Structural Weakness and Collapse Hazard	% NBS based on calculated capacity
Reinforced masonry wall (east elevation) – connection to glulam frame	Shear failure of the single M16 fixing between the horizontal timber struts and the steel brackets bolted to the masonry wall. The connection detail lacks redundancy.	No	79%
Reinforced masonry wall (south elevation) – out of plane capacity	Flexural out of plane failure of the wall. The wall reinforcement details are unknown so have been based on an assumed layout of D12 at 600mm centres.	No	41%
Purlin connection to southern reinforced masonry wall.	Shear failure of the bolted connection between the purlins and the masonry wall.	Yes	88%
Steel braced bays to the western elevation	The two sets of vertical cross bracing have a capacity greater than 100% NBS however there is no viable load path for transferring seismic loads from the pool building into the cross bracing elements.	No	<34%

Photo 6 – Connection between eastern wall and portal frame

- (a) Strengthening options be developed for increasing the seismic capacity of the building to at least 67% NBS and restoring the load paths to the eastern and western walls.
- (b) Undertake a structural condition survey of all hidden fixings to check the levels of corrosion.

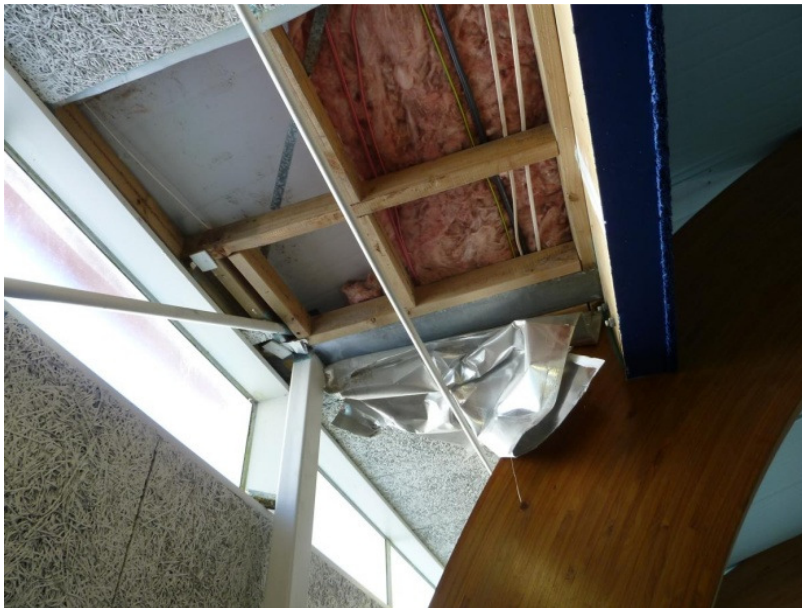
Photo 7 – View of top of steel vertical cross bracing on the western wall
