**Wigram Gymnasium**  
**BU 2556-001 EQ2**  
Detailed Engineering Evaluation  
Quantitative Report  
Version FINAL

29 Springs Road, Hornby

Christchurch City Council

**Date**  
2/10/12

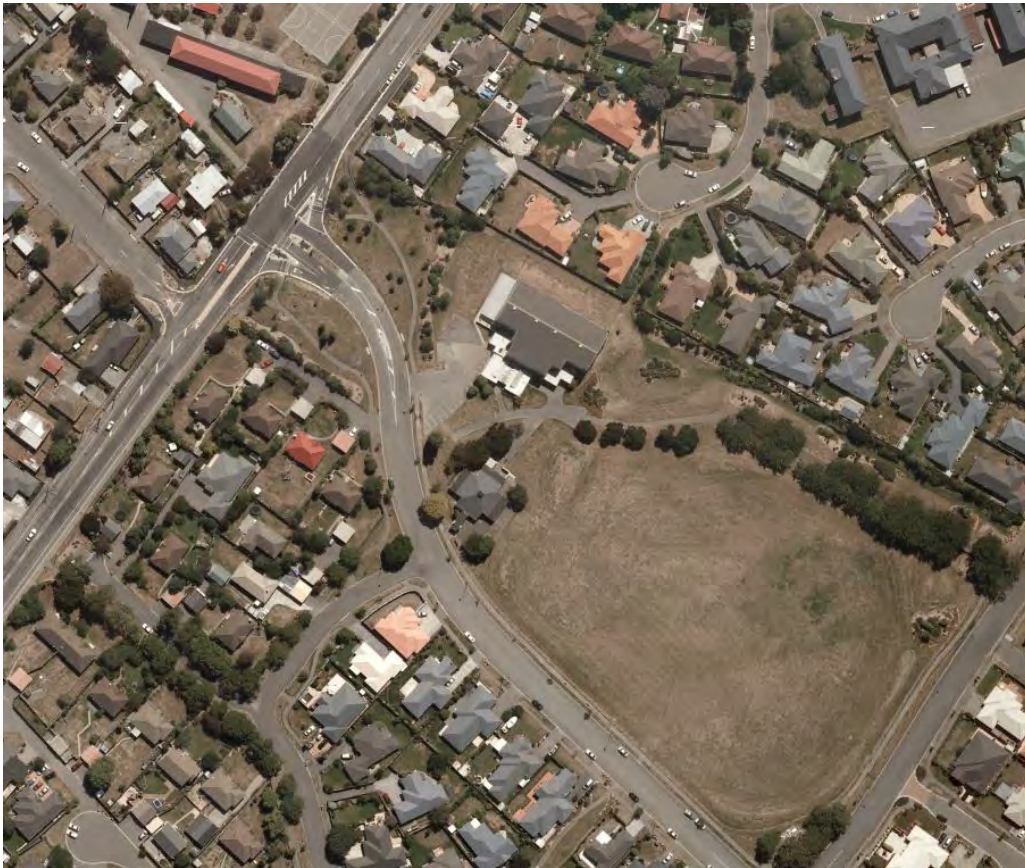
Aerial photography taken following the 22 February 2011 earthquake (Figure 1) shows no signs of liquefaction outside the building footprint or adjacent to the site and the site inspection commented that there was no noticeable ground damage.

**Figure 4**      **Post February 2011 Earthquake Aerial Photography<sup>2</sup>**

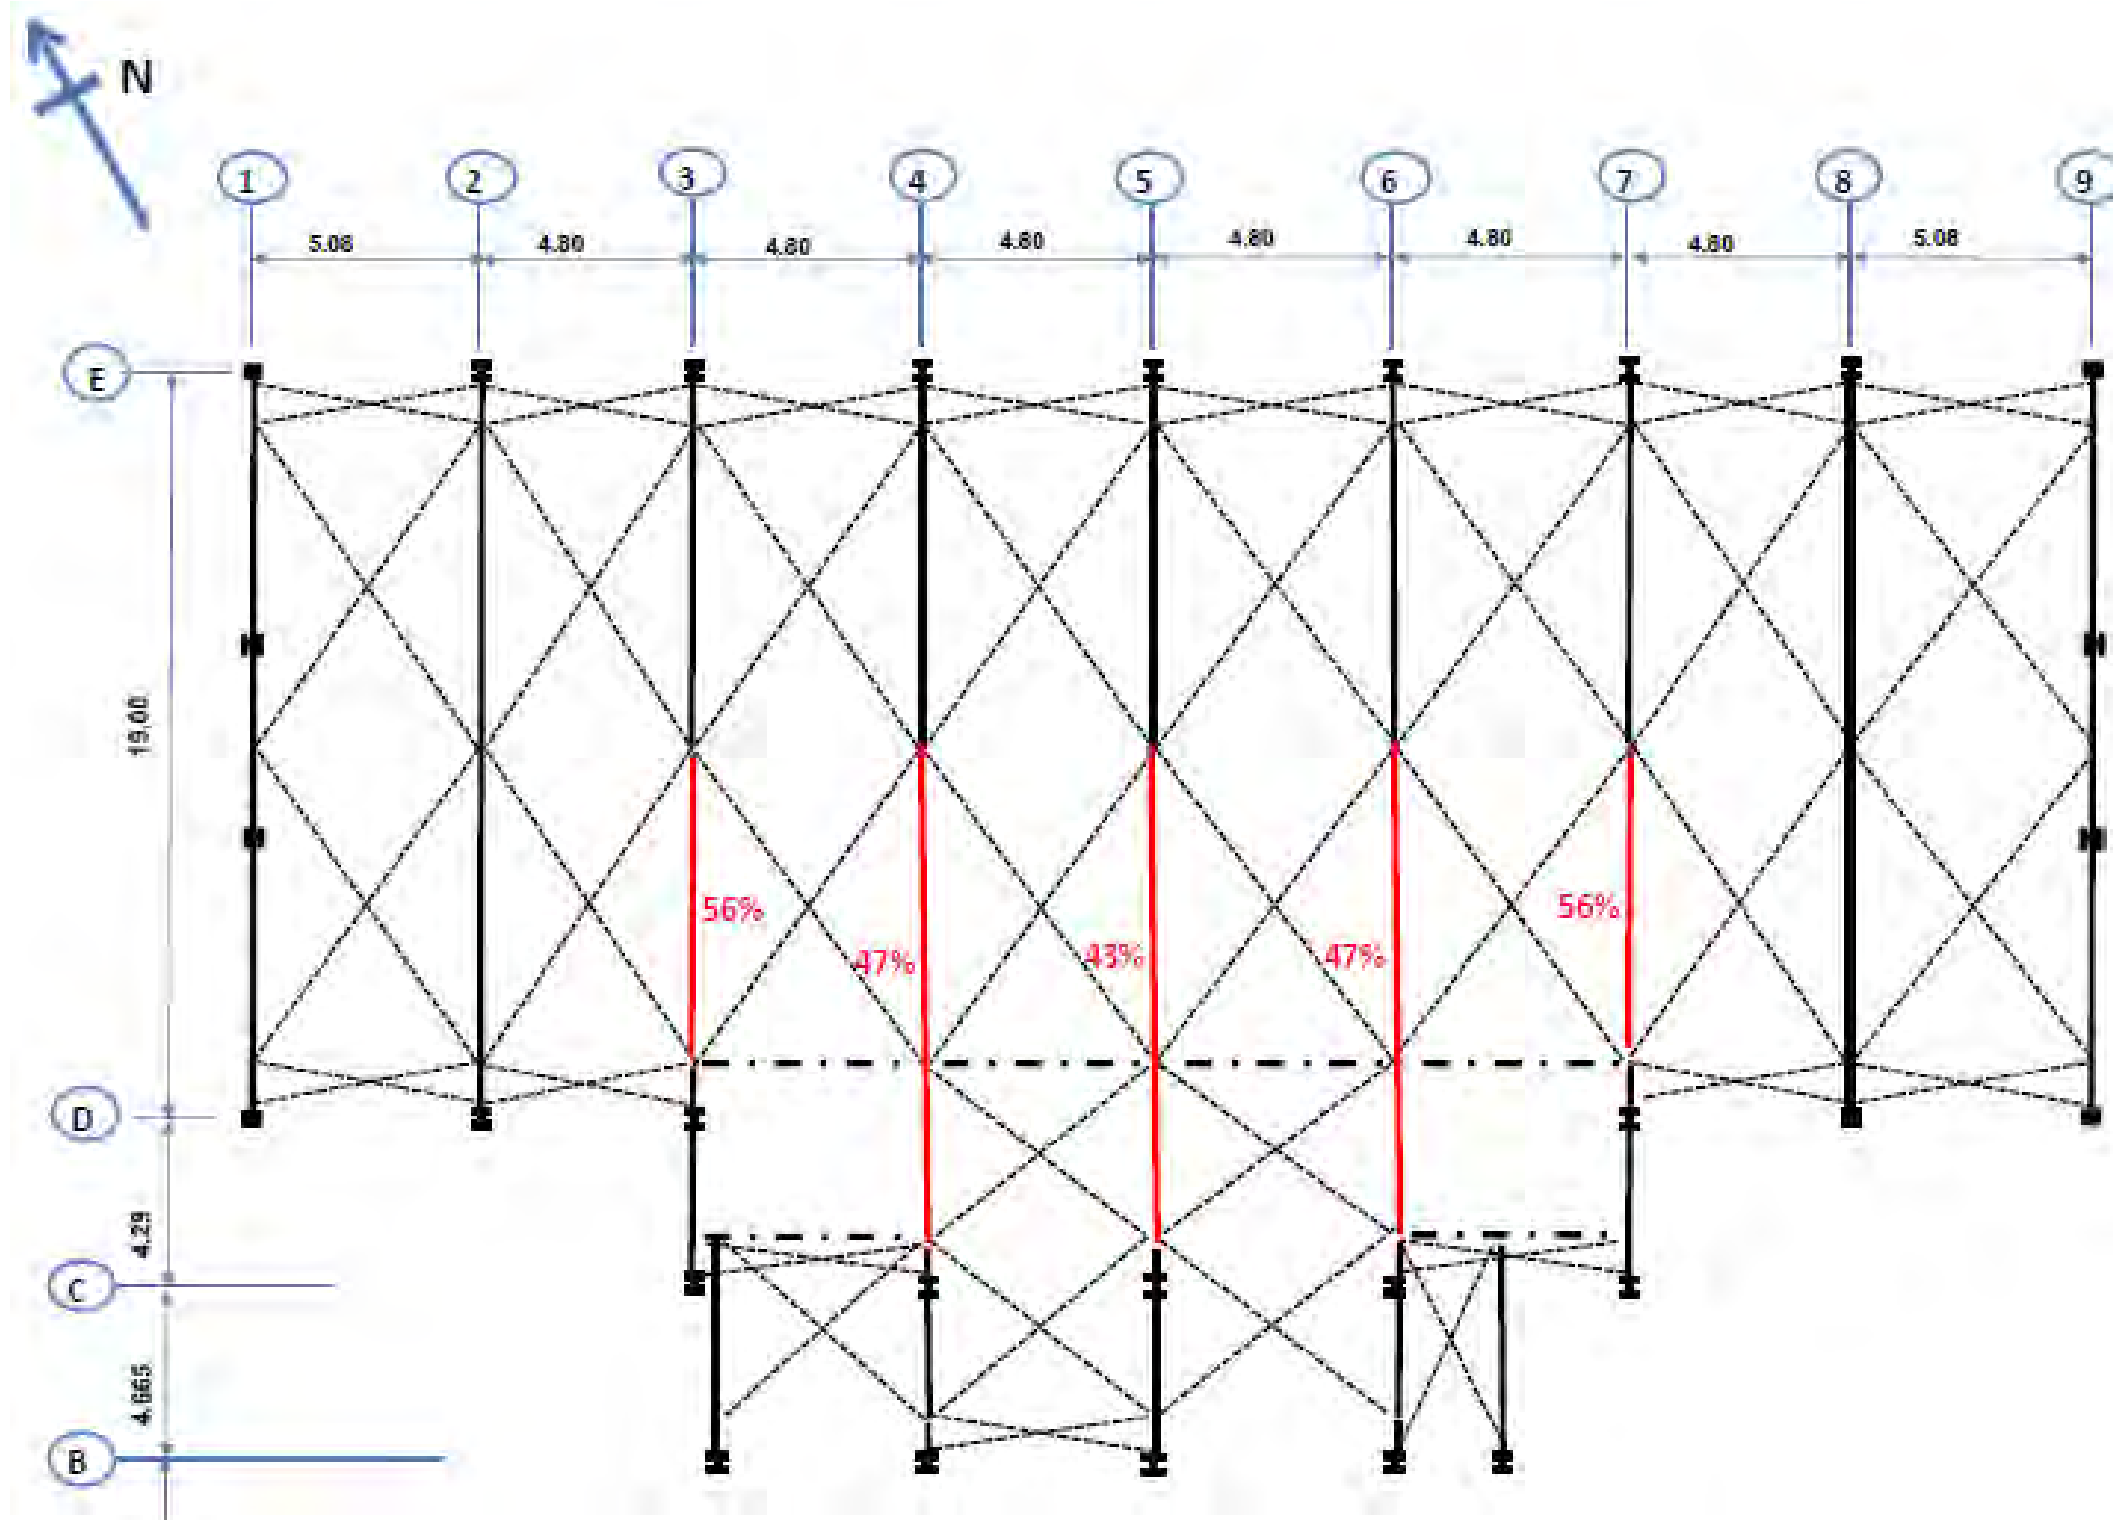
Figure 5 Roof steel rafters rated less than 67%NBS

The critical structural weakness for this building is the rafters of the steel portal frames which support the steel roof system and transfer the roof lateral load down to the foundations. These steel structural elements rated 43% NBS.

The steel portal frames lacks adequate roof and wall bracing to transfer the roof lateral load down to the foundation. The presence of reinforced concrete masonry walls along the perimeter of the portal frames helps to brace the lateral load resisting system but needs additional roof compression strut and wall bracing to make the building structurally robust.

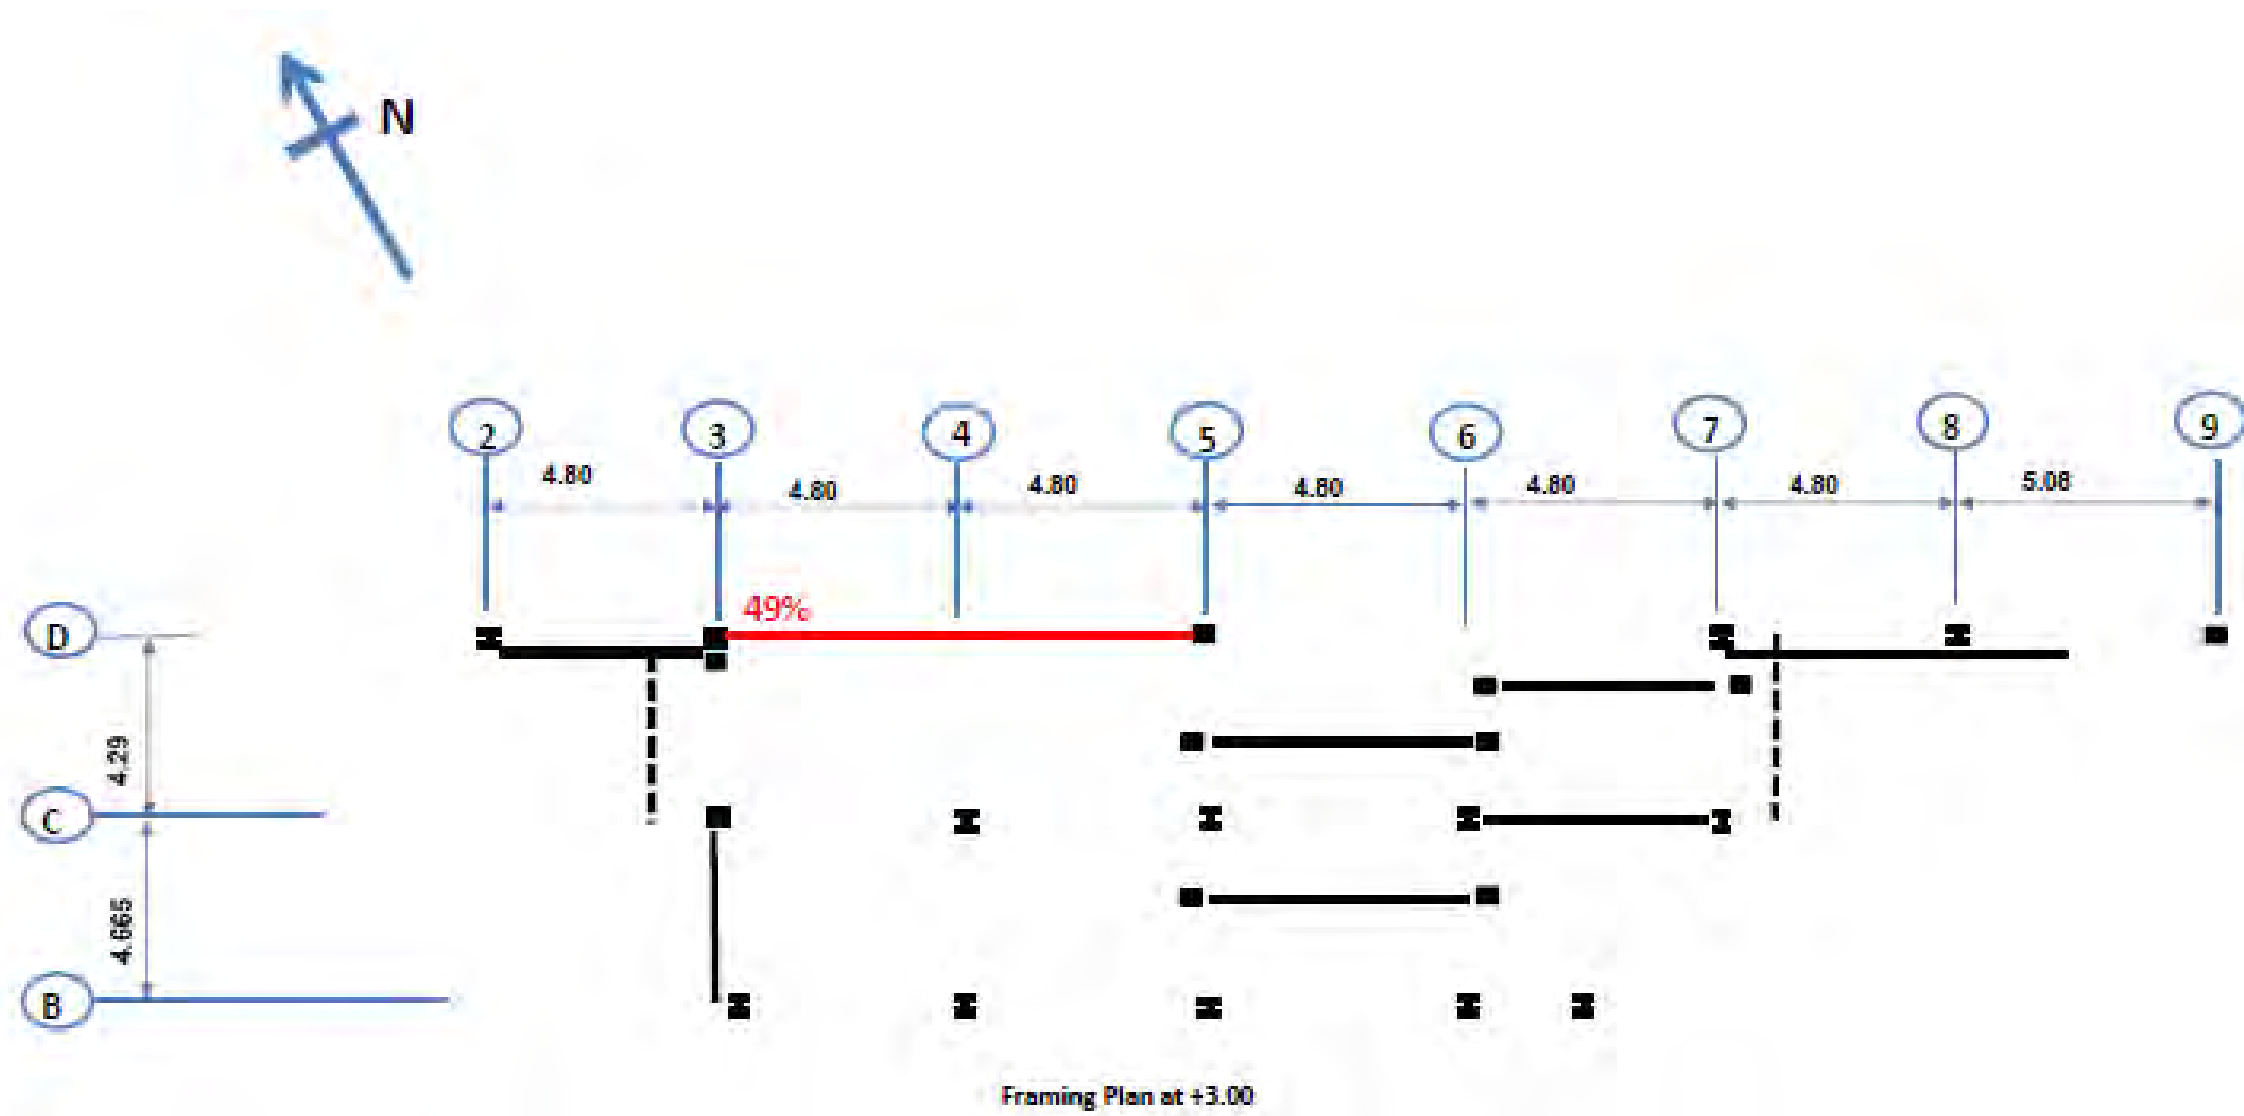
Figure 6 Gallery steel beam rated less than 67%NBS

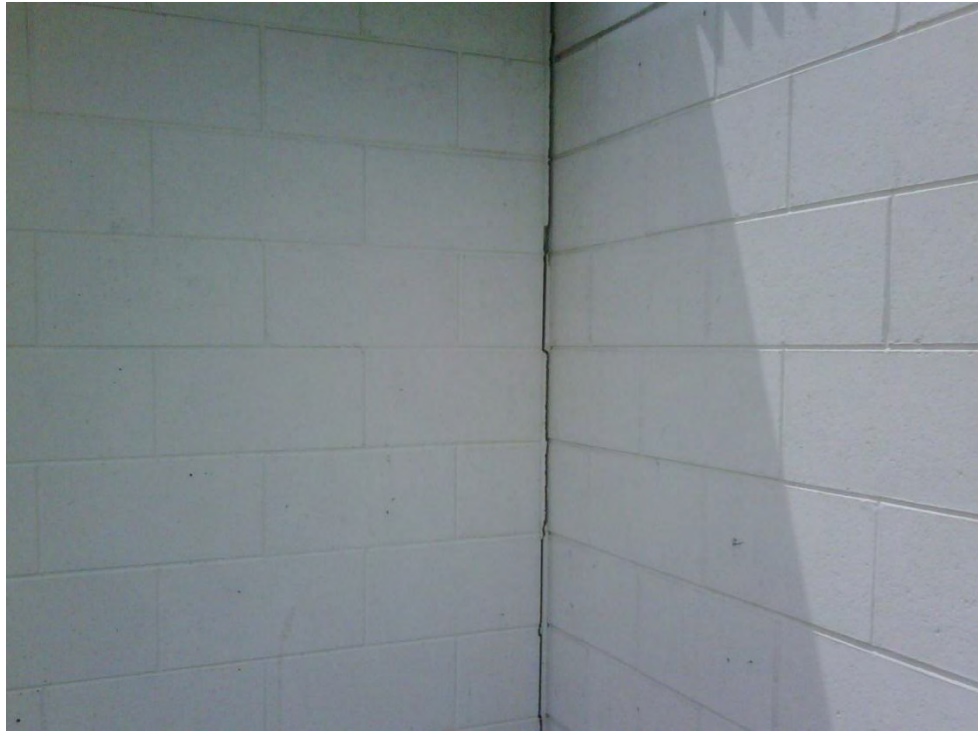
Cracking was also observed around the construction joint between the main gymnasium hall and the external storage area to the west. The cracking is likely due to relative movement between the two different structures. The reinforced concrete masonry storage area was an extension to the existing gymnastics hall and may have not been tied in structurally to the existing building, resulting in the two structures behaving separately. Details of the cracking in this area can be seen in Photographs 3 and 4.

**Photograph 3      Cracking between external storage room and main building.**

- ▶ Minor repairs are undertaken to fill the cracks identified in the reinforced concrete masonry block walls.
- ▶ A strengthening scheme is developed to increase the seismic capacity of the Wigram Gymnasium to as near as practicable to 100%NBS, and at least 67%NBS. This will need to consider compliance with accessibility and fire requirements.

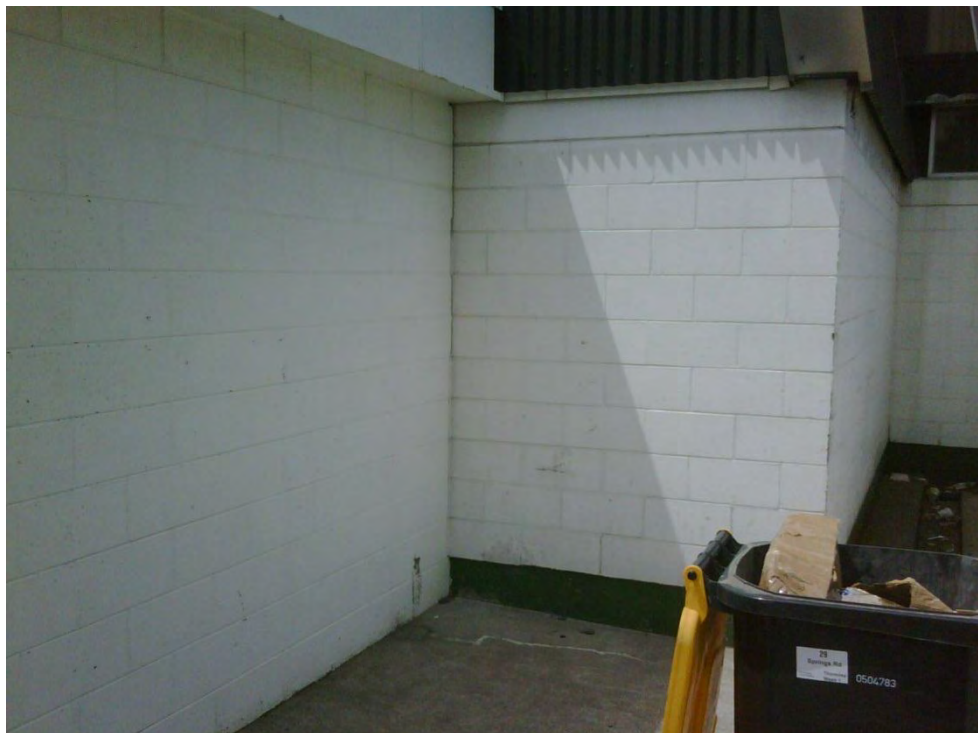
**Photograph 4      View of connection between external storage room and main building.**

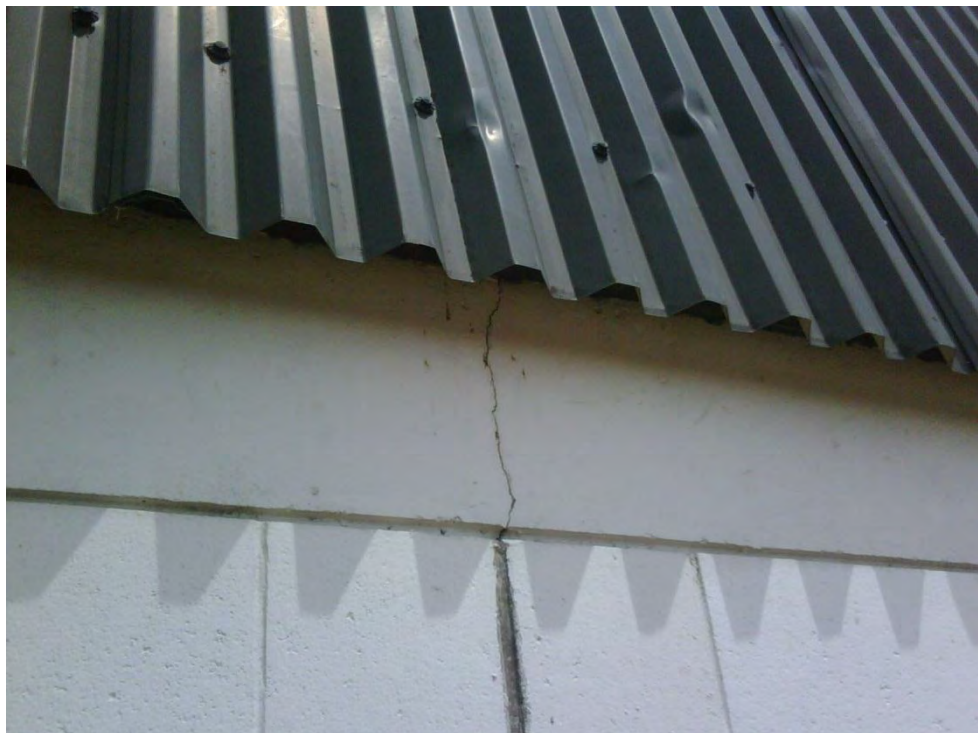
Minor cracks were observed in the reinforced concrete masonry blockwork walls in several areas of the building. On the east face of the building there are minor cracks in the reinforced concrete masonry blockwork walls. These cracks can be seen in Photographs 6 and 7 in Appendix B. These cracks were filled with dirt and as a result it is unlikely that they have occurred as a result of the recent seismic activity. They can more likely be attributed to shrinkage effects.

**Photograph 6** Cracking in concrete masonry wall.

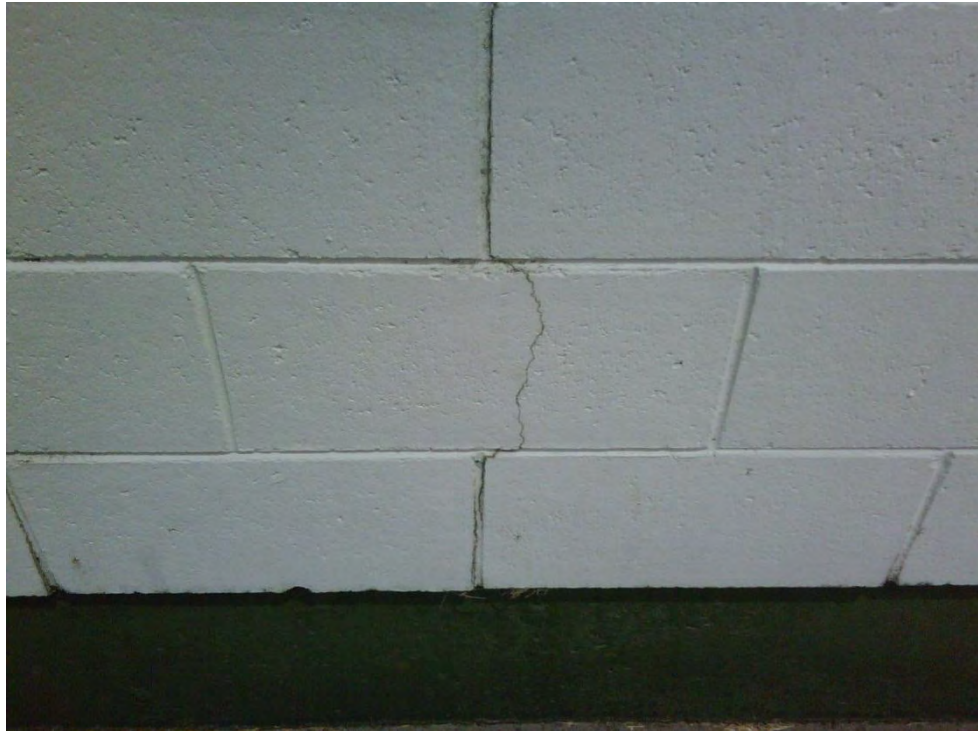
**Photograph 7** Further cracking in concrete masonry wall.
