**Christchurch City Council**  
PRK\_2123\_BLDG\_1015 EQ2  
Toilets – Windsurf Reserve  
Humphreys Drive

QUALITATIVE ASSESSMENT REPORT  
FINAL

- Rev C
- 25 January 2013

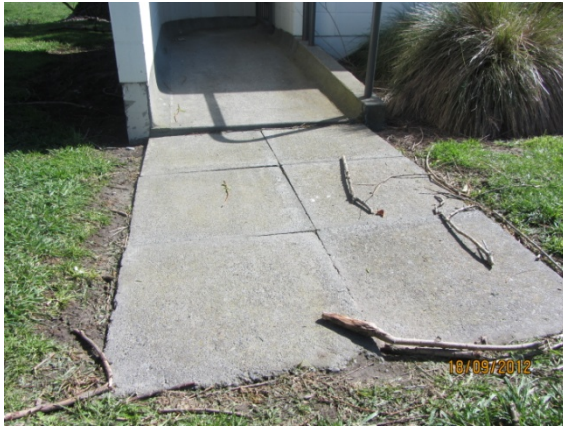
- 1) Pavements leading up to both of the toilet entrances have settled. A difference of 45mm was measured between the pavement and the toilet entrance for the women's toilet. (see photo 6)

Photo 5: Pavement leading to womens toilet entrance

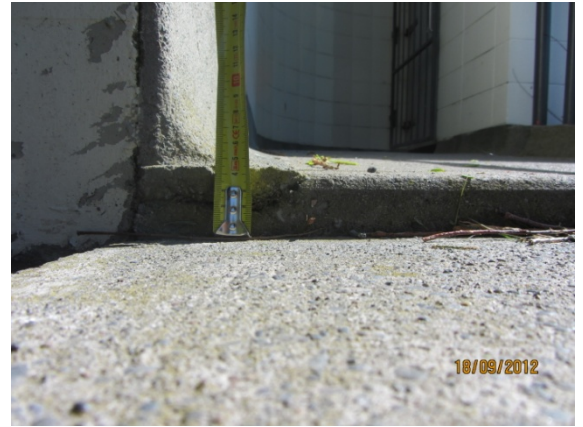
Photo 6: Close up view of photo 5, showing difference of 45mm between pavement and toilet entrance levels.

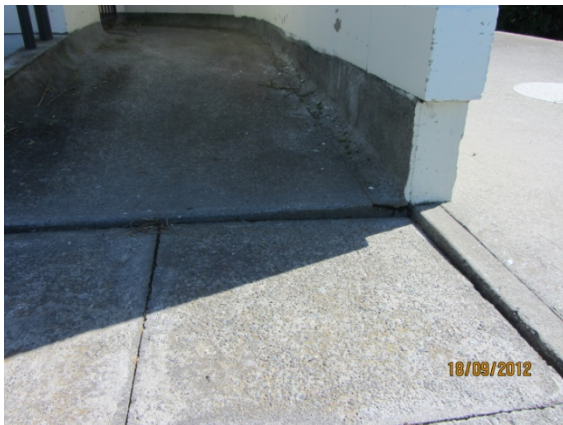
- Pavements leading up to both of the toilet entrances have settled.

Photo 7: Entrance to mens toilet also showing difference in levels between entrance and pavement.
