**AVIARY, WOODHAM PARK**  
**PRK 0697 BLDG 003 EQ2**  
Detailed Engineering Evaluation  
Qualitative Report  
Version DRAFT

157 Woodham Road, Linwood

Christchurch City Council

**Date**  
4<sup>th</sup> October 2012

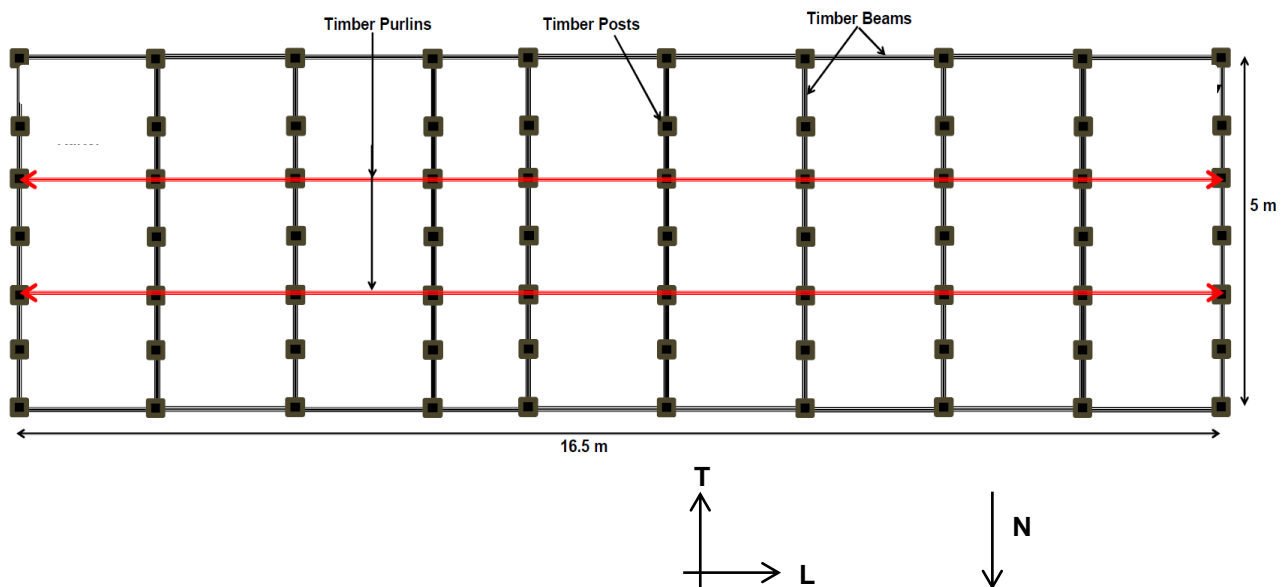
**Figure 2 Plan Sketch Showing Key Structural Elements**

The building is approximately 5m in width, 16m in length and 2.6m in height. The plan area of the building is approximately 80m<sup>2</sup>.

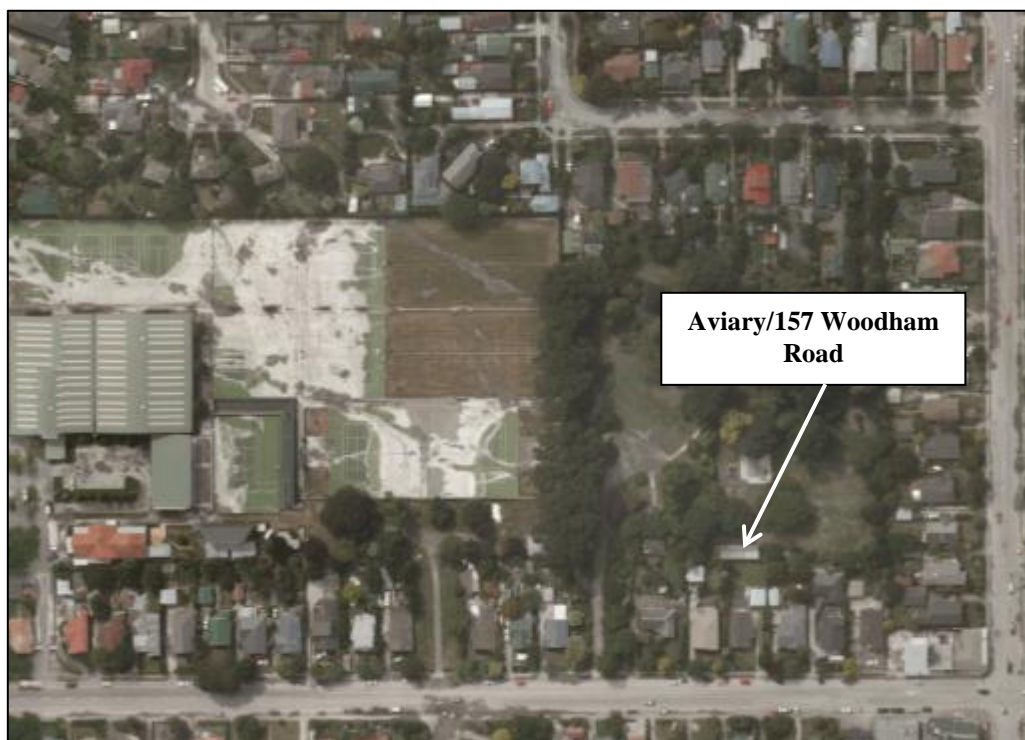
**Figure 3 Post February 2011 Earthquake Aerial Photography** <sup>5</sup>

Aerial photography taken following the 22 February 2011 earthquake shows evidence of liquefaction outside the building footprint as well as significant liquefaction and lateral spreading in adjacent sites, as shown in Figure 3.

Evidence of lateral spreading and sand boil lineations can be seen in the aerial photograph. The author also has previous experience along adjoining sites where lateral spreading was observed.

Should a more comprehensive liquefaction and/or ground condition assessment be required, it is recommended that intrusive investigation be conducted.

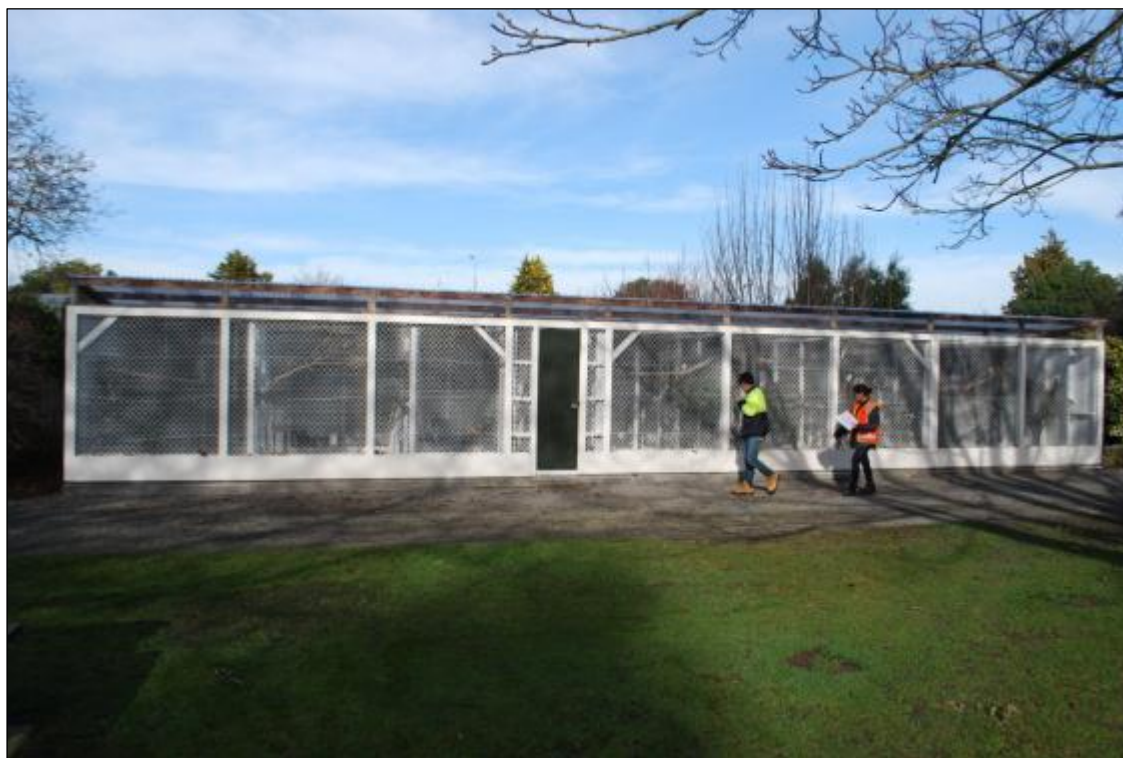
**Photograph 1 Front view of the Aviary.**

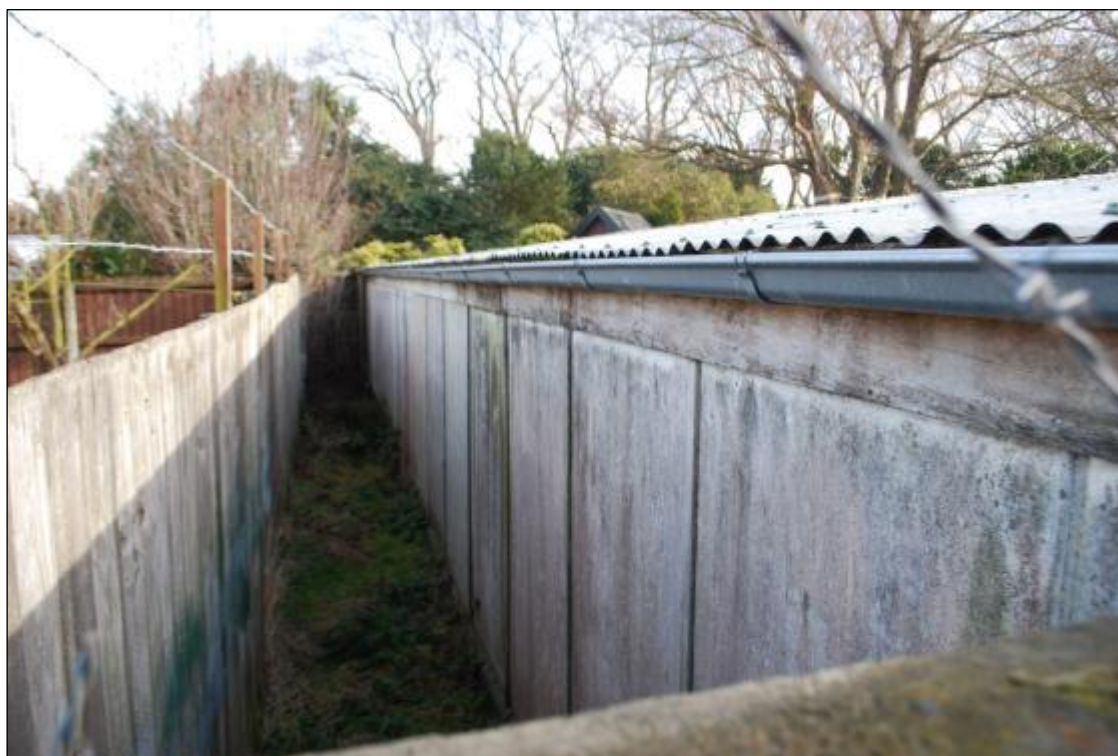
**Photograph 2 Back view of the Aviary.**

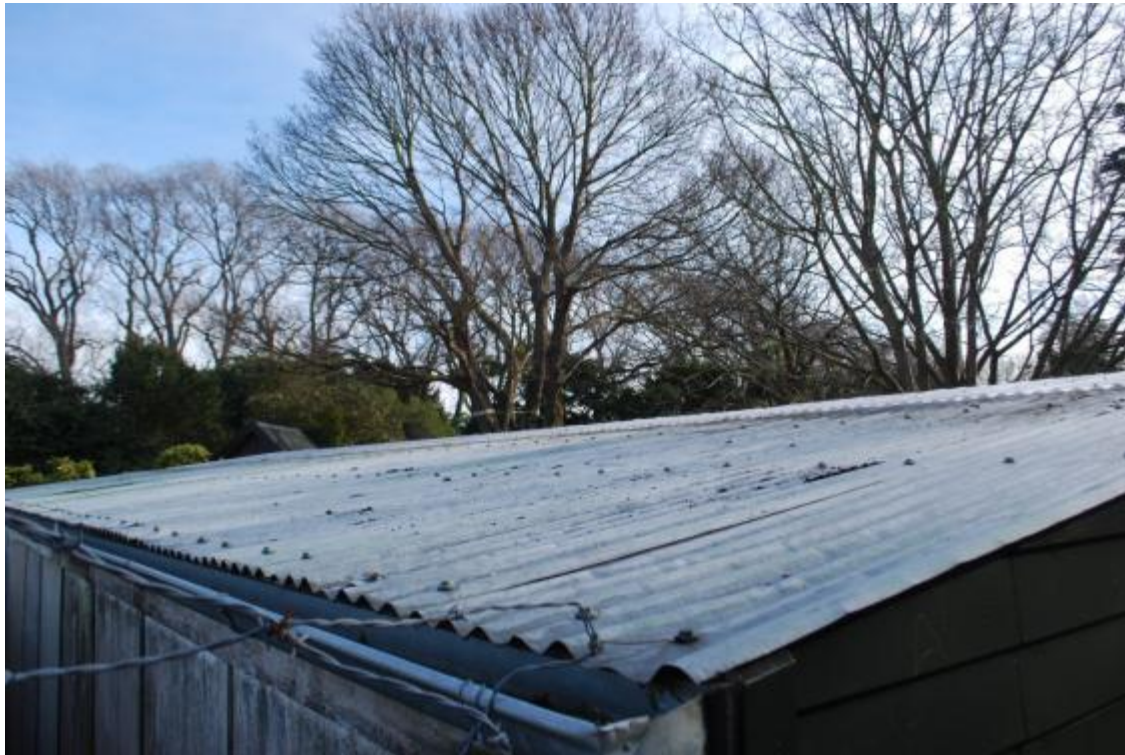
Roof bracing was not observed in the structure however, close spacing of timber purlins supported on timber frames are visible and expected to provide sufficient bracing to the roof.

**Photograph 3 Outside view of the roof.**

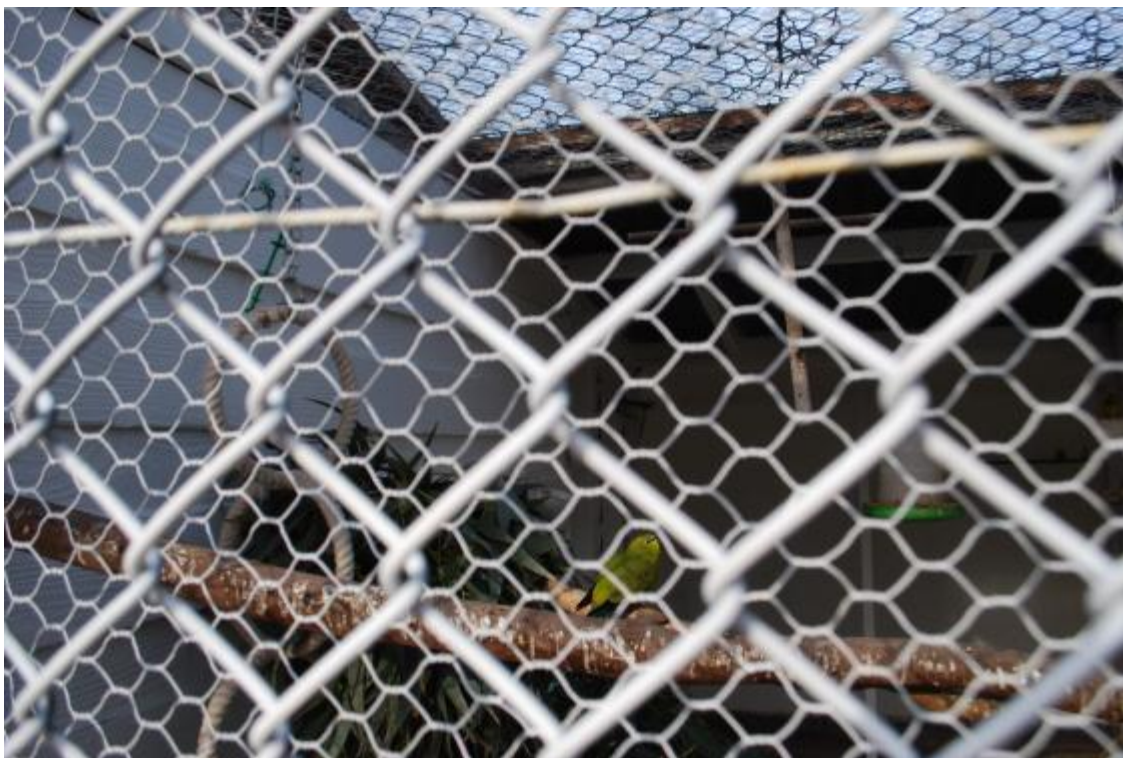
**Photograph 4 Interior view of the Aviary.**

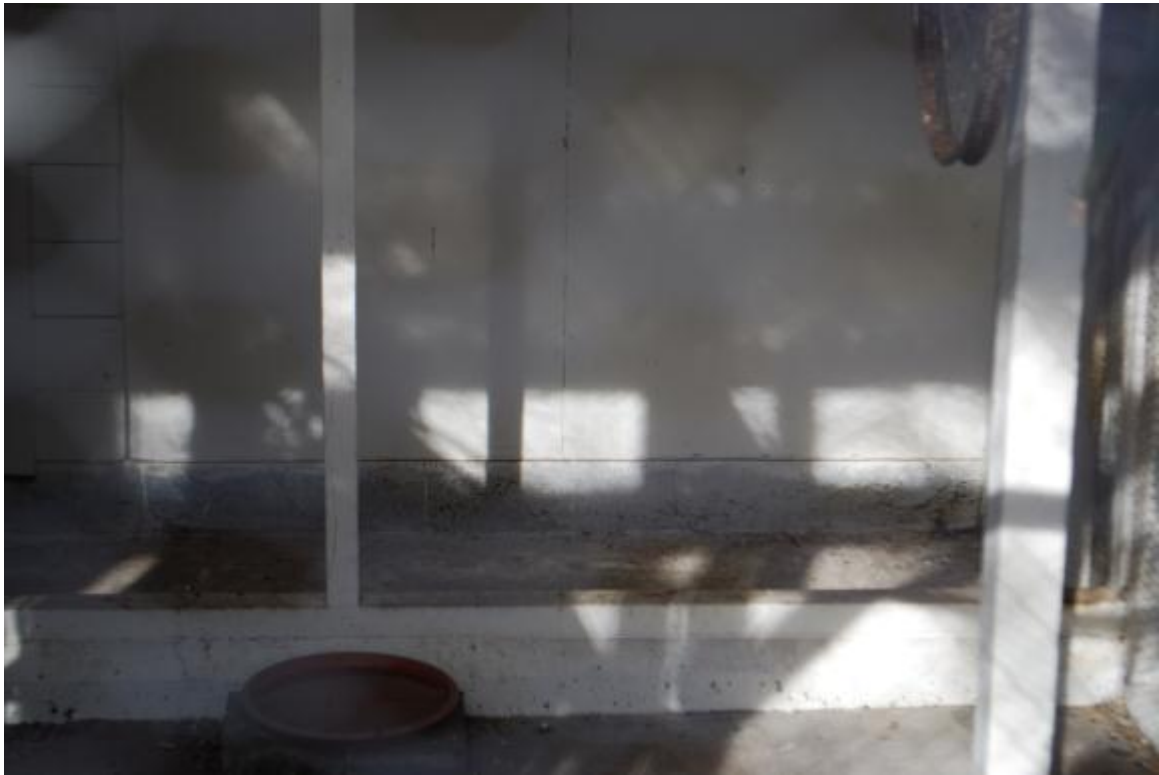
**Photograph 5 Interior view of the Aviary.**
