Woolston Park - Toilet Block
PRK 0919 BLDG 002 EQ2
Detailed Engineering Evaluation
Quantitative Report
Version FINAL

502 Ferry Road, Woolston

Christchurch City Council

Date
5 April 2013

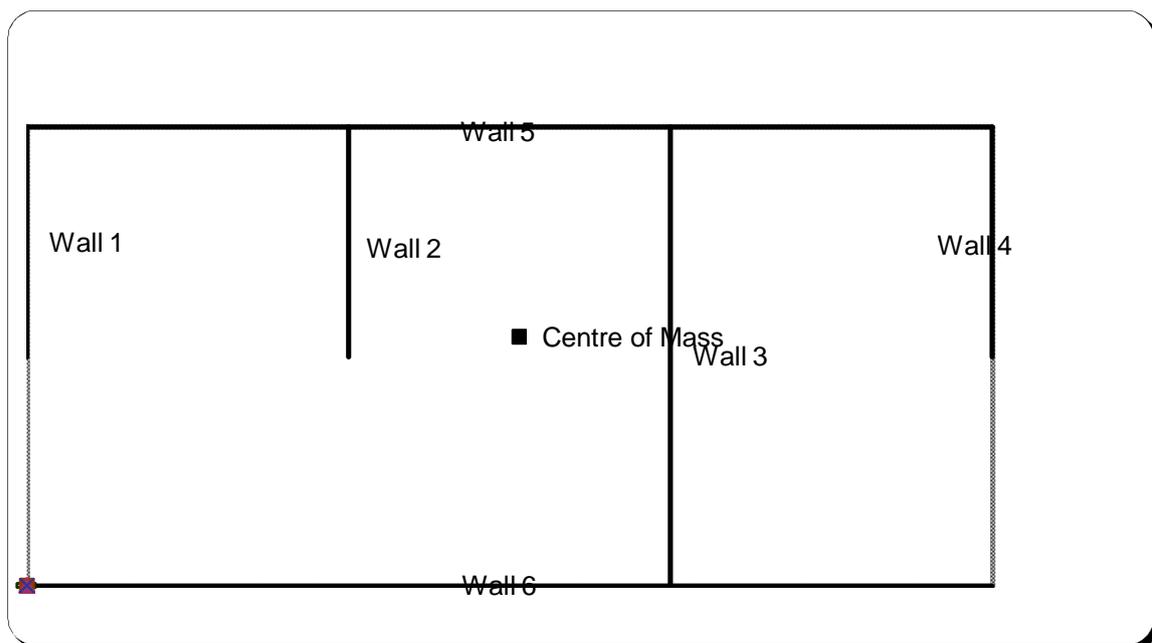
Figure 4 Plan Details and Wall Locations

There are no critical structural weaknesses or collapse hazards identified in this building. The walls have been determined to be weak for out-of-plane bending. The toilet walls have a NBS rating of 50% in out-of-plane bending. In all other load actions to the building is either fully compliant with current NBS levels or at least above 67% NBS. The building has no significant damage and has no collapse hazards.

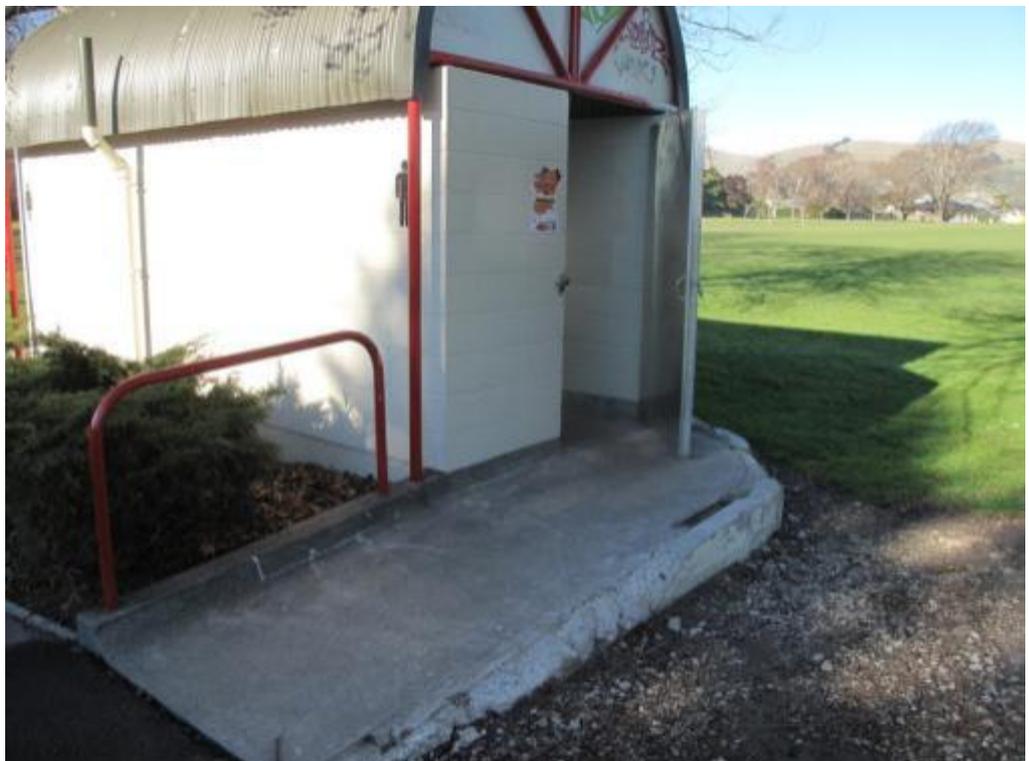
Significant cracks were noted at the base of the removed freestanding walls at the side entrances to the toilet block next to the access ramps. The extent of cracking, debris and damage indicates that removal was likely prompted by earthquake damage. The cracking, damage and minor debris are clearly visible in Photographs 4, 5 and 6 in Appendix A.

Photograph 4 Significant damage to the base where the freestanding wall was removed.

As no immediate collapse hazards or critical structural weaknesses have been identified and the building has achieved 50% NBS the building can remain occupied. It is recommended that the removed freestanding privacy walls should be reinstated to bring the building back to a pre-earthquake condition.

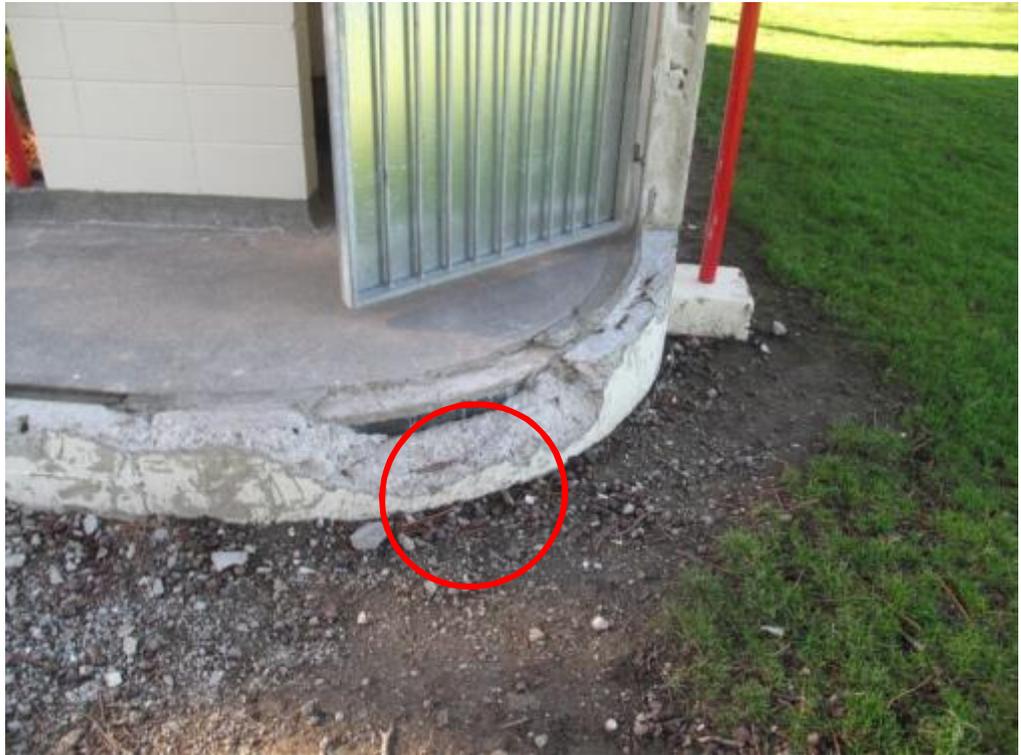
Photograph 5 Cracking, damage, and exposed reinforcement at base of removed wall.

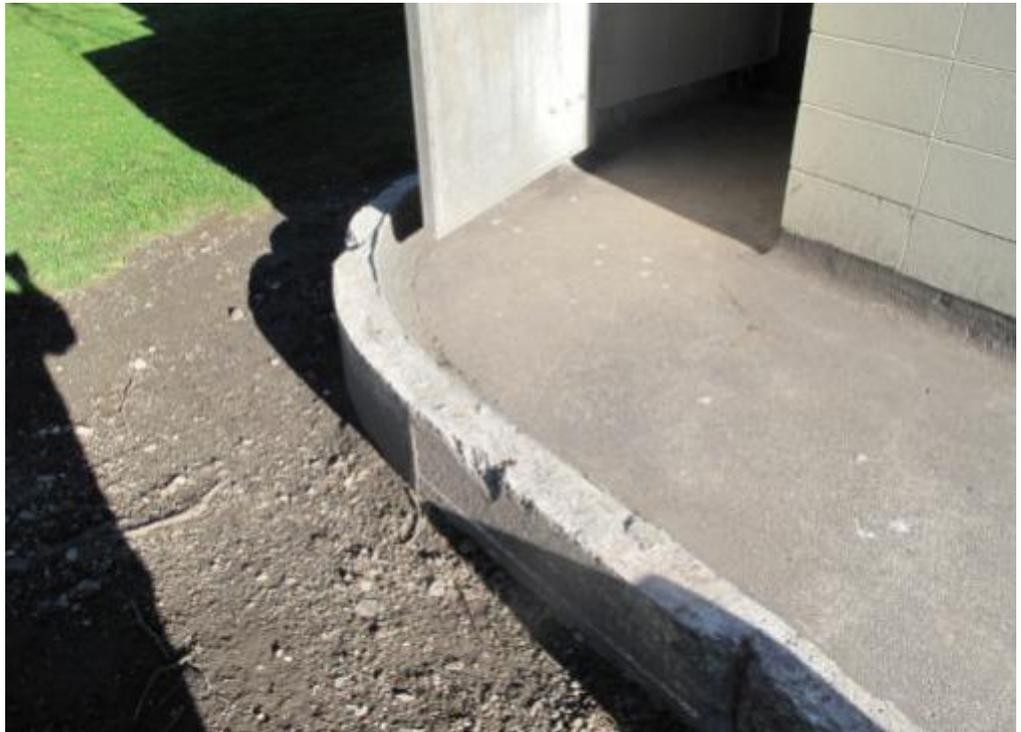
Photograph 6 Base of freestanding wall on eastern side shows fewer signs of cracking

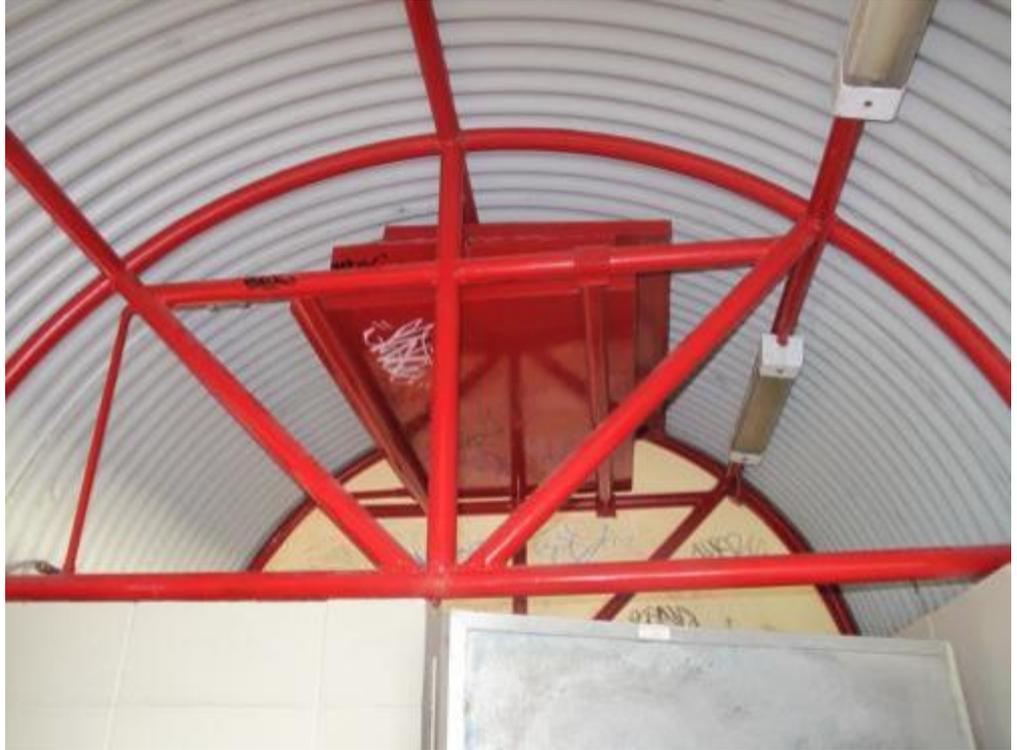
No damage was evident to the steel truss roof structure and no damage was evident to the exterior of the building.

Photograph 7 Steel trusses and welded structure.

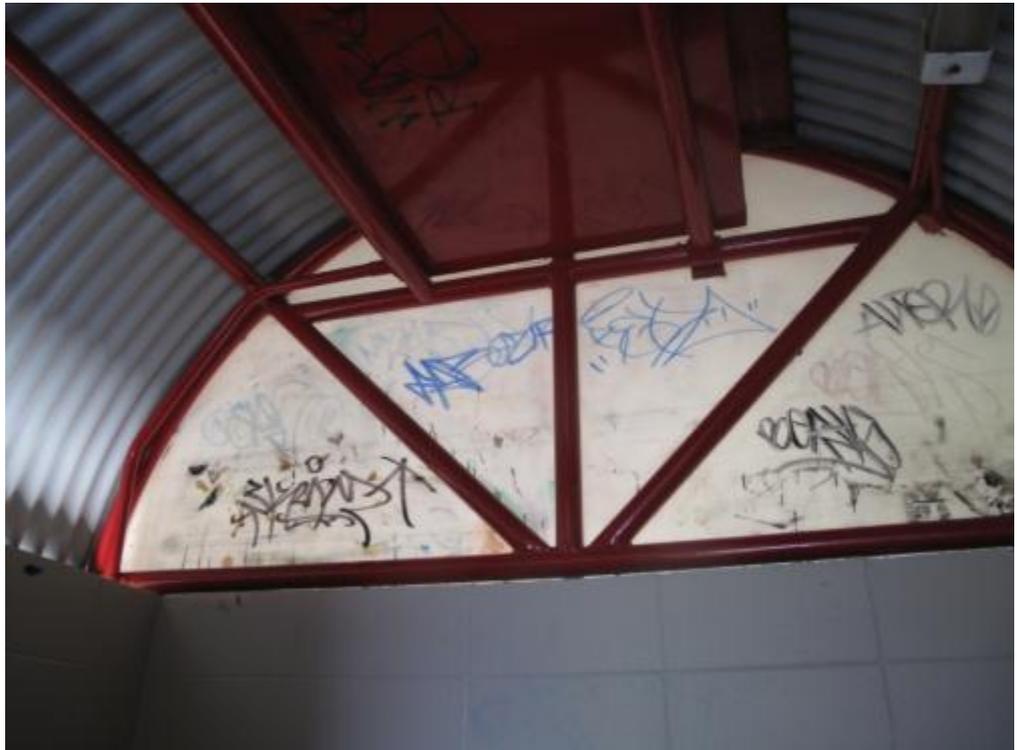
Photograph 8 Edge of roof structure with steel truss.

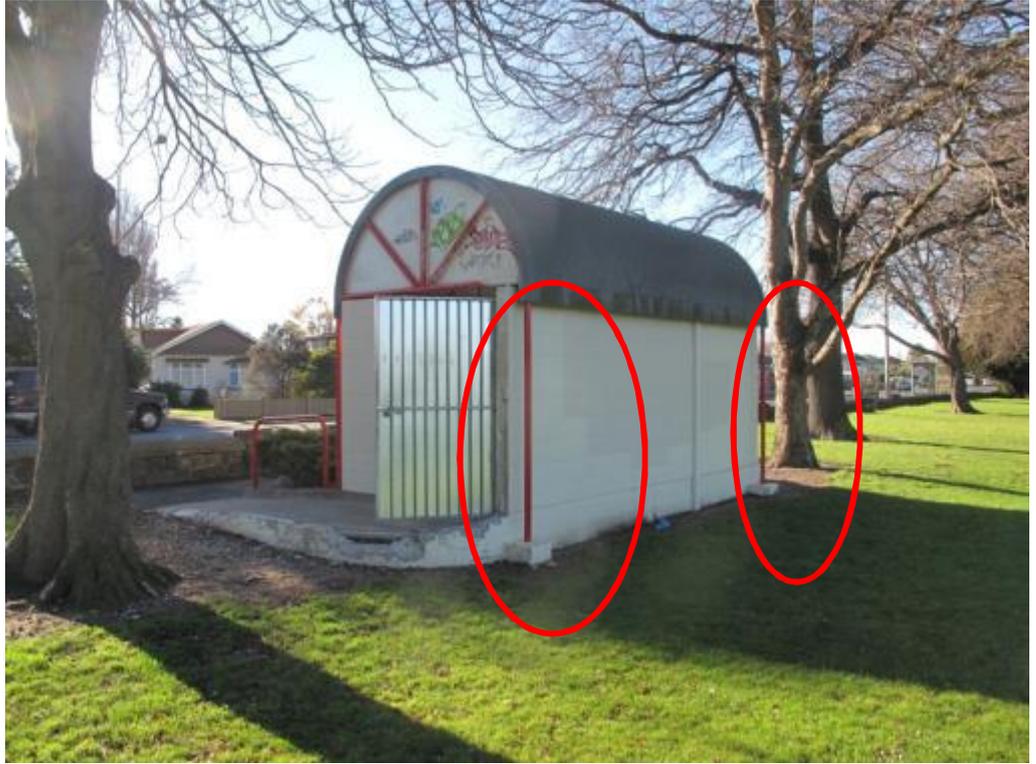
Photograph 9 Roof structure is largely supported by four steel posts.

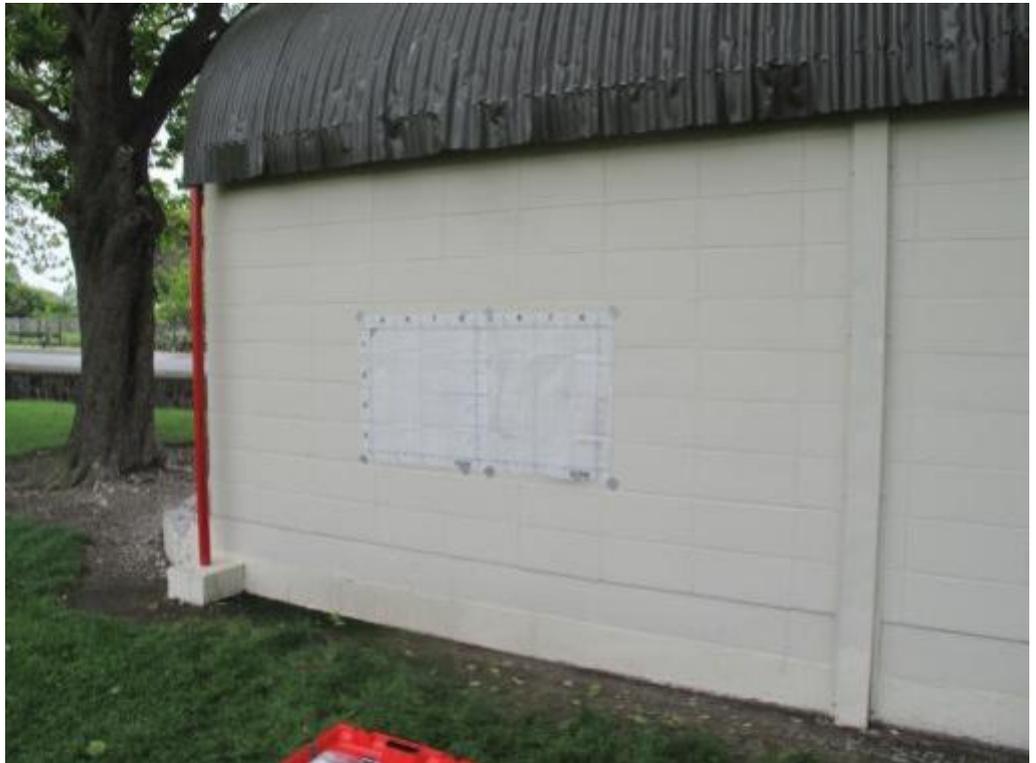
Photograph 10 Area of rear wall where reinforcement checks have been done.
