CHRISTCHURCH CITY COUNCIL
PRK_1145_BLDG_001
Toilets at Wordsworth St.
Wordsworth St. near Colombo St.

QUALITATIVE ASSESSMENT REPORT
FINAL

- Rev B
- 19 November 2013

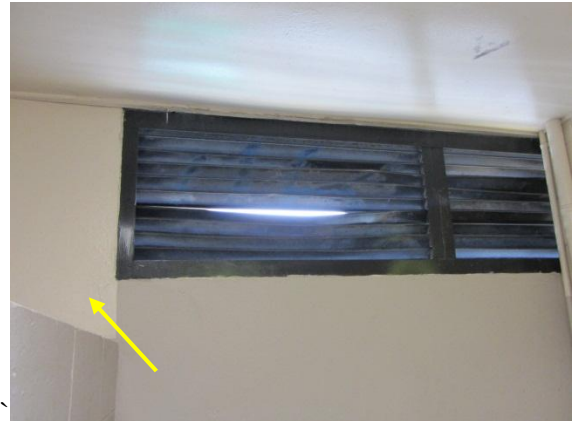
- 1) Hairline cracking, ranging from 0.1mm to 0.4mm, on the south panel running vertically above and below the concrete panel opening and also diagonally from the corners of the opening (photos 6-16).

Photo 6: South panel opening – Interior view, men's side (east)

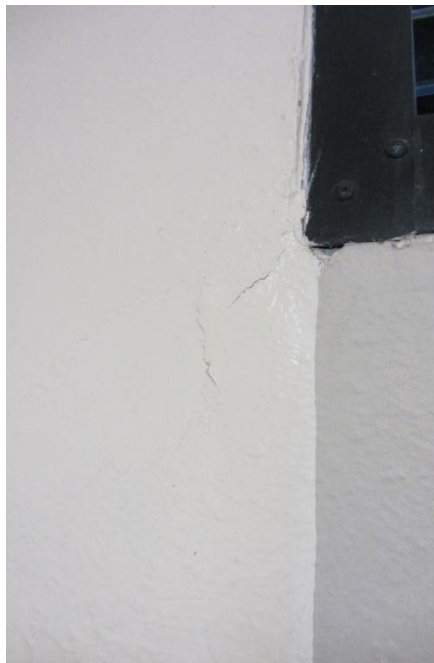
Photo 7: Detail view of crack in Photo 6

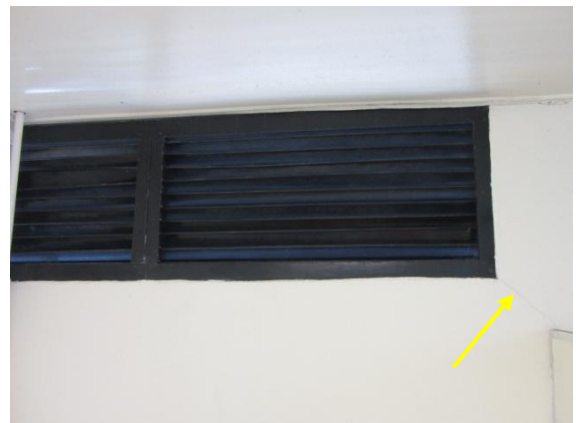
Photo 8: South panel opening – Interior view, women's side (west)

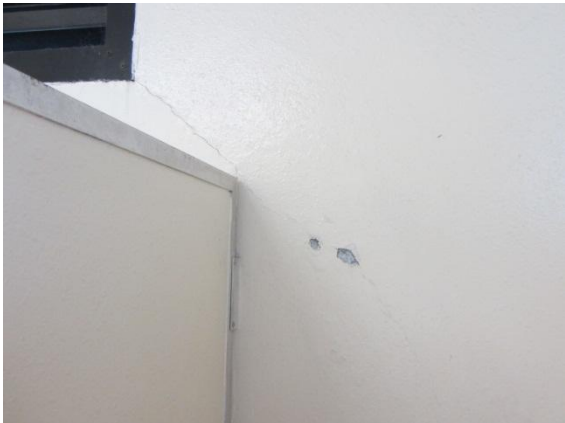
| <p>Photo 9: Detail view of crack in Photo 8</p> | <p>Photo 10: South panel opening – Exterior view</p> |

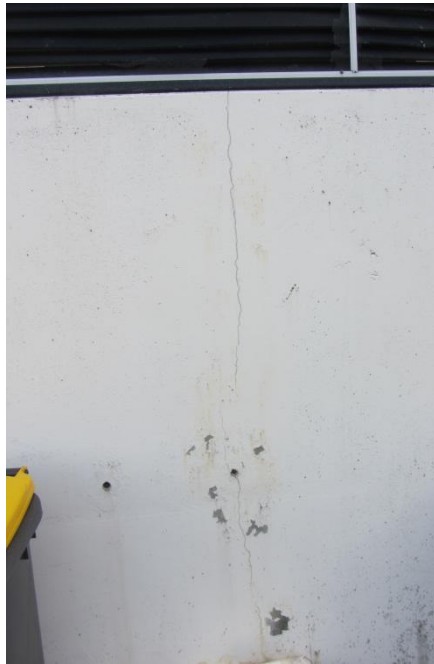
Photo 13: Detail view of cracks in Photo 10, bottom middle

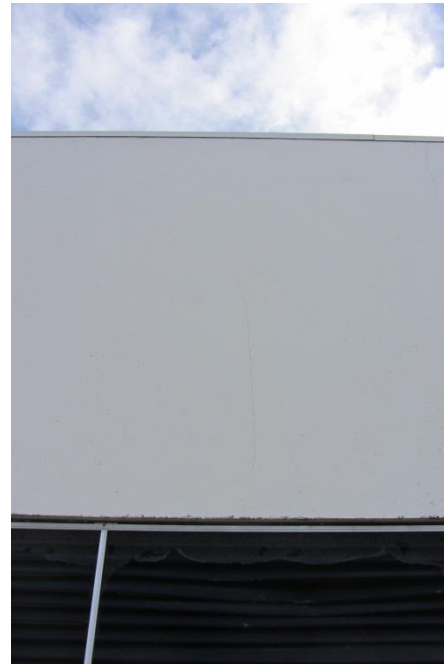
Photo 14: Detail view of cracks in Photo 10, top middle

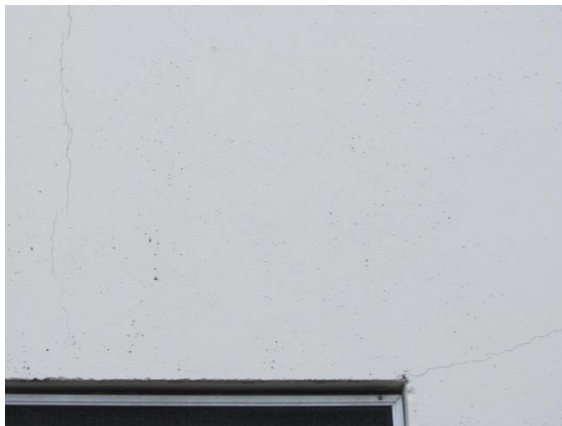
Photo 15: Detail view of cracks in Photo 10, top east corner

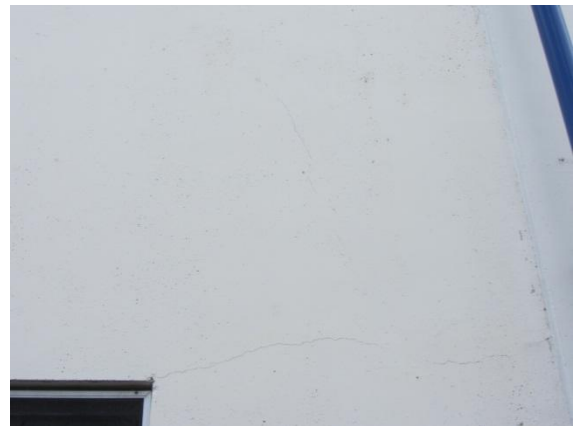
Photo 16: Detail view of cracks in Photo 10, top east corner

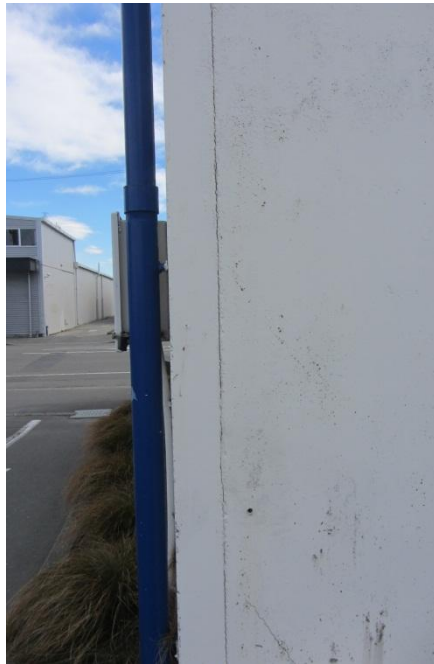
- 4) Cracking/separation between the panel joint on the exterior south-west corner, the interior part of the joint was not visible (photos 25-26). This distress appears to be normal movement between the panel joints and is not cause for concern.

Photo 25: South-west panel joint – Exterior view, bottom

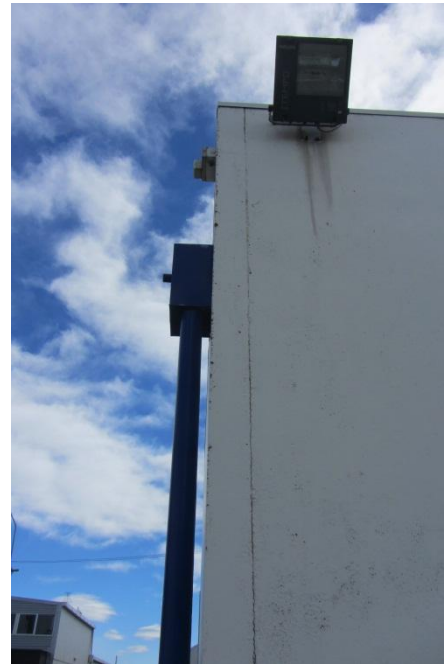
Photo 26: South-west panel joint – Exterior view, top

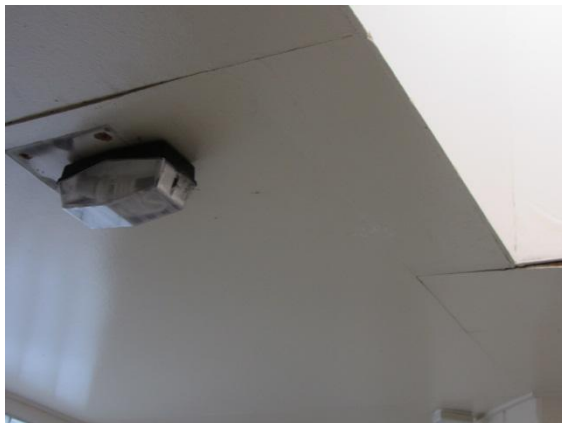
- 5) Sagging of the gib ceiling in the woman's side of the toilet block. This damage does not appear to be a result of seismic activity (photo 27).
- 6) Cladding broken off the corner of the canopy on the west side. This damage does not appear to be a result of seismic activity (photo 28).

Photo 27: Sagging gib ceiling panels

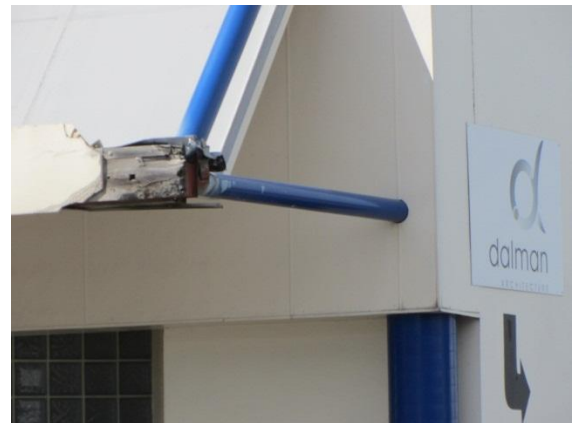
Photo 28: Cladding broken on west side of canopy

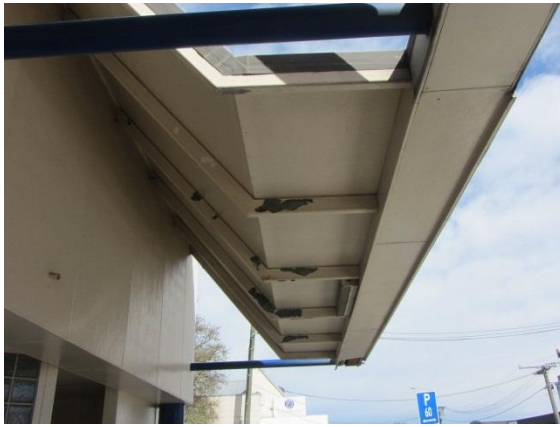
- 7) Paint peeling off of structural steel members supporting the canopy. This damage does not appear to be a result of seismic activity (photo 29).

Photo 29: Paint peeling off of structural steel members supporting canopy
