Yaldhurst Memorial Hall
BU 1643-001 EQ2
Detailed Seismic Assessment Report
Stage 2 – Quantitative Report
CHRISTCHURCH CITY COUNCIL

Report Number 1520

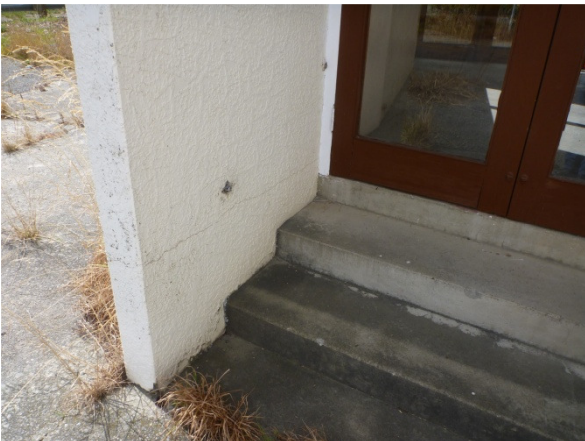
11. Wing wall at Entrance (North/West Elevation) - Horizontal cracking

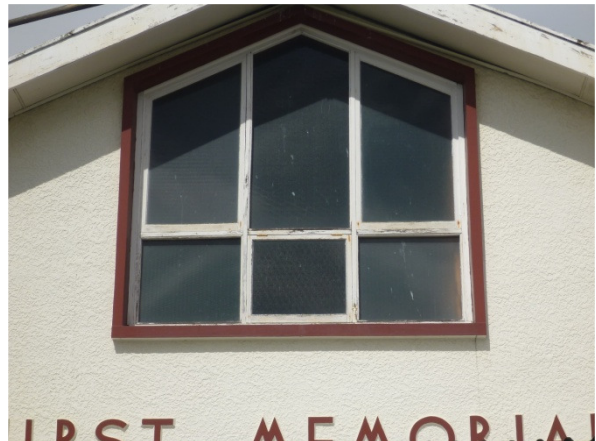
12. North Elevation – Vertical Cracks either side columns of concrete frame

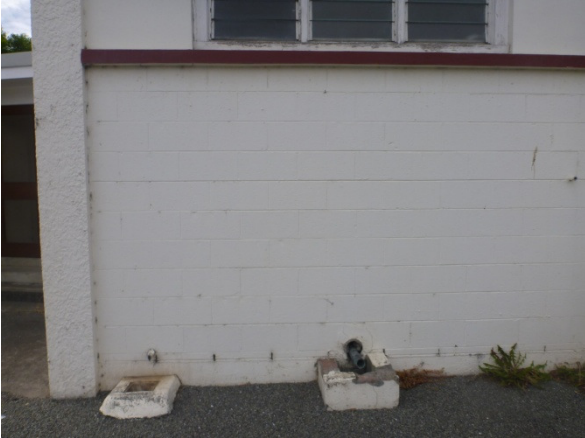
13. West Elevation – Stepped Cracks in blockwork

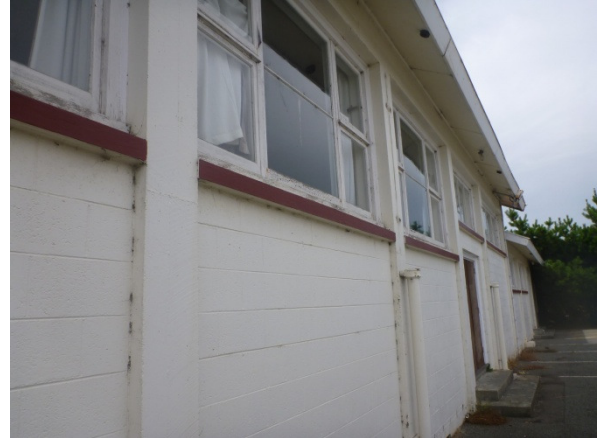
14. West Elevation – separation cracks between columns and masonry panels

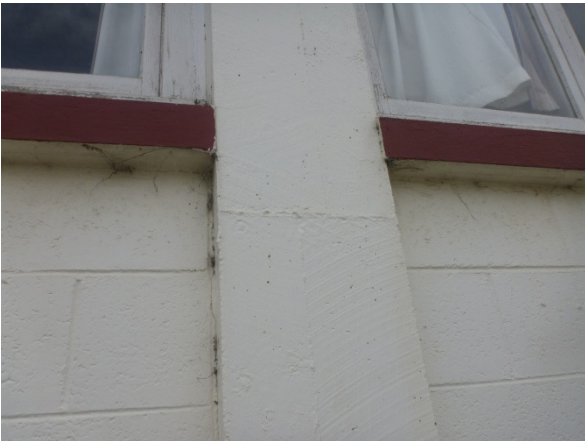
15. West Elevation – Horizontal cracks to columns at construction joint locations below windows

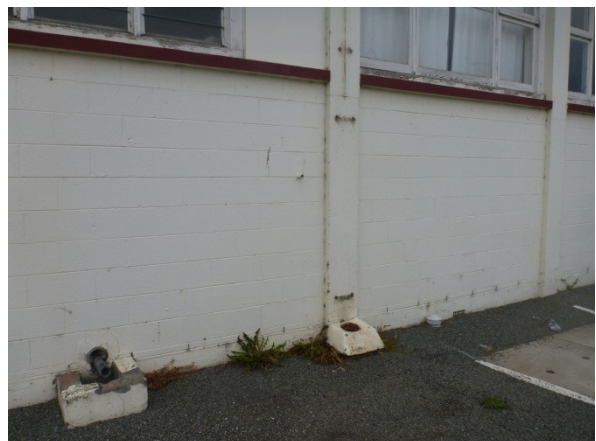
16. West Elevation – stepped cracks in masonry panels

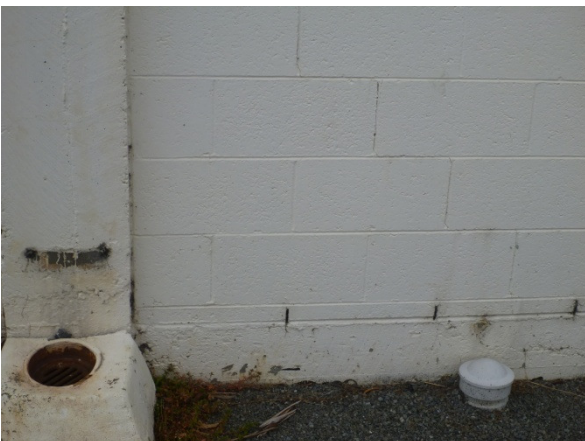
17. West Elevation - Stepped cracking in masonry wall panel

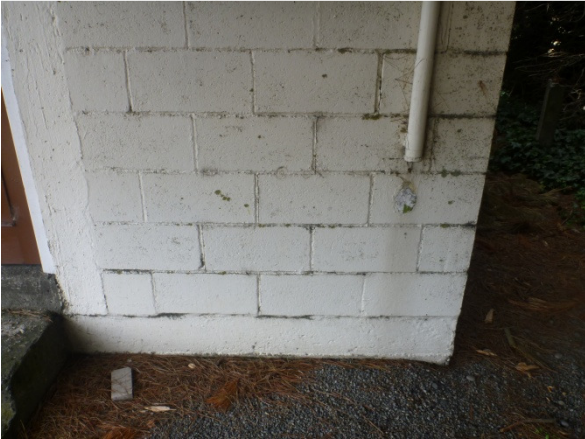
19. West Elevation – south corner – stepped crack in masonry

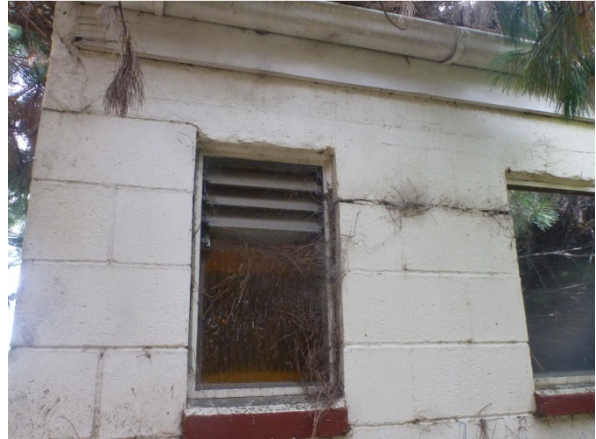
20. South Elevation – Horizontal cracks in masonry at lintel height

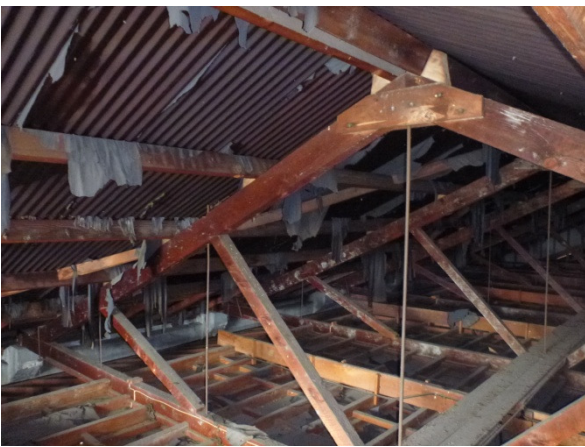
21. Roof construction
