Arboricultural Report

1 November 2017

**Christchurch City Council
Ōpāwaho/Heathcote River
Bank Stabilisation Stage 1
Land Drainage Recovery Programme 518 Project**

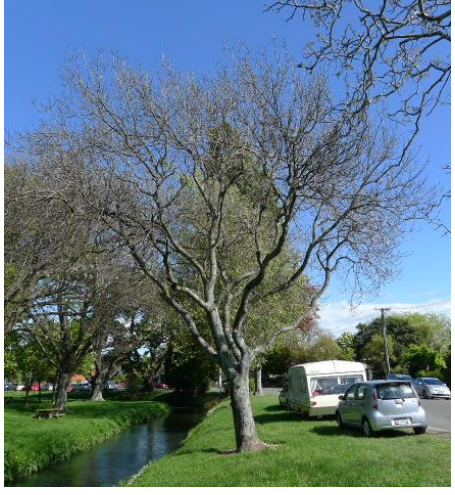
Nearest Address:	211 Ashgrove Tce

CCC ID:	70203	
Tree Species:	English Ash (<i>Fraxinus excelsior</i>)	
Height:	9.0 metres	
Canopy Spread:	13.0 metres	
DBH:	0.48 metres	
Health:	Good (2)	
Form:	Fair (3)	
Overall Condition:	Fair (3)	
Reasonably good foliage density. Some decay around old pruning wounds and surface root damage.

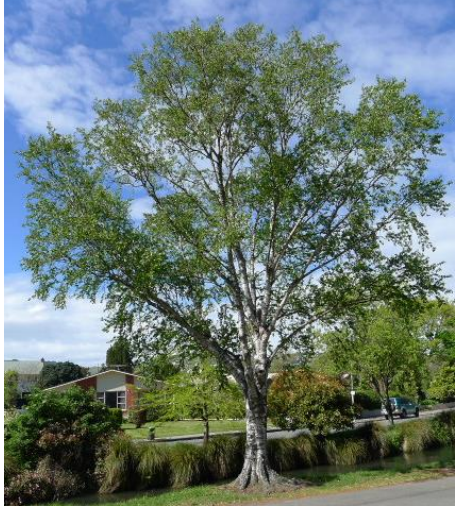
Nearest Address:	327 Ashgrove Tce

CCC ID:	91658	
Tree Species:	Silver Birch (<i>Betula pendula</i>)	
Height:	11.0 metres	
Canopy Spread:	10.0 metres	
DBH:	0.46 metres	
Health:	Fair (3)	
Form:	Fair (3)	
Overall Condition:	Fair (3)	
Minor isolated dieback. Decay around old pruning wounds.

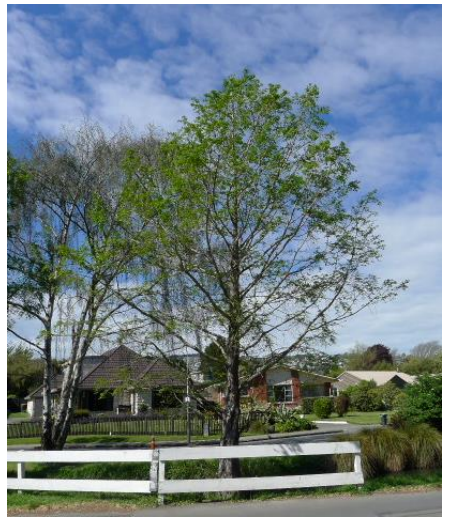
Nearest Address:	331 Ashgrove Tce

CCC ID:	91659	
Tree Species:	Dawn Redwood (<i>Metasequoia glyptostroboides</i>)	
Height:	8.5 metres	
Canopy Spread:	8.0 metres	
DBH:	0.35 metres	
Health:	Fair (3)	
Form:	Fair (3)	
Overall Condition:	Fair (3)	
Possibly up to 30% dieback. Tree and ground possibly slumped during earthquakes.

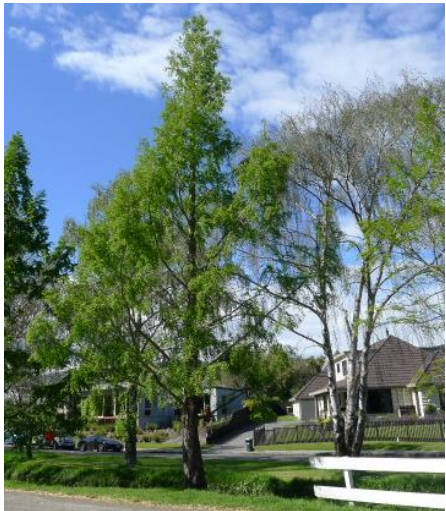
Nearest Address:	333 Ashgrove Tce

CCC ID:	91660	
Tree Species:	Dawn Redwood (<i>Metasequoia glyptostroboides</i>)	
Height:	14.0 metres	
Canopy Spread:	9.0 metres	
DBH:	0.44 metres	
Health:	Fair (3)	
Form:	Fair (3)	
Overall Condition:	Fair (3)	
Minor foliage density loss, but less than 30% decline. Some structural defects present, but reasonably sound structurally.

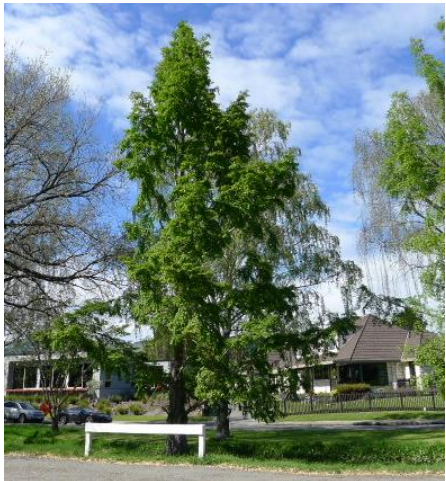
Nearest Address:	335 Ashgrove Tce

CCC ID:	91661	
Tree Species:	Dawn Redwood (<i>Metasequoia glyptostroboides</i>)	
Height:	12.5 metres	
Canopy Spread:	8.0 metres	
DBH:	0.50 metres	
Health:	Fair (3)	
Form:	Fair (3)	
Overall Condition:	Fair (3)	
Minor foliage density loss, but less than 30% decline. Tree and ground possibly slumped during earthquakes.

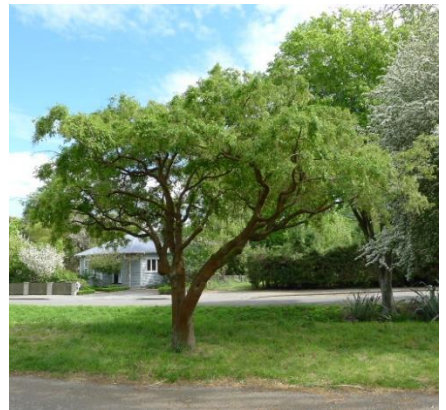
Nearest Address:	70 Colombo St (in Hunter Tce)

CCC ID:	69008	
Tree Species:	Ribbonwood (<i>Plagianthus regius</i>)	
Height:	5.5 metres	
Canopy Spread:	9.0 metres	
DBH:	0.50 metres	
Health:	Fair (3)	
Form:	Fair (3)	
Overall Condition:	Fair (3)	
Minor foliage density loss, but less than 30% decline. Twin stems originating from near ground level. Included union near base with old crack. Trunk diameter measured at base.

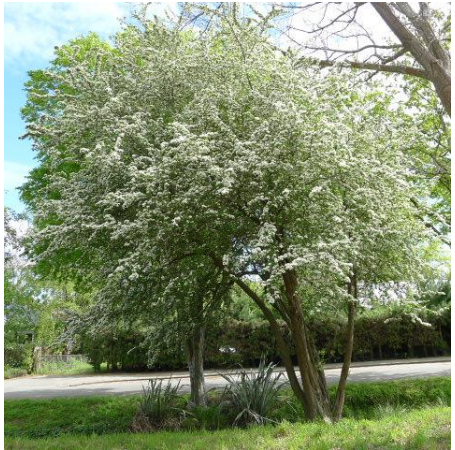
Nearest Address:	70 Colombo St (in Hunter Tce)

CCC ID:	71252	
Tree Species:	Common Hawthorne (<i>Crataegus monogyna</i>)	
Height:	8.0 metres	
Canopy Spread:	9.0 metres	
DBH:	0.60 metres	
Health:	Fair (3)	
Form:	Fair (3)	
Overall Condition:	Fair (3)	
More than approximately 10% foliage density loss, reasonably good foliage density overall. Some structural defects present, but reasonably sound structurally.

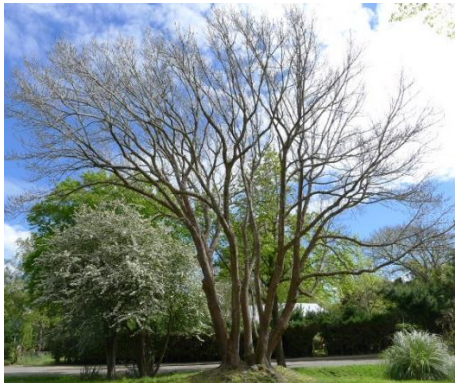
Nearest Address:	70 Colombo St (in Hunter Tce)

CCC ID:	71254	
Tree Species:	English Ash (<i>Fraxinus excelsior</i>)	
Height:	18.0 metres	
Canopy Spread:	20.0 metres	
DBH:	2.00 metres	
Health:	Fair (3)	
Form:	Fair (3)	
Overall Condition:	Fair (3)	
Multiple stems from base. Areas of decay around base and old pruning wounds, but reasonably sound structurally. Trunk diameter measured at base.

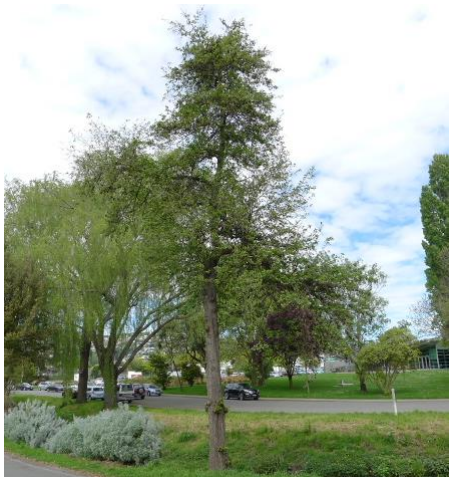
Nearest Address:	43 Waimea Tce

CCC ID:	71304	
Tree Species:	Common Alder (<i>Alnus glutinosa</i>)	
Height:	16.0 metres	
Canopy Spread:	11.0 metres	
DBH:	0.45 metres	
Health:	Fair (3)	
Form:	Fair (3)	
Overall Condition:	Fair (3)	
Tree appears to have lost the central leader and a secondary leader has become dominant.

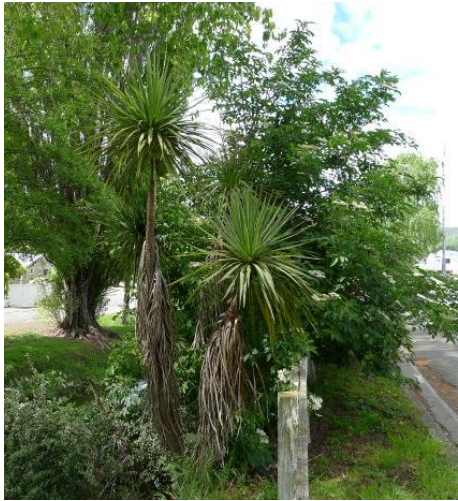
Nearest Address:	55 Centaurus Rd (in Sloan Tce)

CCC ID:	72663	
Tree Species:	Cabbage Tree (<i>Cordyline australis</i>)	
Height:	3.5 metres	
Canopy Spread:	1.5 metres	
DBH:	0.25 metres	
Health:	Fair (3)	
Form:	Fair (3)	
Overall Condition:	Fair (3)	
Some foliage density loss, but less than 30% decline. Two stems from base.

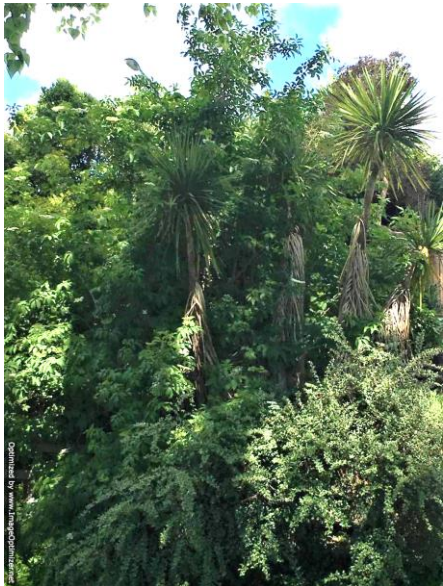
Nearest Address:	55 Centaurus Rd (in Sloan Tce)

CCC ID:	72664	
Tree Species:	Cabbage Tree (<i>Cordyline australis</i>)	
Height:	3.0 metres	
Canopy Spread:	2.0 metres	
DBH:	0.25 metres	
Health:	Fair (3)	
Form:	Fair (3)	
Overall Condition:	Fair (3)	
Some foliage density loss, but less than 30% decline. Multiple stems from base.

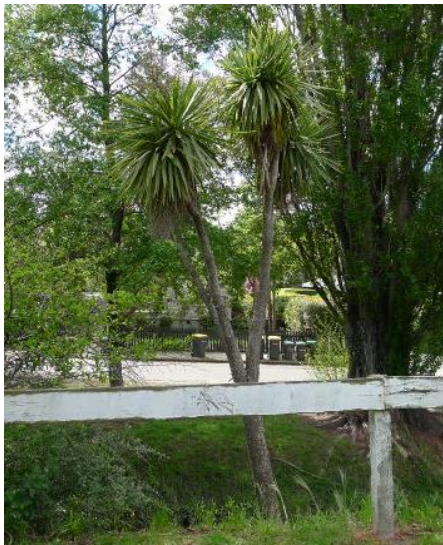
Nearest Address:	55 Centaurus Rd (in Sloan Tce)

CCC ID:	72665	
Tree Species:	Cabbage Tree (<i>Cordyline australis</i>)	
Height:	7.0 metres	
Canopy Spread:	2.0 metres	
DBH:	0.28 metres	
Health:	Fair (3)	
Form:	Fair (3)	
Overall Condition:	Fair (3)	
Some foliage density loss, but less than 30% decline. Three stems from included union.

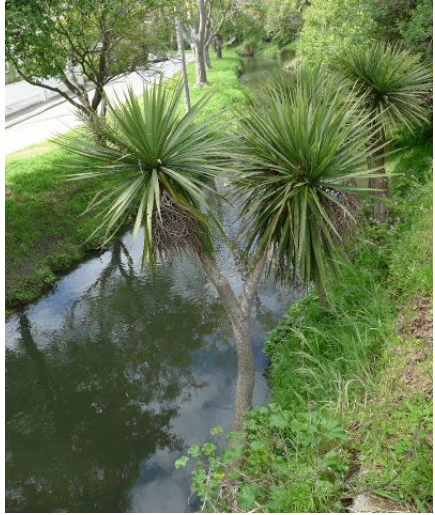
Nearest Address:	55 Centaurus Rd (in Sloan Tce)

CCC ID:	138443	
Tree Species:	Cabbage Tree (<i>Cordyline australis</i>)	
Height:	4.5 metres	
Canopy Spread:	2.0 metres	
DBH:	0.18 metres	
Health:	Good (2)	
Form:	Fair (3)	
Overall Condition:	Fair (3)	
Reasonably good foliage density. Co-dominant with included union.

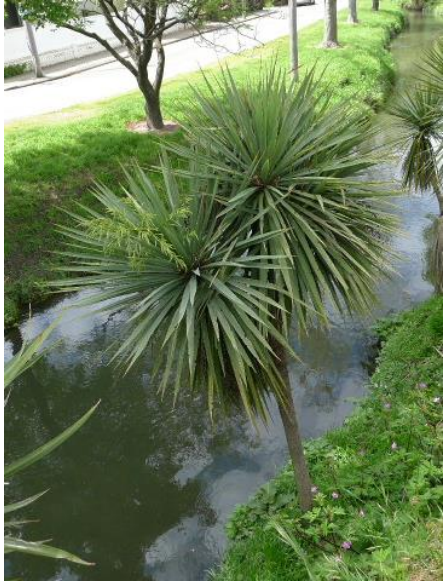
Nearest Address:	55 Centaurus Rd (in Sloan Tce)

CCC ID:	138444	
Tree Species:	Cabbage Tree (<i>Cordyline australis</i>)	
Height:	4.5 metres	
Canopy Spread:	1.5 metres	
DBH:	0.10 metres	
Health:	Good (2)	
Form:	Good (2)	
Overall Condition:	Good (2)	
Reasonably good condition.

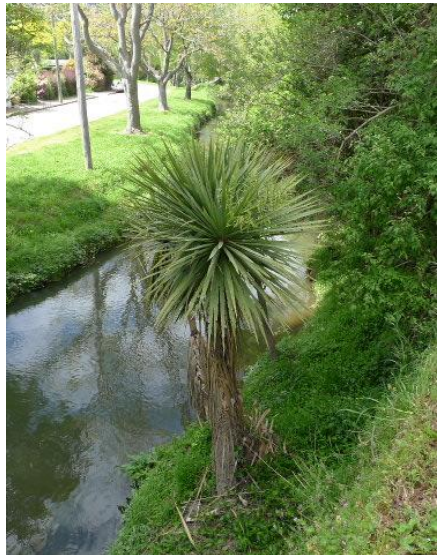
Nearest Address:	55 Centaurus Rd (in Sloan Tce)

CCC ID:	138445	
Tree Species:	Cabbage Tree (<i>Cordyline australis</i>)	
Height:	4.5 metres	
Canopy Spread:	3.0 metres	
DBH:	0.25 metres	
Health:	Good (2)	
Form:	Fair (3)	
Overall Condition:	Fair (3)	
Reasonably good foliage density. Two stems originating from base

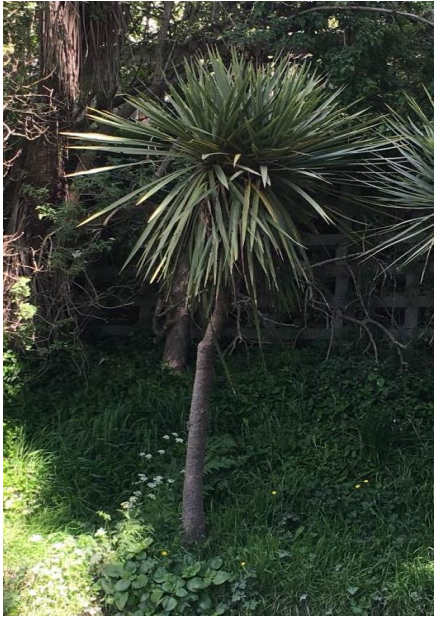
Nearest Address:	55 Centaurus Rd (in Sloan Tce)

CCC ID:	138446	
Tree Species:	Cabbage Tree (<i>Cordyline australis</i>)	
Height:	4.0 metres	
Canopy Spread:	1.0 metres	
DBH:	0.10 metres	
Health:	Fair (3)	
Form:	Fair (3)	
Overall Condition:	Fair (3)	
Some foliage density loss, but less than 30% decline.

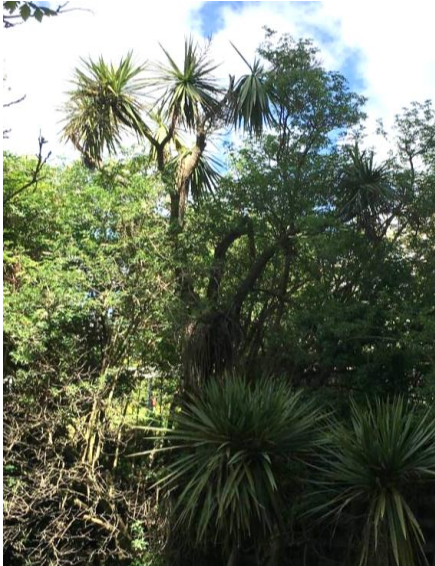
Nearest Address:	55 Centaurus Rd (in Sloan Tce)

CCC ID:	138447	
Tree Species:	Cabbage Tree (<i>Cordyline australis</i>)	
Height:	7.0 metres	
Canopy Spread:	3.0 metres	
DBH:	0.30 metres	
Health:	Fair (3)	
Form:	Fair (3)	
Overall Condition:	Fair (3)	
Some foliage density loss, but less than 30% decline.

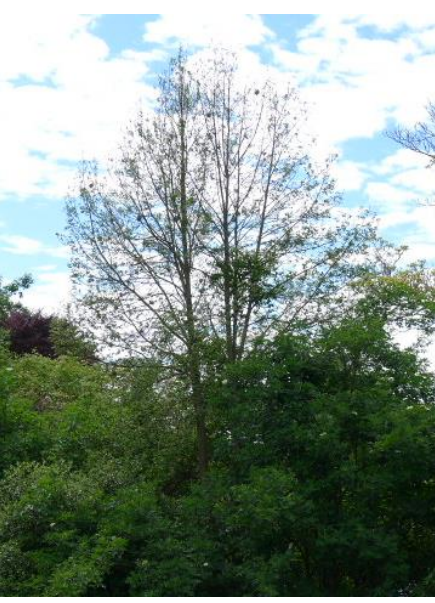
Nearest Address:	55 Centaurus Rd (in Sloan Tce)

CCC ID:	Nil	
Project ID:	520	
Tree Species:	Ribbonwood (<i>Plagianthus regius</i>)	
Height:	9.0 metres	
Canopy Spread:	3.5 metres	
DBH:	0.30 metres	
Health:	Fair (3)	
Form:	Fair (3)	
Overall Condition:	Fair (3)	
Some foliage density loss, but less than 30% decline. Included stem and branch unions.

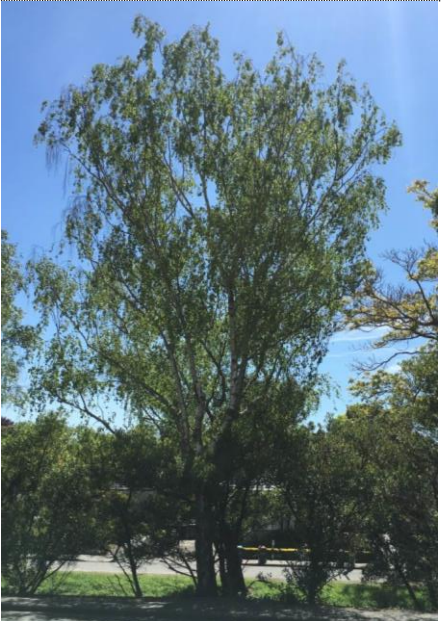
Nearest Address:	34 Centaurus Rd

CCC ID:	71409	
Tree Species:	Silver Birch (<i>Betula pendula</i>)	
Height:	8.5 metres	
Canopy Spread:	9.0 metres	
DBH:	0.50 metres	
Health:	Fair (3)	
Form:	Fair (3)	
Overall Condition:	Fair (3)	
Foliage density becoming sparse, but less than 30% decline. Some structural defects present, but reasonably sound structurally.

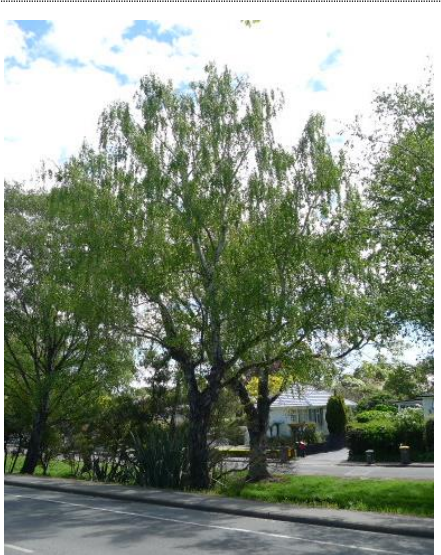
Nearest Address:	36 Centaurus Rd

CCC ID:	71407	
Tree Species:	Silver Birch (<i>Betula pendula</i>)	
Height:	11.0 metres	
Canopy Spread:	11 metres	
DBH:	0.60 metres	
Health:	Fair (3)	
Form:	Fair (3)	
Overall Condition:	Fair (3)	
Foliage density becoming sparse, but less than 30% decline. Some structural defects present, but reasonably sound structurally.

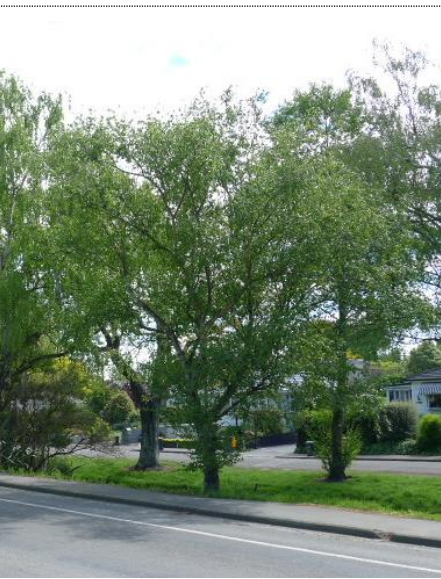
Nearest Address:	38 Centaurus Rd

CCC ID:	71406	
Tree Species:	Silver Birch (<i>Betula pendula</i>)	
Height:	8.0 metres	
Canopy Spread:	10.0 metres	
DBH:	0.40 metres	
Health:	Fair (3)	
Form:	Fair (3)	
Overall Condition:	Fair (3)	
Foliage density becoming sparse, but less than 30% decline. Some structural defects present, but reasonably sound structurally.

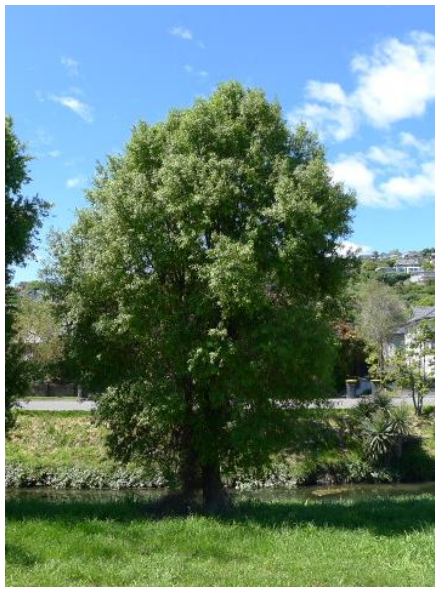
Nearest Address:	89 Corson Ave (in Eastern Tce)

CCC ID:	72623	
Tree Species:	Narrow-leaved Lacebark (<i>Hoheria angustifolia</i>)	
Height:	4.0 metres	
Canopy Spread:	4.0 metres	
DBH:	0.30 metres	
Health:	Good (2)	
Form:	Good (2)	
Overall Condition:	Good (2)	
Reasonably good foliage density. Included stem and branch unions, typical of species.

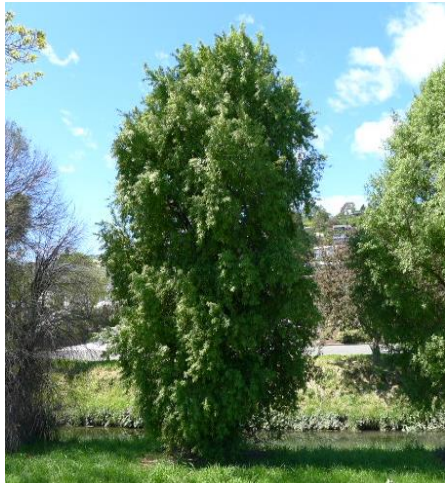
Nearest Address:	89 Corson Ave (in Eastern Tce)
CCC ID: 72624	72624
Tree Species:	Narrow-leaved Lacebark (<i>Hoheria angustifolia</i>)
Height:	4.0 metres
Canopy Spread:	3.0 metres
DBH:	0.20 metres
Health:	Good (2)
Form:	Good (2)
Overall Condition:	Good (2)
Reasonably good foliage density.	
Included stem and branch unions, typical of species.

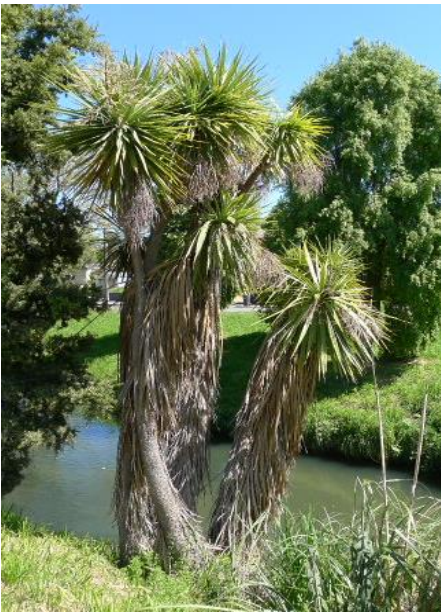
Nearest Address:	4 Palatine Tce
CCC ID:	72693
Tree Species:	Cabbage Tree (<i>Cordyline australis</i>)
Height:	4.0 metres
Canopy Spread:	3.5 metres
DBH:	0.60 metres
Health:	Fair (3)
Form:	Fair (3)
Overall Condition:	Fair (3)
Some foliage density loss, but less than 30% decline. 6 x stems originating from base. Trunk diameter measured at base.

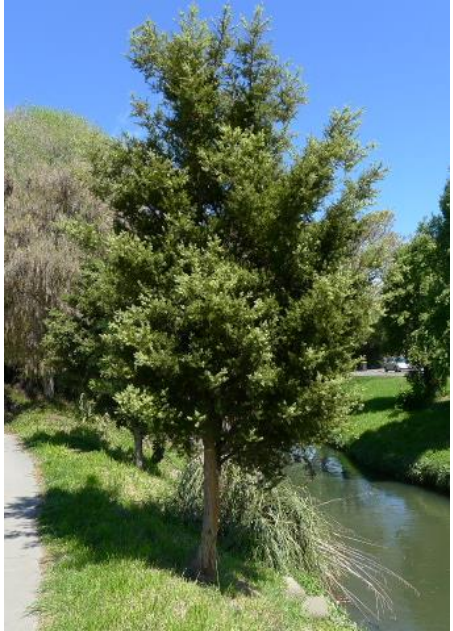
Nearest Address:	4 Palatine Tce

CCC ID:	72695	
Tree Species:	Totara (<i>Podocarpus totara</i>)	
Height:	5.0 metres	
Canopy Spread:	3.0 metres	
DBH:	0.12 metres	
Health:	Good (2)	
Form:	Fair (3)	
Overall Condition:	Fair (3)	
Reasonably good foliage density. Old basal wound and lower trunk decay. May be possible to relocate, but transplanting may not be viable as a long-term option due to existing basal damage.

In addition to the trees listed above, it may also be possible to successfully transplant the following two (2) trees that are also listed as trees to be removed. Further investigations are required to determine the viability of transplanting these trees (due to the size of 72452 and the condition of 72695).

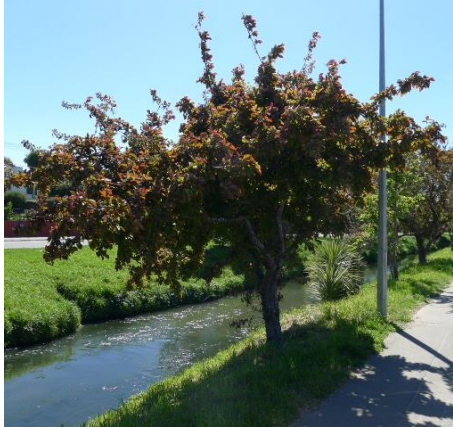
Nearest Address:	6 Palatine Tce

Tree ID:	69929	
Tree Species:	Crab Apple (<i>Malus cultivar</i>)	
Height:	4.0 metres	
Canopy Spread:	6.0 metres	
DBH:	0.20 metres	
Health:	Good (2)	
Form:	Fair (3)	
Overall Condition:	Fair (3)	
Reasonably good foliage density. Inclusions in stem unions, but reasonably sound structurally.

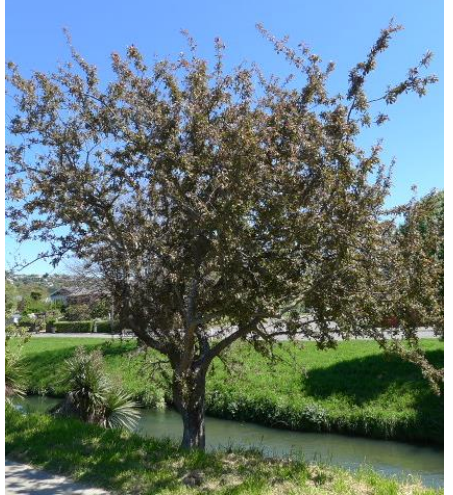
Nearest Address:	8 Palatine Tce

CCC ID:	69926	
Tree Species:	Crab Apple (<i>Malus cultivar</i>)	
Height:	4.5 metres	
Canopy Spread:	7.0 metres	
DBH:	0.40 metres	
Health:	Fair (3)	
Form:	Fair (3)	
Overall Condition:	Fair (3)	
Foliage density becoming sparse, but less than 30% decline. Structural defects present, but reasonably sound structurally.

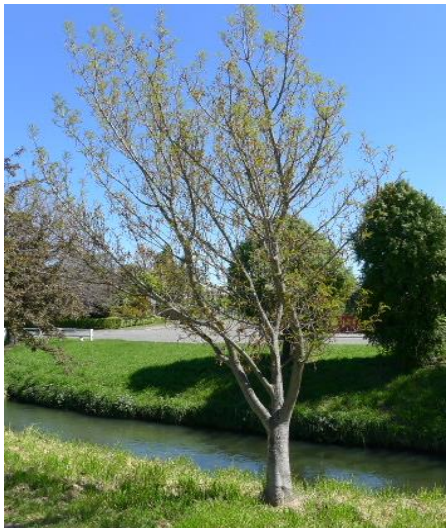
Nearest Address:	10 Palatine Tce

CCC ID:	72698	
Tree Species:	Large-leaved Kowhai (<i>Sophora tetraptera</i>)	
Height:	3.0 metres	
Canopy Spread:	4.0 metres	
DBH:	0.20 metres	
Health:	Good (2)	
Form:	Fair (3)	
Overall Condition:	Fair (3)	
Reasonably good foliage density. Some structural defects present, but reasonably sound structurally.

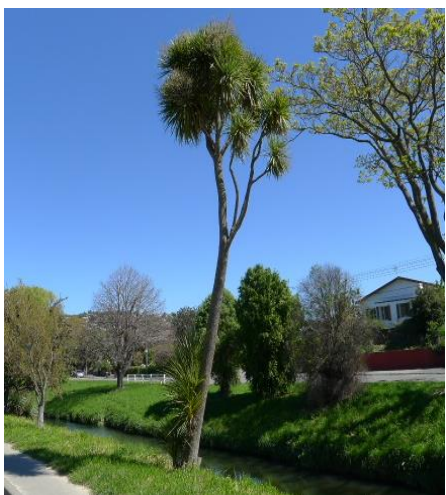
Nearest Address:	10 Palatine Tce

CCC ID:	69024	
Tree Species:	Cabbage Tree (<i>Cordyline australis</i>)	
Height:	6.0 metres	
Canopy Spread:	3.0 metres	
DBH:	0.20 metres	
Health:	Good (2)	
Form:	Fair (3)	
Overall Condition:	Fair (3)	
Reasonably good foliage density. Basal wounds. Slight tree lean towards river.

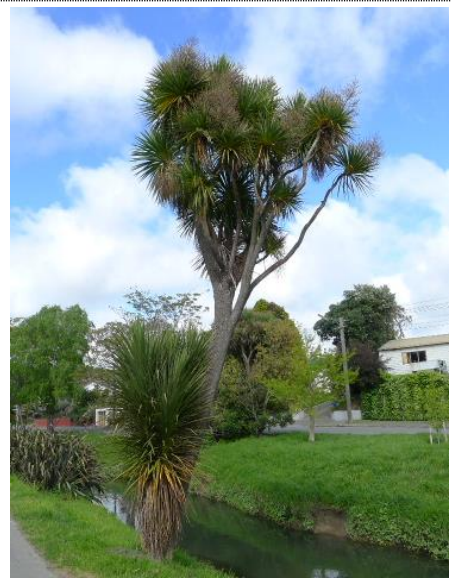
Nearest Address:	20 Palatine Tce
CCC ID:	71444
Tree Species:	Cabbage Tree (<i>Cordyline australis</i>)
Height:	7.5 metres
Canopy Spread:	3.0 metres
DBH:	0.35 metres
Health:	Fair (3)
Form:	Fair (3)
Overall Condition:	Fair (3)
Minor foliage density loss, but less than 30% decline. Slight tree lean and weight towards river.

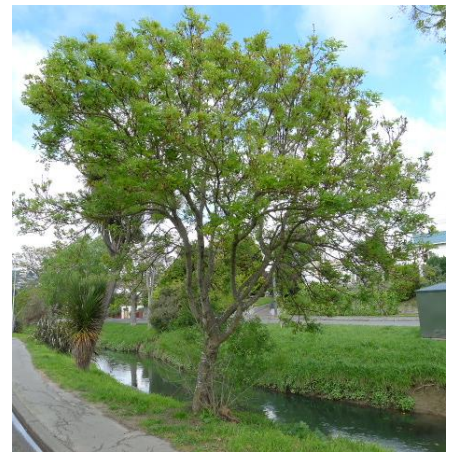
Nearest Address:	20 Palatine Tce
CCC ID:	72415
Tree Species:	Golden Ash (<i>Fraxinus excelsior Aurea</i>)
Height:	5.0 metres
Canopy Spread:	7.0 metres
DBH:	0.30 metres
Health:	Good (2)
Form:	Fair (3)
Overall Condition:	Fair (3)
Reasonably good foliage density, but extensive sucker growth. Slight tree lean and weight to north.

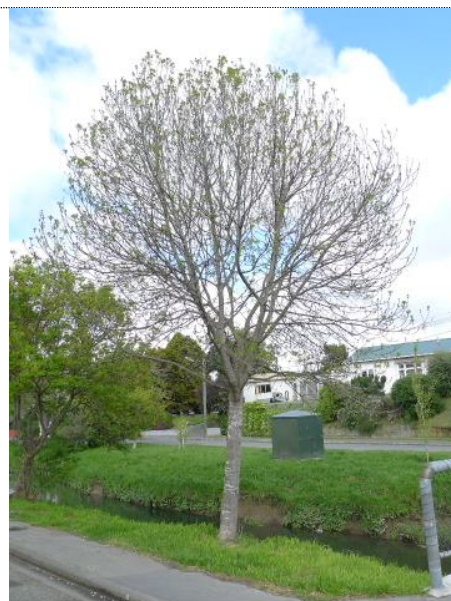
Nearest Address:	20 Palatine Tce
CCC ID:	72416
Tree Species:	English Ash (<i>Fraxinus excelsior</i>)
Height:	6.5 metres
Canopy Spread:	7.0 metres
DBH:	0.24 metres
Health:	Good (2)
Form:	Good (2)
Overall Condition:	Good (2)
Reasonably good foliage density and structure.

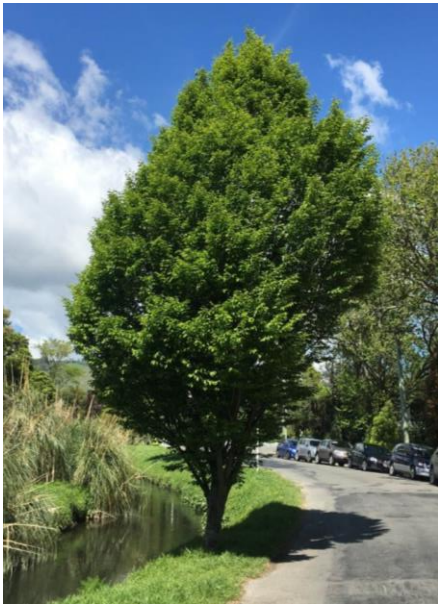
Nearest Address:	71 Sandwich Road (Eastern Tce)
CCC ID:	72452
Tree Species:	Fastigiated Hornbeam (<i>Carpinus betulus Fastigiata</i>)
Height:	9.0 metres
Canopy Spread:	5.0 metres
DBH:	0.35 metres
Health:	Good (2)
Form:	Good (2)
Overall Condition:	Good (2)
Reasonably good foliage density. Included stem and branch unions, typical of species. It may be possible to relocate the tree, but this will depend upon potential site constraints due to the size of the tree.

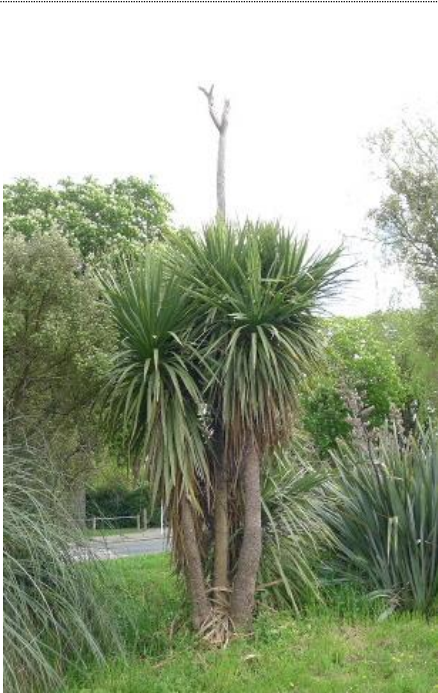
Nearest Address:	52 Palatine Tce
CCC ID:	69933
Tree Species:	Cabbage Tree (<i>Cordyline australis</i>)
Height:	7.0 metres
Canopy Spread:	2.5 metres
DBH:	0.50 metres
Health:	Fair (3)
Form:	Fair (3)
Overall Condition:	Fair (3)
Central stem dead, but less than 30% decline overall. 6 stems originating from base. Trunk diameter measured at base.
