Intrusive Investigation Report

Grand National (Public) Stand

Client: Canterbury Jockey Club

14-Apr-2015

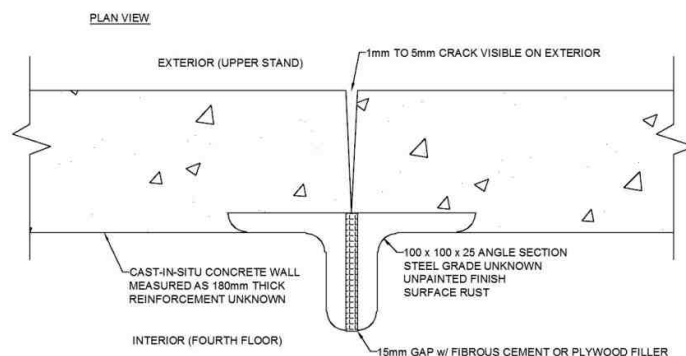
Figure 3: Cracking in concrete wall on Level 4

When viewed from the upper stand, the shear wall panels on level 4 show signs of full height vertical cracks at regular spacing along the 70m length of the wall. These vertical cracks vary in width ranging from greater than 1mm to approximately 5mm. These vertical cracks coincide with the location of cast-in double angle column members which support the roof of the upper stand. No cracks are visible at these locations on the level 4 side of the wall. It is thought that under north-south directional seismic excitation these panels acted like simply supported members hinging at their weakest point, at the vertical column support, and as a result these flexural cracks opened up. These steel members do not appear damaged, although they are showing signs of their age, with much surface rust visible.

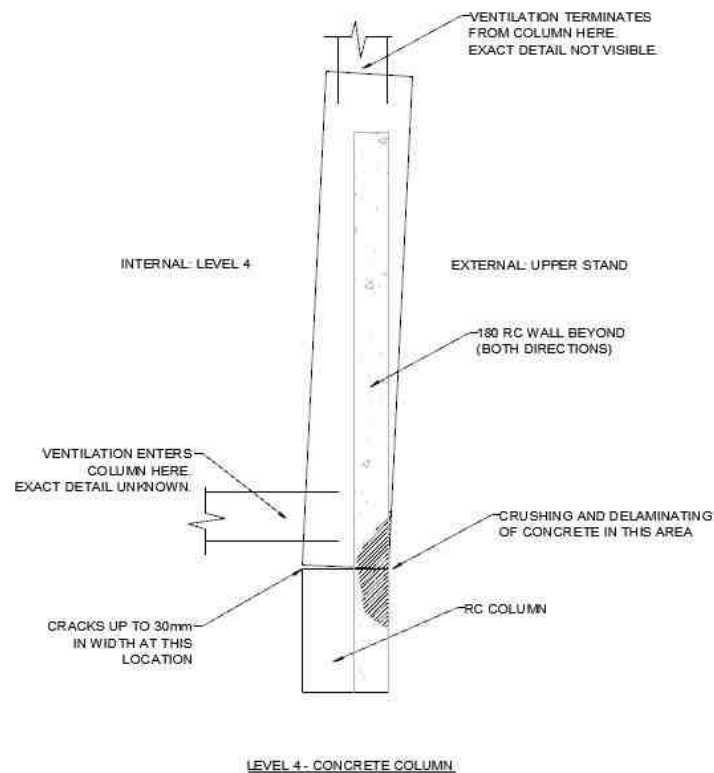
Figure 4: Severe damage to ventilation shaft column on Level 4

There is a discontinuity at the centre of the shear wall on level 4. At this point there is a concrete column which houses a ventilation shaft. There is evidence of flexural failure of this column. There is severe damage to this column with cracks up to 30mm in width visible on the south face of the column, these cracks taper to approximately 3mm wide at their smallest, on the edge of the north face. The north face is obscured by the RC walls and this face of the column is clad on the exterior (upper stand level). There is evidence of crushing of the concrete in this region on the north, east, and west faces and there are multiple vertical spalling cracks.

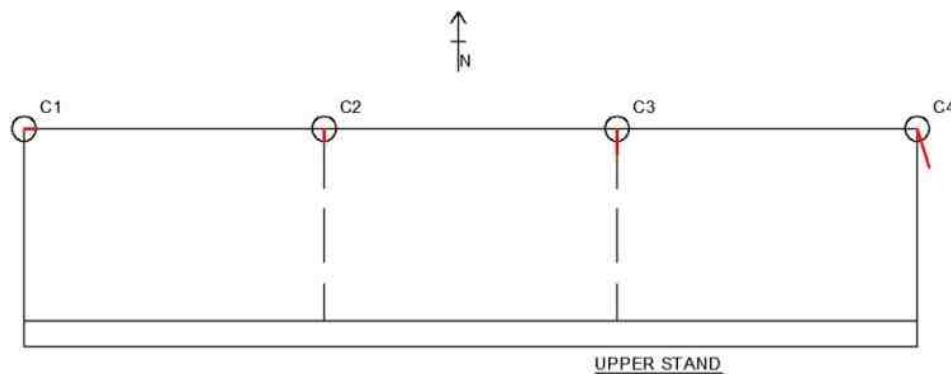
Figure 6: Direction of verticality measurements in upper grandstand support columns

It is clear from these verticality measurements that both the upper and lower stand support columns appear to be leaning in a generally easterly direction. The lower columns are leaning significantly further off vertical than the upper columns. The upper and lower columns are not a single continuous member. The lower column is bolted to the underside of a plated girder at upper stand and the upper column is bolted to the top of this plate girder. It is not possible to determine with a spirit level whether this accentuated lower level lean is due to the lower columns hinging at their base supports or hinging directly under their top support at the underside of the upper stand. AECOM will endeavour to clarify at the detailed investigation stage by the combined use of a laser plumb and theodolite. This will allow AECOM to measure the verticality of the stand columns with greater accuracy.

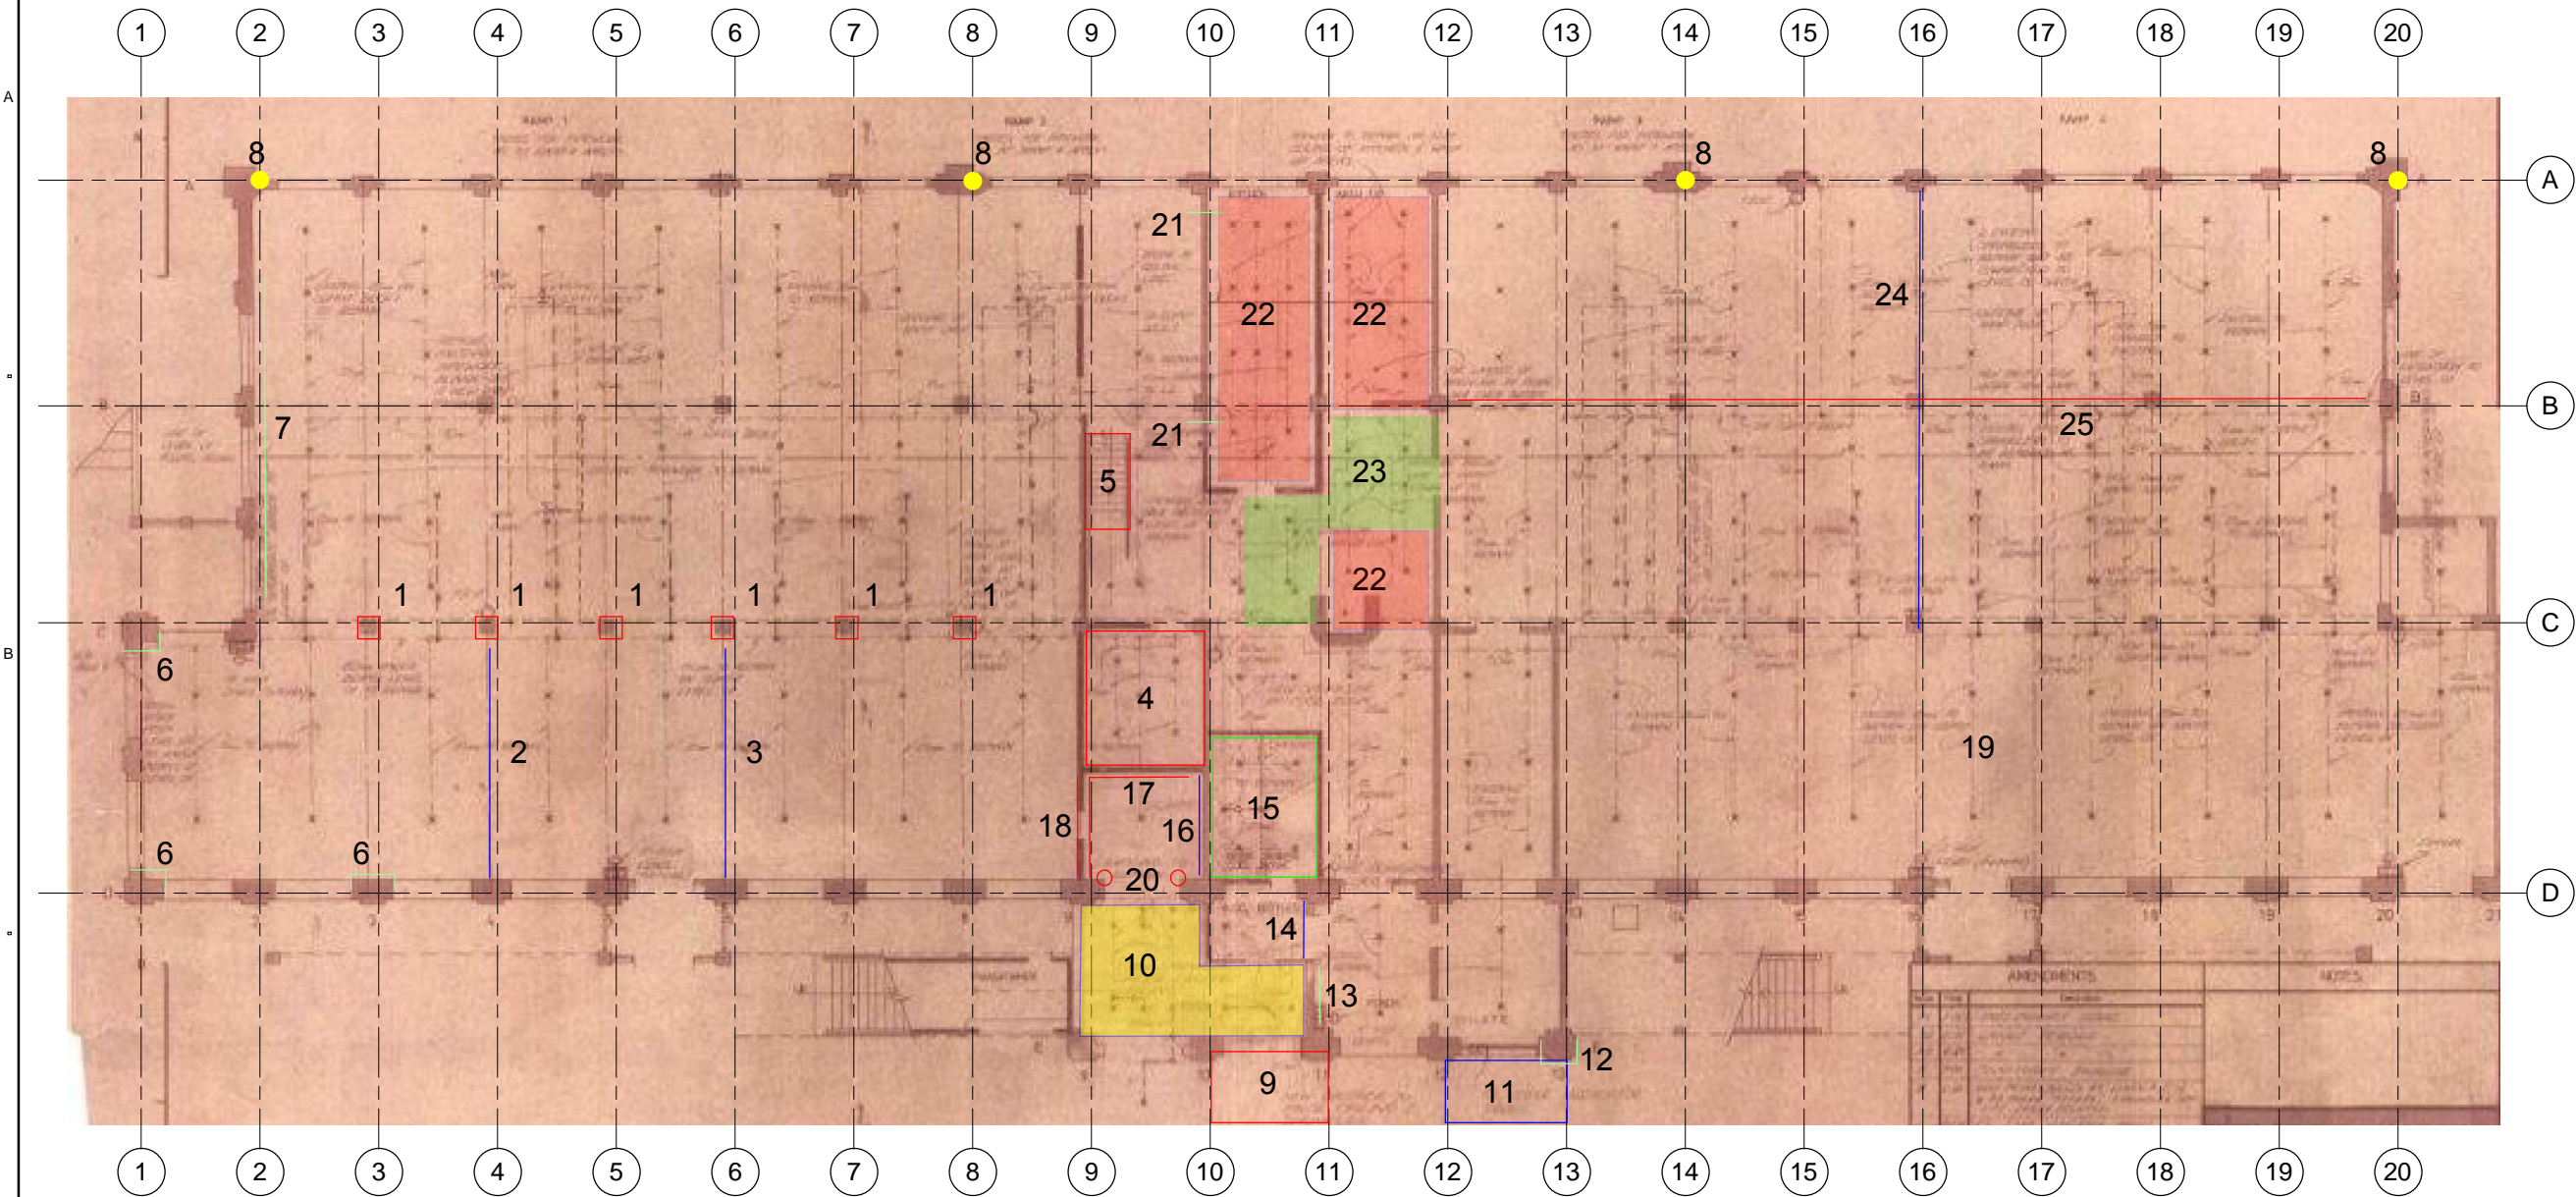
LEVEL 0
Scale: 1 : 125

1. Horizontal cracks below beam-column joint, on all faces of column.

2. Full depth flexural cracks visible at discrete intervals along length of RC beam.

3. Deficient workmanship in suspended RC beam. Concrete mix has segregated at midspan.

6. Crack damage to columns in workshop area.

7. Some cracking damage to wall panels, columns, and window lintels in this area.

12. Horizontal cracking in RC column, visible inside toilet block.

13. Diagonal crack in RC wall panel.

14. Vertical full height crack in RC wall panel to the right of the door.
Crack #13 visible at this location also - appears to be a full depth crack.

17. Red brick infill wall panel, some diagonal step cracking at left edge.

21. Vertical cracks in concrete walls. Likely RC wall, reinforcement unknown.

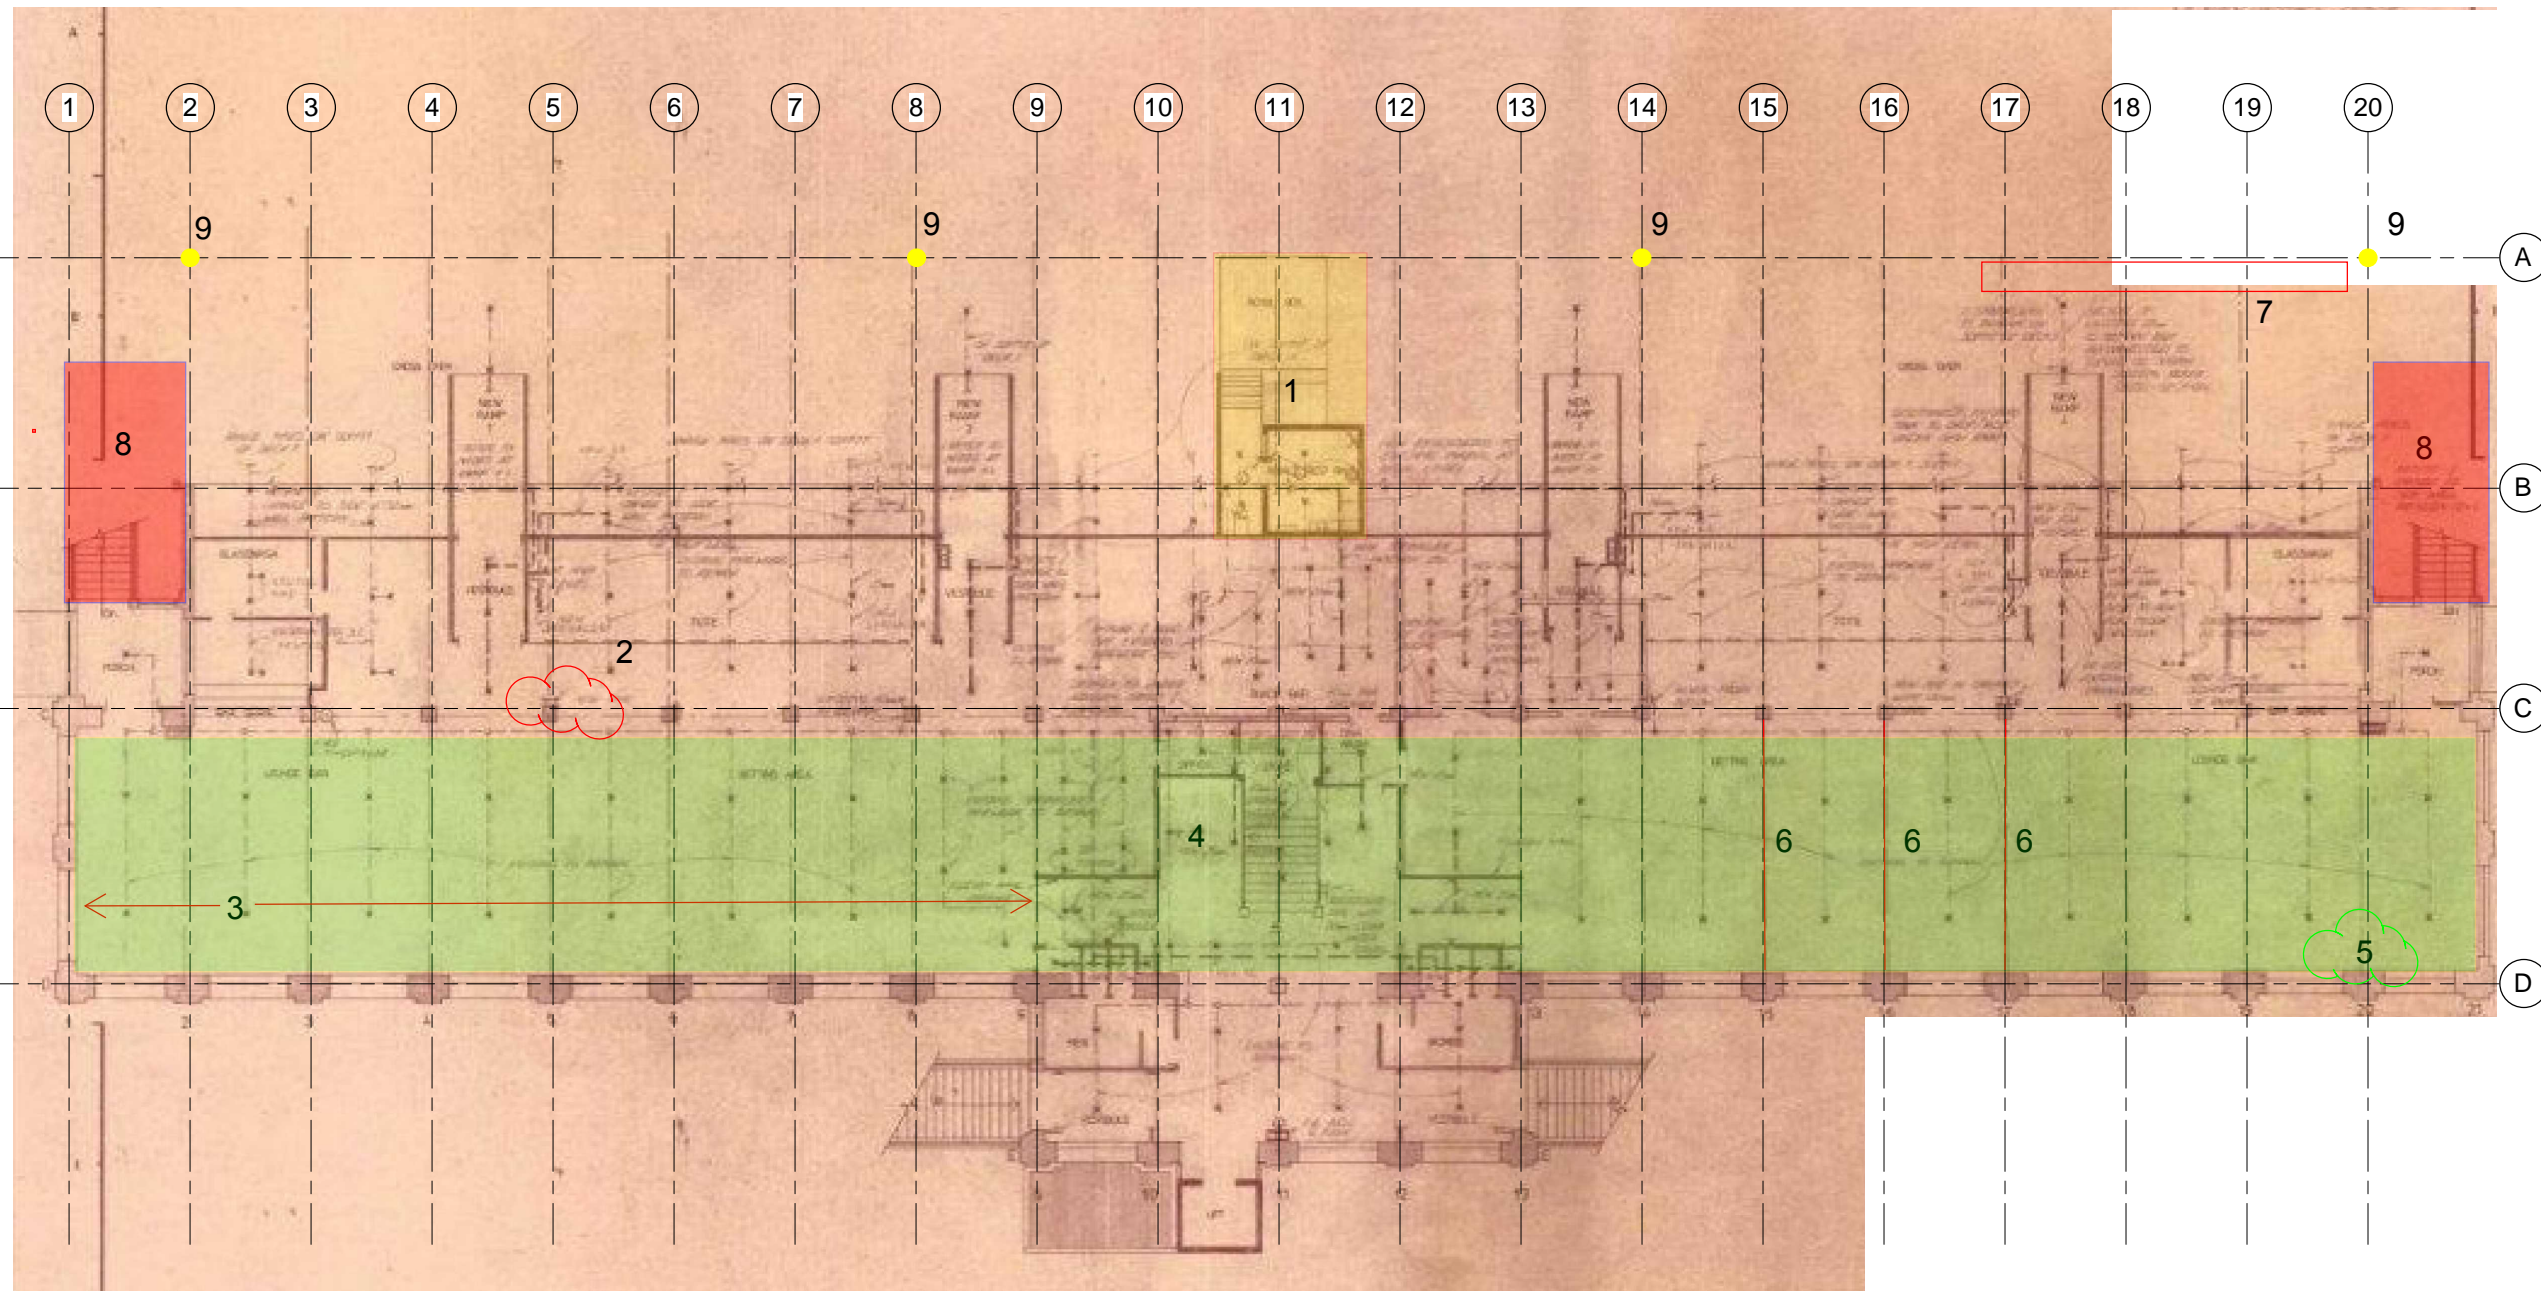
LEVEL 1
Scale: 1 : 125

1. Royal box area shown on historic plans does not exist.
2. Severe cracking damage to suspended RC floor slab, >3.5mm in width. Crack is visible where carpet is torn. Crack is likely to be on the interface between the original slab and 1980's additional section below the stand.
3. Floor levels appear to undulate under foot throughout this area.
4. HAZARD. Plaster finish to underside of ceiling may be Asbestos.
5. Moisture damage to plaster ceiling finish.
6. Full depth flexural cracks visible at discrete intervals along length of RC beam.
7. Rotten and loose timber decking boards. Trip hazard.
8. HAZARD. Significant cracking damage to RC stairs / ramps. Do not use until further notice.
9. Outline/ position of stand-supporting circular cast iron columns.

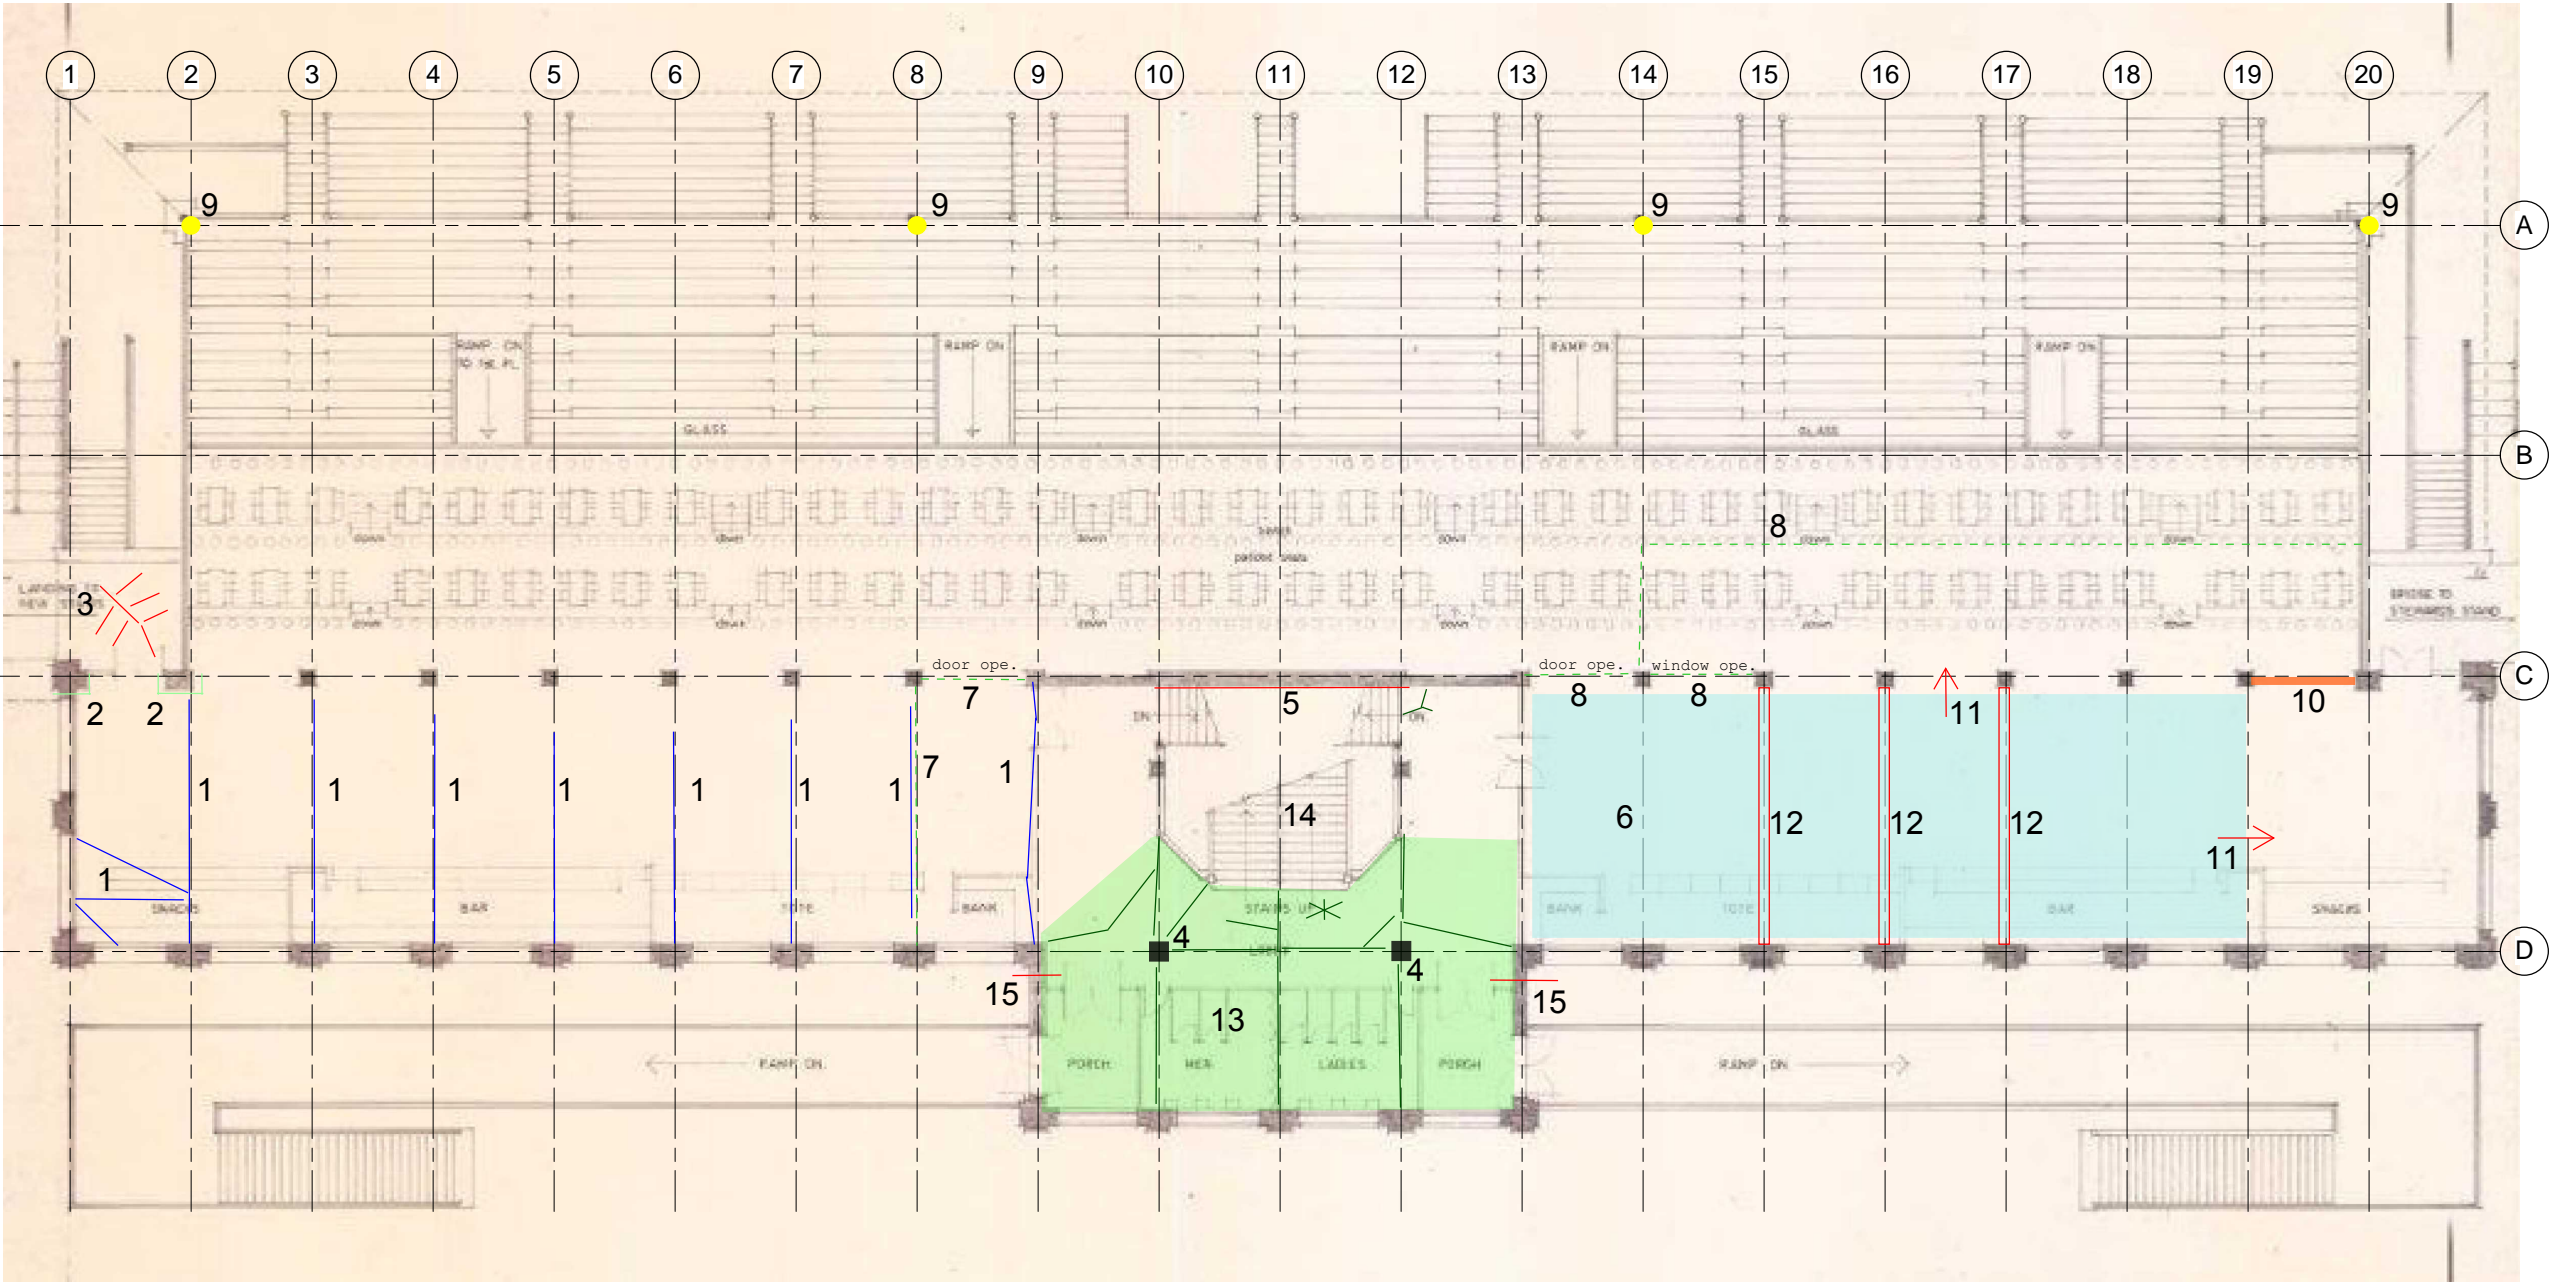
LEVEL 2

1. Approximate pattern of cracking observed in exposed RC floor slab on western end of structure (marked in blue).
2. Crack damage to columns at this location.

3. Spiderweb-like pattern of cracking observed on deck.
4. Reinforced concrete columns exist at this location - not shown on historic drawings.
5. Horizontal crack across full width of shear wall.

9. Outline/ position of stand-supporting circular cast iron columns.
10. Concrete infill wall panel - not shown on historic plans. Likely RC, reinforcement unknown. Horizontal cracking across full width of wall at approx 2.5m above ground.

11. Step up from carpeted area.
12. Full depth flexural cracks visible at discrete intervals along length of RC beam.
13. Significant cracking in stairwell. Major cracks marked on plan in dark green.

14. Full investigation of stair and connection required at detailed stage - cracking noted.
15. Full height vertical cracks in concrete wall panels. Likely RC panels, reinforcement unknown. It appears that the area beyond Gridline D has pulled away from the rest.

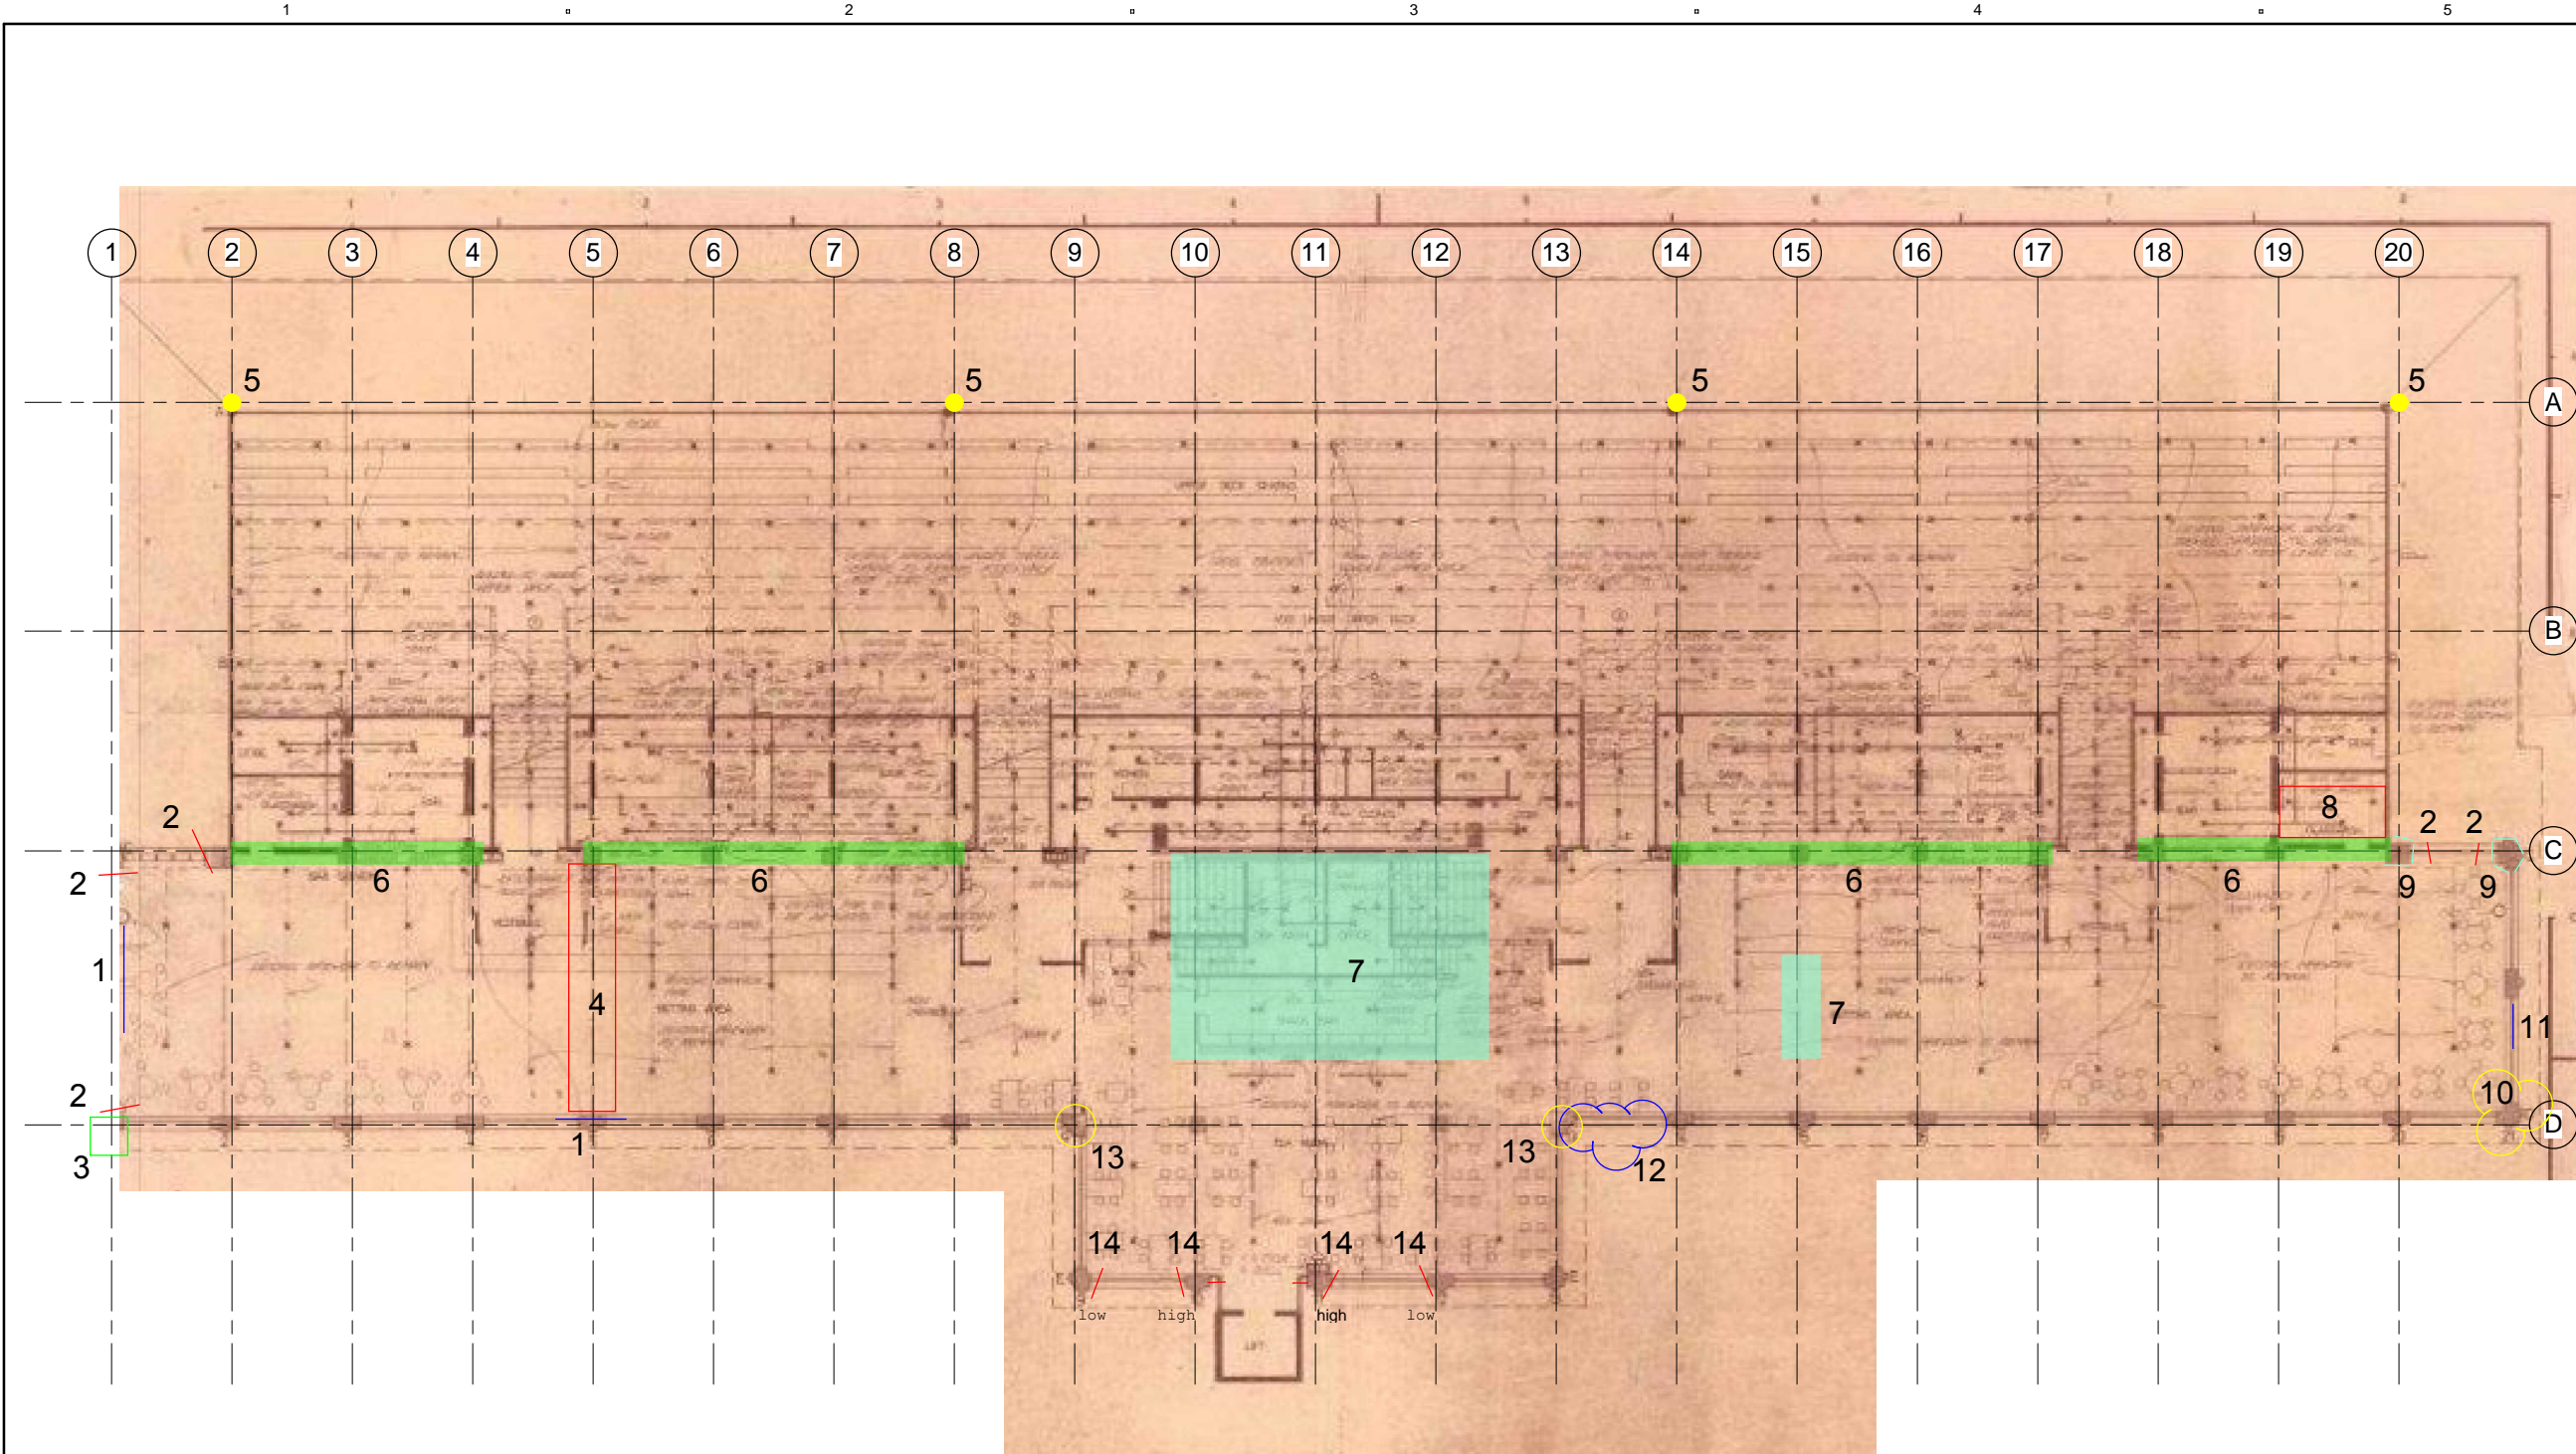
LEVEL 3
Scale: 1 : 125

1. Patch repair of concrete observed on concrete column at window level.

2. Vertical cracking (1mm x 1m) in concrete wall members at columns.

3. Vertical spalling and cracking of RC column observed on exterior at the SW corner.

7. Evidence of significant water penetration through concrete ceiling slab. HAZARD. plaster ceiling lining may contain Asbestos.
8. Damage to timber floor - settles noticeably under foot.

9. Horizontal cracks at discrete intervals vertically along columns.

10. Significant vertical spalling and cracking of RC column observed on exterior at the SE corner. Major vertical cracks in parapet.

12. Severe damage to soffit.

14. Cracking damage to concrete wall elements. Elevator core appears to have pulled from main structure at high level.

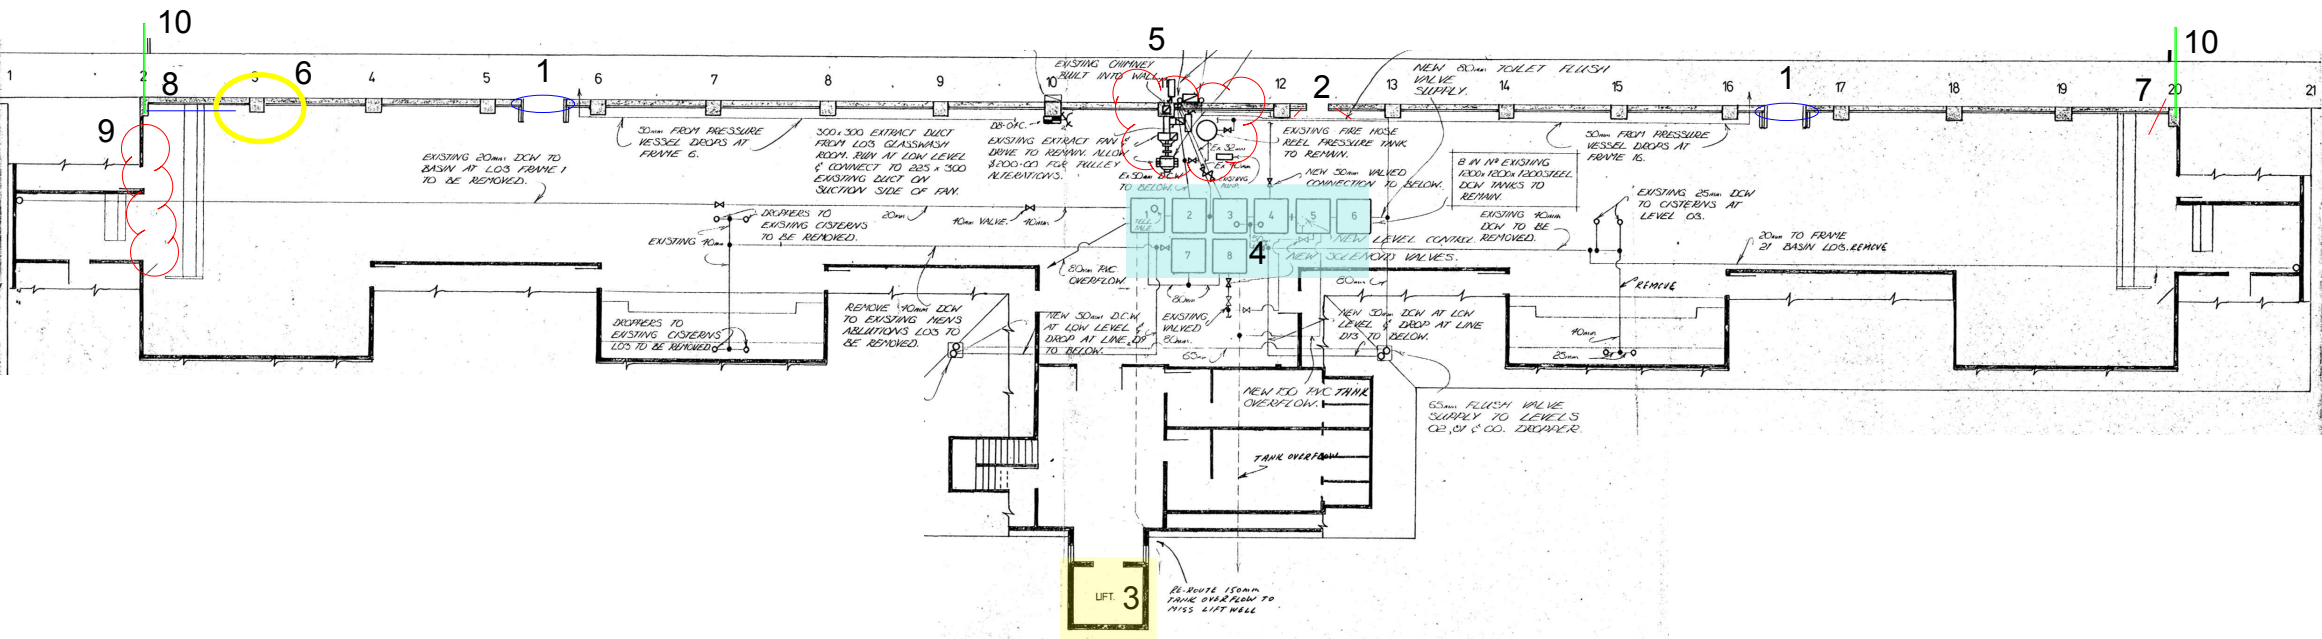
LEVEL 4
Scale: 1 : 100

3. Could not access fourth floor via elevator. Elevator works down only. No damage observed to elevator core, connections to main structure or to roof locally.

4. Evidence of significant amounts of water ponding under water tanks.
5. Concrete column containing ventilation has failed. Cracks up to 30mm visible from fourth floor level.

6. None of these columns are concrete rectangles as shown. All columns are double steel angle sections, inset into the rear of the RC wall.
Vertical cracks in exterior of RC wall (up to 5mm in width) line up with the location of these columns. Full crack mapping exercise to follow in detailed stage.

7. Cracking to the interior of the RC wall.
8. Historic damage to RC wall. Formwork may have failed during concrete pour.
Segregation of concrete and bulging of wall at joint in formwork.

9. Horizontal cracking of RC 'wing-wall', some spalling and exposed horizontal reinforcing steel. Bars appear to be approx 2no. 6mm bars at 400mm vertical centres.

10. Steel trusses (roof system) connect to RC structure at this point - detailed investigation of roof to follow in detailed stage. Some purlins and other timber members visibly broken from quick inspection.
