24 March 2017  
File: 0294

## **OLD MUNICIPAL CHAMBERS REPAIR, RECONSTRUCTION & RESTORATION: DEVELOPED DESIGN**

### **ARCHITECT DESIGN REPORT CONSERVATION ARCHITECT HERITAGE ASSESSMENT REPORT**

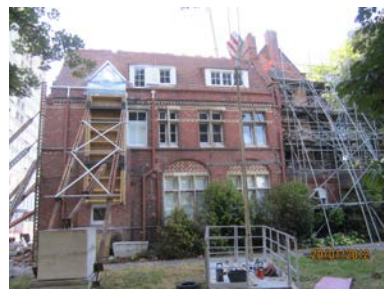
The principle damage is the loss of the chimney behind the props and ply bandage to the left of the photo and damage to parapet walls to the west gable. The chimney had previously been strengthened by filling the flues with reinforced concrete. The remaining parapets and chimneys adjacent to the north-west stair tower will require deconstruction as part of the permanent repair work.

The north façade with the chimney behind the stabilisation structure to the left from which the upper part of the chimney has been removed. The stairwell in the north-west corner partially concealed by the scaffolding.

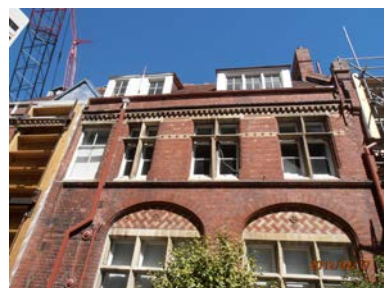
The stone mullions and transoms to the first floor windows have dislodged from one another and from the timber window frame behind

The displacement of the stone window mullions and transoms is apparent on some windows and the cracking and movement of the brickwork adjacent to the west corner is obvious.

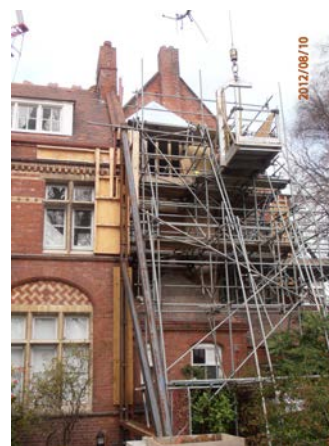
The north-west stair well partially concealed by the stabilising scaffold.

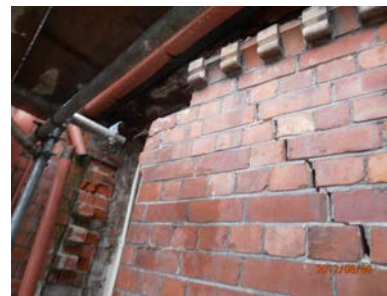
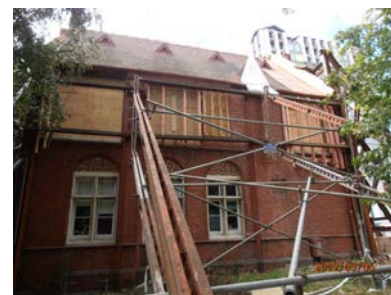
Shear cracking of the brickwork below the eaves level. This area has now been deconstructed. The single wythe 230mm brick wall construction of the north-west stair walls can be seen in this photo.

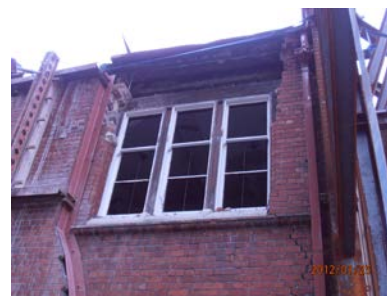
West Façade following the removal of the leadlight and stained glass windows, stone window mullions and transoms and brick to the lintols.

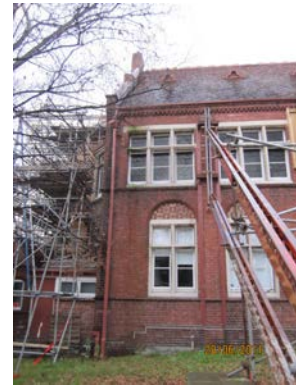
The south window of the west façade to the Council

Chamber suffered from movement of the corner brickwork, and collapse of the stone mullions and transoms and the brickwork to the lintel.

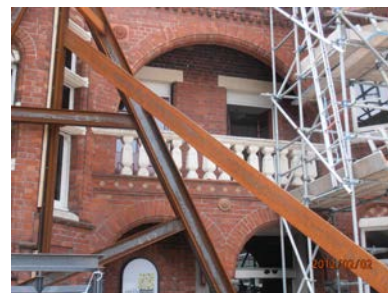
The south façade of the Municipal Chambers during the installation of the stabilisation structure. The turret roof and upper floor of the turret have been deconstructed.

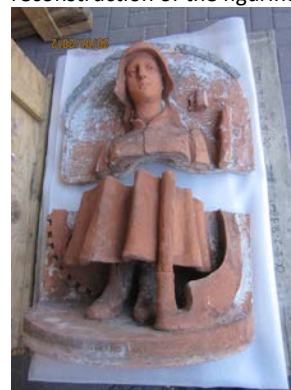
The Figurine, 'Industry', prior to removal showing the displacement of the brickwork securing the panels in place, and after removal. The damaged profiled bricks forming the alcove opening have been recorded and stored enabling the reconstruction of the figurines.

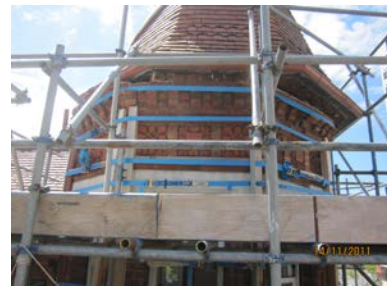
The roof structure had been displaced approximately 300mm by the earthquakes, with consequential displacement of the elaborate eaves/lintel frieze detail and rotation of the upper, attic level windows and mullions. The terracotta shingle roof tiles were removed and the timber roof structure lifted and lowered to the ground where it has been protected from the weather. The brick mullions and brickwork to the walls have been deconstructed to the level of the upper attic roof space floor level and the remaining brickwork has been stabilised. The rest of the brickwork to the turret is badly damaged and further deconstruction will be required during the repair process.

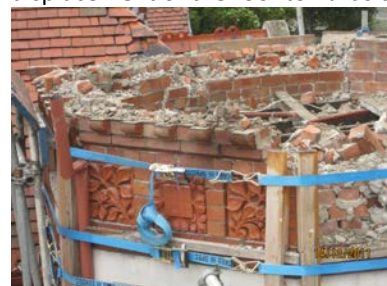
The turret to the south-east corner showing the displacement of the roof towards the east.

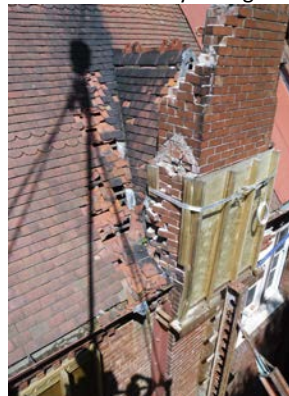
One of the two Chimneys in the east roof with damage to the roof caused by falling masonry

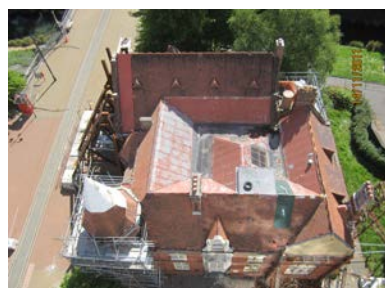
The Council Chamber west wall collapsed chimney.

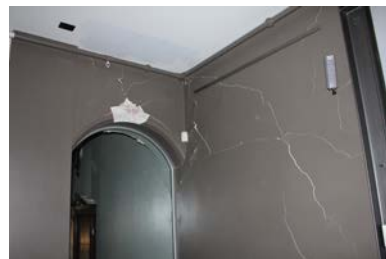
The interior of the north-west stairwell is critically damaged structurally and there is extensive cracking and collapse of plaster and brickwork to the interior and onto the stairs.

The ground floor stairwell.
