7. SCHEDULE OF AUTHENTICITY, SIGNIFICANCE, CONDITION & STATUS Refer to the report Section 5.1, CONSERVATION PLAN (2000) for the Statements of Significance and Overall Cultural Heritage Values, exterior and interior.

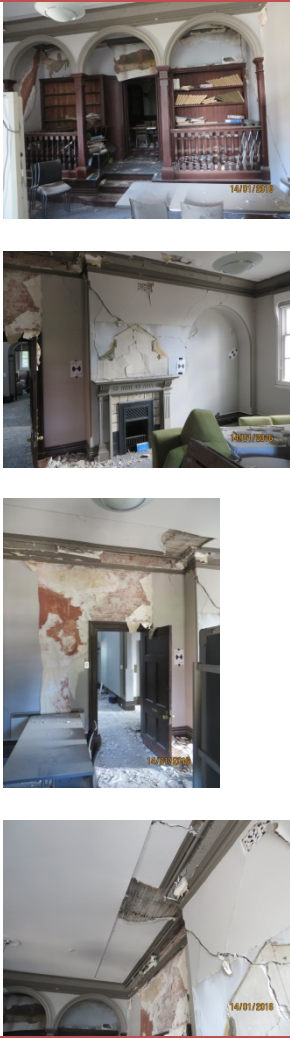
SPACE 1-1 Original use: Library Current use: The Library

<p>The Library, space 1-1, is in its original form and has high authenticity value.</p> <p>The space retains its original book shelving to the west wall to the Chamber and the arched arcade and balustrade to the step between the two levels. The brick masonry walls are plaster rendered and the lath and plaster ceilings and plaster cornices remain. Plaster mouldings decorate the capitals of columns, arches and cornices.</p> <p>French doors to the balcony are the original doors and the timber windows to the corner turret remain in their original form.</p> <p>The Chamber and Landing doors are the original timber framed and panelled doors with the library door having leather studded sound insulation.</p> <p>The fireplace with its over-mantle retains a high level of authenticity.</p> <p>The floors are concealed by floor coverings and weren't assessed.</p>	<p>Overall assessed heritage value of the space: Exceptional.</p> <p>Assessed heritage value of contributing fabric: Considerable: Fireplace, mantelpiece, French doors to balcony, arches adjacent Council Chamber, shelving, balustrading, cornices, skirtings, trim, steps.</p> <p>Not Relevant or Intrusive: Non-original fender, tiles to fireplace, fans, up-lights.</p>	<p>The plaster rendered brick masonry walls have cracking and loss of plaster.</p> <p>The lath and plaster ceilings have losses of plaster where exposed, and the condition could not be assessed where this is concealed by later plasterboard linings. The plaster ceiling cornices are extensively damaged and missing. Sufficient evidence remains for their reconstruction.</p> <p>The plaster rendered arcade appears to have suffered little damage.</p> <p>The floor was not assessed, being concealed by floor coverings.</p> <p>The timber window and door joinery has suffered some damage but is repairable. Likewise the book shelving and balustrade.</p> <p>The fireplace front has suffered some damage with the loss of the over-mantle and tiles to the sides of the fireplace. Plaster render to the chimney has considerable cracking.</p>
