Old Municipal Chambers

Geotechnical Report

Old Municipal Chambers Geotechnical Report

PREPARED FOR: Christchurch City Council

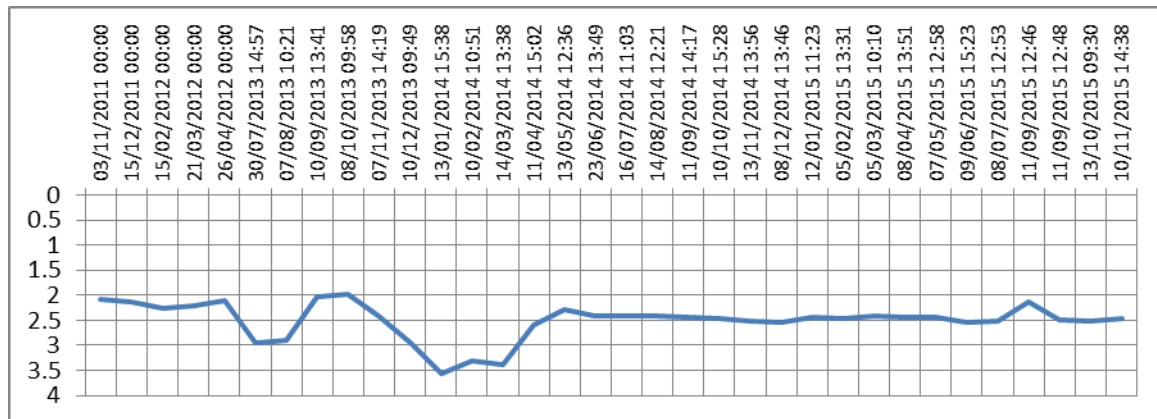
Figure 4.3 depths to water in monitoring well CGD 735

the top of the bank immediately across the river from the site. The variation in the data recorded between November 2011 and November 2015 is shown in Figure 4.3

It is considered reasonable to take this well data as representative of the ground water at the site. With a mean ground level of RL4.44, this gives the median depth to groundwater as 1.9m in a 15% - 85% range of 1.6 – 2.0m.

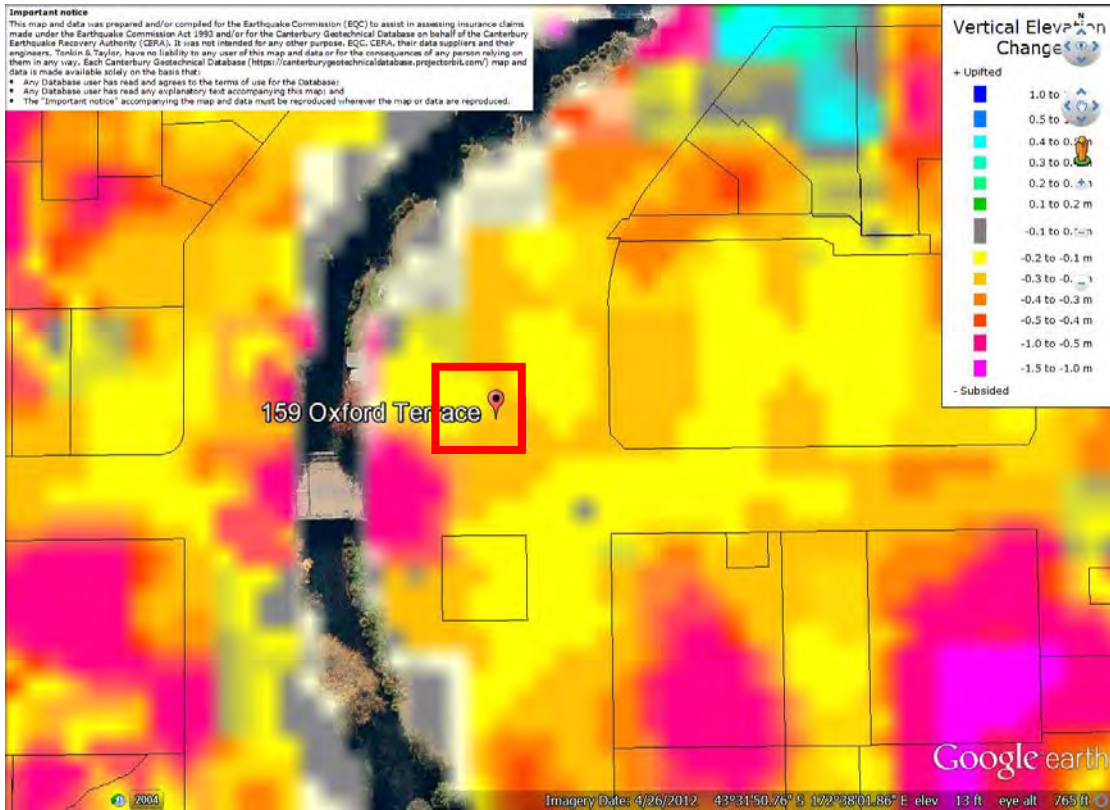
Figure 5.1 Cumulative vertical movement from all earthquakes, from LiDAR surveys
CGD Important Notice – see footnote p20

The Canterbury geotechnical Database (CGD) contains information on vertical ground movement derived from LiDAR surveys of the city before the earthquake sequence and following each of the major events. The cumulative movement from before the first earthquake to April 2012, is shown in Figure 5.1. The yellow shading on the west side and to the northeast of the site indicates 0.1 – 0.2m of vertical settlement; the light orange to the north and south indicates 0.2 – 0.3m of settlement. Larger settlement is indicated of the fill to the abutments on both sides of the Worcester St bridge.

It must be noted that the LiDAR surveys have some error associated with them, and that the elevations as used to calculate the changes are from manipulated data to remove buildings, vehicles etc to give a ground surface. Some of the areas which appear to show high settlements are probably related to this manipulation and are actually associated with the removal of buildings and the like. There is no marked trend visible however, with settlements in the area appearing to be relatively uniform.

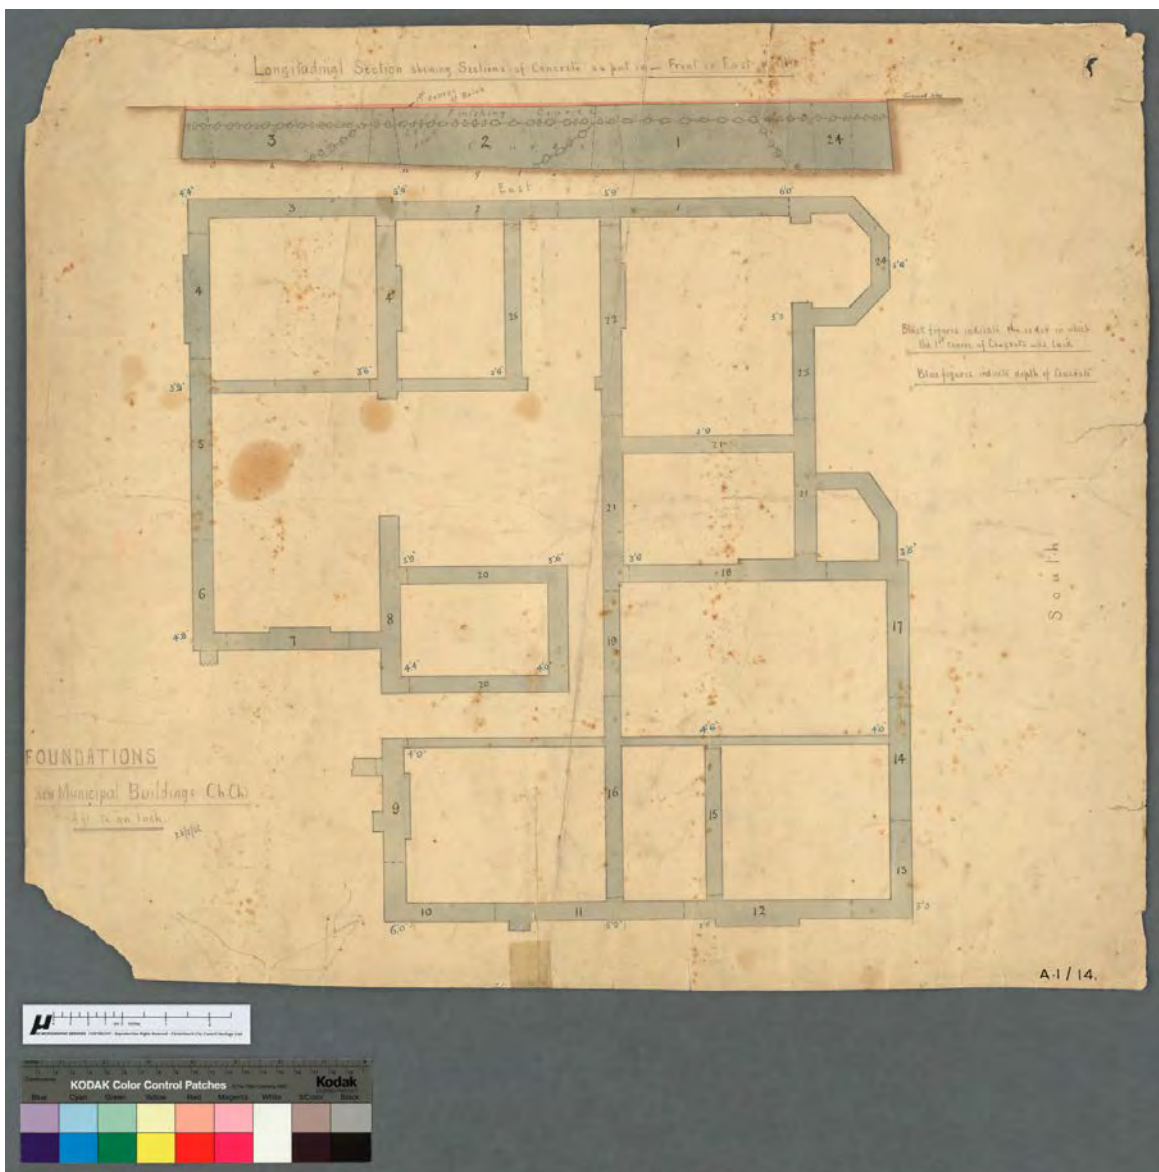
Figure 6.1 – Plan of 1886 Foundations

Drawings of the building include a plan of the 1886 foundations, reproduced here as Figure 6.1. All the brick walls are supported on concrete strip footings. The majority of these are understood to be 0.6m wide, but some internal footings appear to be somewhat narrower. Cross sections of the building show these foundations with shallow piles to the timber floors internal to the rooms.

The Conservation Report of 2000 reports that “continuous mass concrete foundations approximately 600mm wide by 600mm deep support the walls of the building”, but this is likely to be a layer of “finishing” concrete placed over the top of a concrete base.

The section of the eastern footing along the Oxford Terrace side (at the top of Figure 6.1) details 3 pours of concrete below the “finishing” concrete. Numbers on the plan indicate the foundation was poured in 24 sections below the finishing layer, which is presumably the 0.6m by 0.6m foundation referred to in the conservation report. The drawings also suggest a taper to the foundations, so that the base may well be wider than 0.6m.

The plan has dimensions noted at intervals and these appear to be the depth of footing. Depths through the middle of the building (north to south) are consistently shallowest at 1.05 – 1.15m (3 ft-6inch to 3ft-9 inch), but increase to both the east and west walls. The east wall varies from 1.3m at the north end to 1.8m at the south and the west wall varies from 1.6m at the south to 1.8m at the north. The depths are presumably from the top of concrete which is generally close to ground level. The depth of footings can be compared with the depth to gravel as determined from the CPT tests, as shown in Table 6.1.

The depths do not match particularly well, but do suggest that the foundations were taken to found directly on the gravel. This was the practice on other important heavy masonry buildings at the time, including what is now the Art Centre and the stone Provincial Chamber.

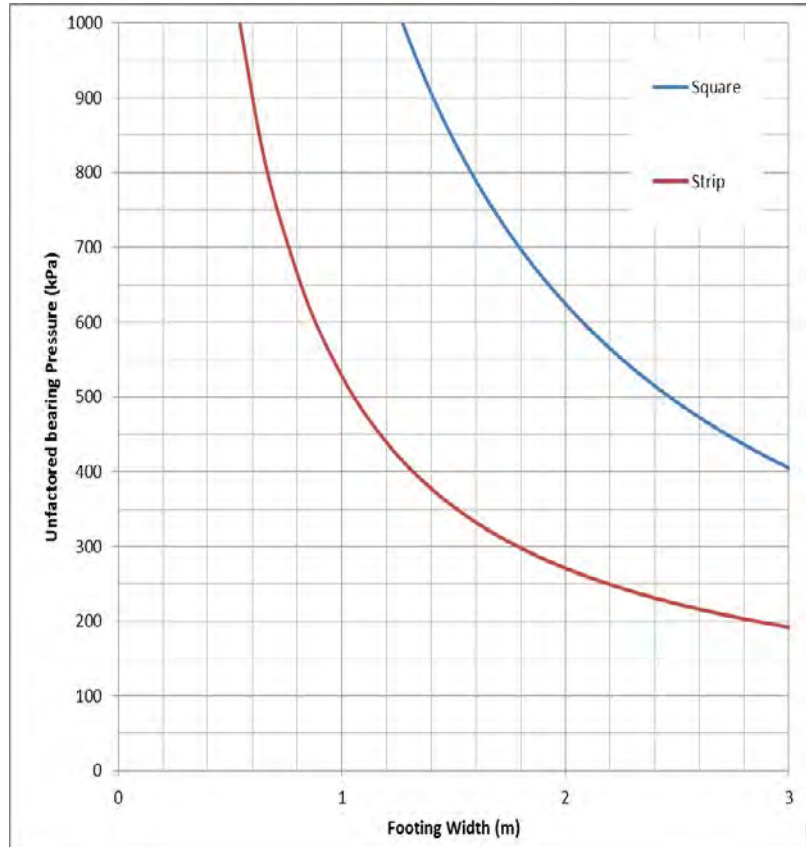
Figure 7.1
SLS bearing pressures (kPa) under shallow footings at 1.0m depth to limit settlement to 25mm

The bearing values should limit settlement to less than 25mm for strip and square footings. Stresses to limit settlement to values other than 25mm can be estimated by multiplying the values from the figure by the ratio of the settlement to 25mm.

The values in Figure 7.1 are for normal static conditions. Greater and unpredictable settlements must be expected with strong earthquake shaking sufficient to cause liquefaction of susceptible layers or consolidation of loose gravel lenses under the site

The bearing stresses in Figure 7.1 are very high for smaller width footings. We recommend that an upper limit of 300 kPa be applied for unfactored loads.
