ROBERT MCDUGALL ART GALLERY

ROBERT MCDOUGALL ART GALLERY – DETAILED SEISMIC ASSESSMENT REPORT

Prepared For:
CHRISTCHURCH CITY COUNCIL

Date: 2 September 2013
Project No: 104653.02
Revision No: 1

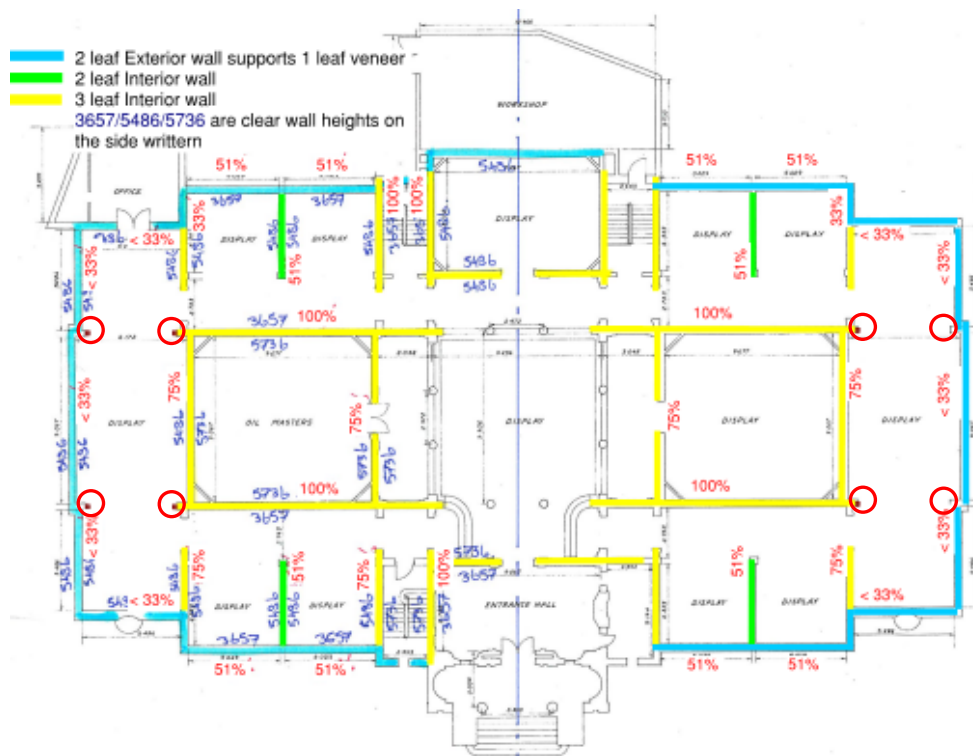
Figure 3-4 Plan indicating the % current code for out-of-plane wall capacity. The red circles indicate the locations where roof beams are supported on pilaster columns with very limited seismic capacity.

Critical Structural Weaknesses (CSWs) were identified in both end wings where a concrete encased steel roof beam is supported on a small step in the exterior walls (see “red” circles Figure 3-4). These supporting wall regions develop severe damage at low levels of seismic demand and represent a collapse hazard for the roof skylights at these locations. Further discussion of CSWs is provided in Appendix A.

The limited out-of-plane capacity of the exterior walls around the full perimeter of the building, and four interior walls dividing the “Large Oils” alcoves (see “green” walls Figure 3-4), also represent CSWs.

The red circles in Figure 3-4 indicate the locations where existing pilaster columns formed by unreinforced masonry support skylight beams above. These pilasters have very limited ability to sustain earthquake deformations and develop severe damage at relatively low levels of earthquake intensity.

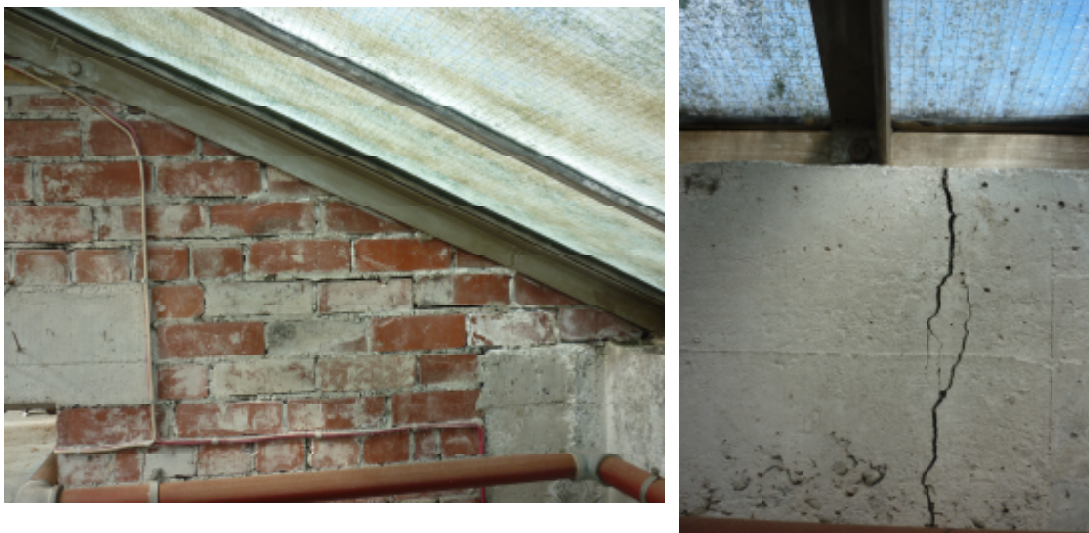
Stepped cracking of the mortar joints in the end skylight bulkhead walls has been observed and cracking of the concrete encasement around some of the skylight roof beams have been noted.

Figure 4-5: (a) Stepped mortar cracking in the skylight bulkheads (b) cracks in the encasing concrete of the skylight steel beams

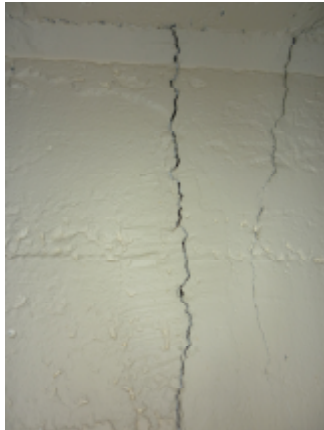
Damaged Item	Location	Example	Recommended Repair
1. Basement and Foundations			
1.1. Cracking of the foundation walls and beams. Some minor spalling	Noted throughout the basement, but seems to be more significant on the west side and south end.

<ul style="list-style-type: none"> • Epoxy inject cracks and repaint. • Patch concrete repairs where cover has spalled

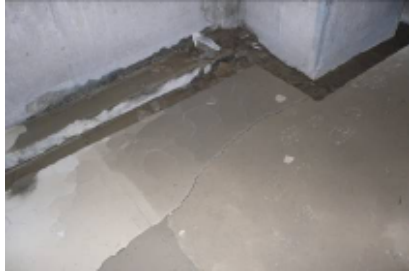
1.2. Potential settlement of south-west corner	Noted that cracking in basement is more concentrated in the west and south areas of the building

Level survey does not show the building to be significantly out-of-level. Geotech report does not suggest the settlement is critical or that future settlement potential is significant. Therefore no repair recommended.

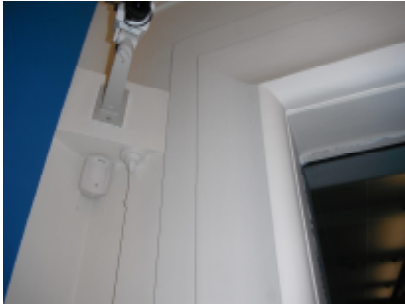
Damaged Item	Location	Example	Recommended Repair
3. Concrete lintel beams over interior doors			
3.1. Minor cracking of lintel beam	Door into theatre off central sculpture hall		Review with Heritage consultants for possible repairs if necessary.
3.2. Minor cracking of lintel beam	South-east door to Large Oils gallery

Review with Heritage consultants for possible repairs if necessary.
4. Interior walls			
4.1. Unreinforced masonry walls	South-west Large Oils gallery

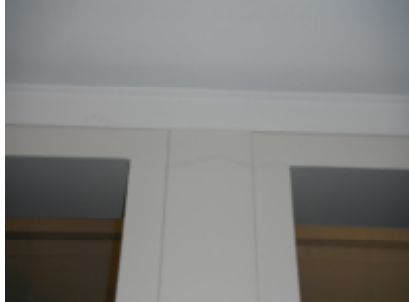
Damaged Item	Location	Example	Recommended Repair
5. Interior pilaster columns:			
5.1. Unreinforced masonry pilaster column	South-west gallery

Refer to Heritage consultant advice on appropriate repair methodology for such elements
6. Skylight bulkhead walls			
6.1. Stepped cracking in mortar beds	South and North skylights

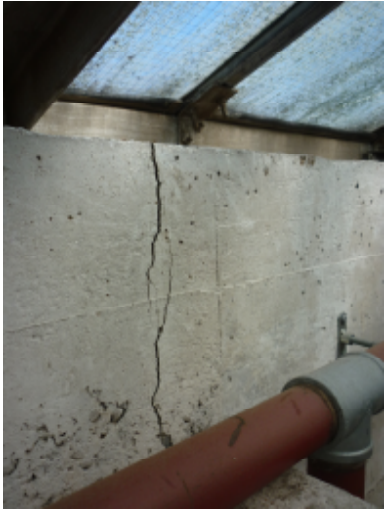
Damaged Item	Location	Example	Recommended Repair
7. Skylight Concrete Encased Steel beams			
7.1. Cracking of concrete up to 2mm in width	Various

Epoxy inject cracks in accordance with the Specification.
8. Exterior Concrete/Stone Roof Bond beam			
8.1. Level 1: Moderate cracking in concrete bond beam	Wall/beam corners adjacent to chimney on east elevation

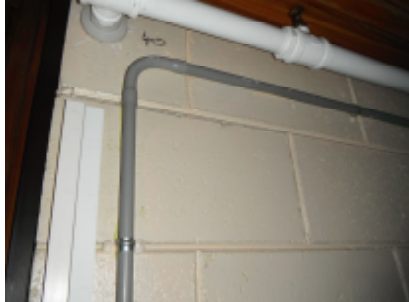
Damaged Item	Location	Example	Recommended Repair
9. Canaday Wing			
9.1. Level 1: Minor cracking in concrete wall	North wall adjacent to original McDougall Building

Epoxy inject cracks in accordance with the Specification.
10. Parapet Capstone movement and parapet rocking			
	<p>Various capstones appear to have moved.</p> <p>Parapet over/by main entrance was noted to have moved following June 2011 event.</p>
