# **Seismic Strengthening Options Summary Robert McDougall Gallery**

Robert McDougall Gallery Seismic Strengthening – 2017: Options Summary

Prepared For:  
Christchurch City Council

Date: 28 November 2017  
Project No: 104653.05  
Revision No: 1.0

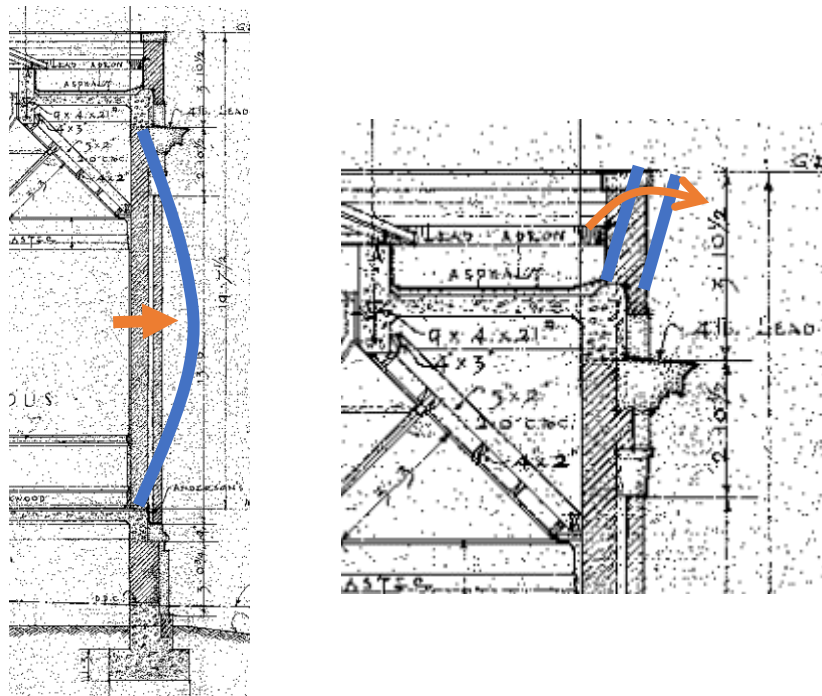
The exterior walls have a seismic out-of-plane capacity to resist forces perpendicular to the wall face (Figure 5-2a) that is less than 33% of current code, and similarly the unrestrained parapets are considered a significant hazard with capacity at less than 33% of current code (Figure 5-2b).

Figure 5-2: (a) Masonry wall out-of-plane seismic response and potential collapse (b) parapet out-of-plane topple mechanism.

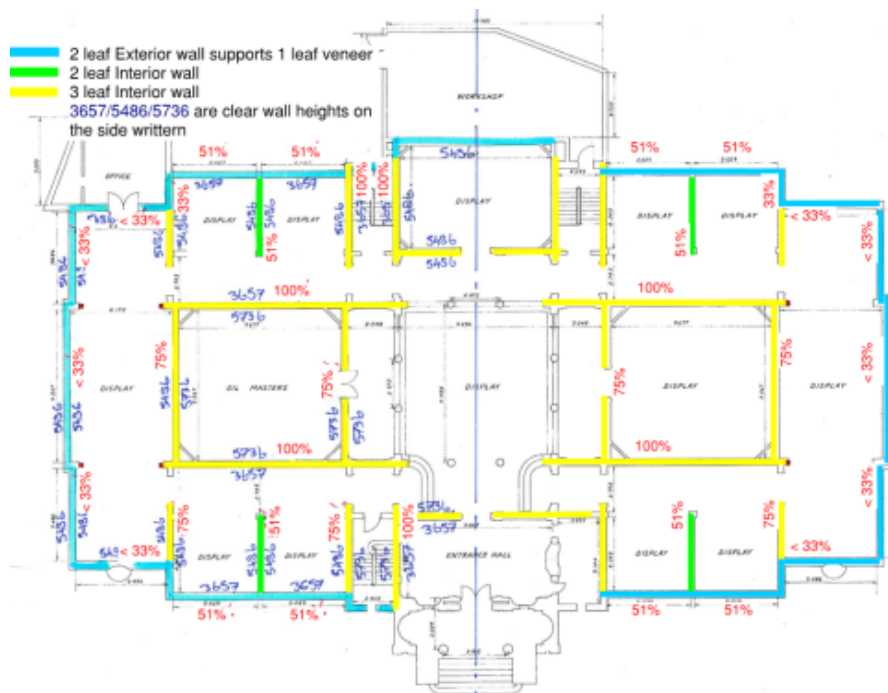
2. Wall out-of-plane flexural capacity i.e. the ability of the main walls to resist forces that push the wall in/outwards from the building, perpendicular to the wall length. This behaviour is considered critical for the structural capacity with perimeter walls being < 33%NBS and some internal walls <67%NBS (IL3).

Figure 5-3: Summary plan of wall out-of-plane seismic capacity %NBS (of IL3). Values below 67% are being considered for out-of-plane seismic strengthening.

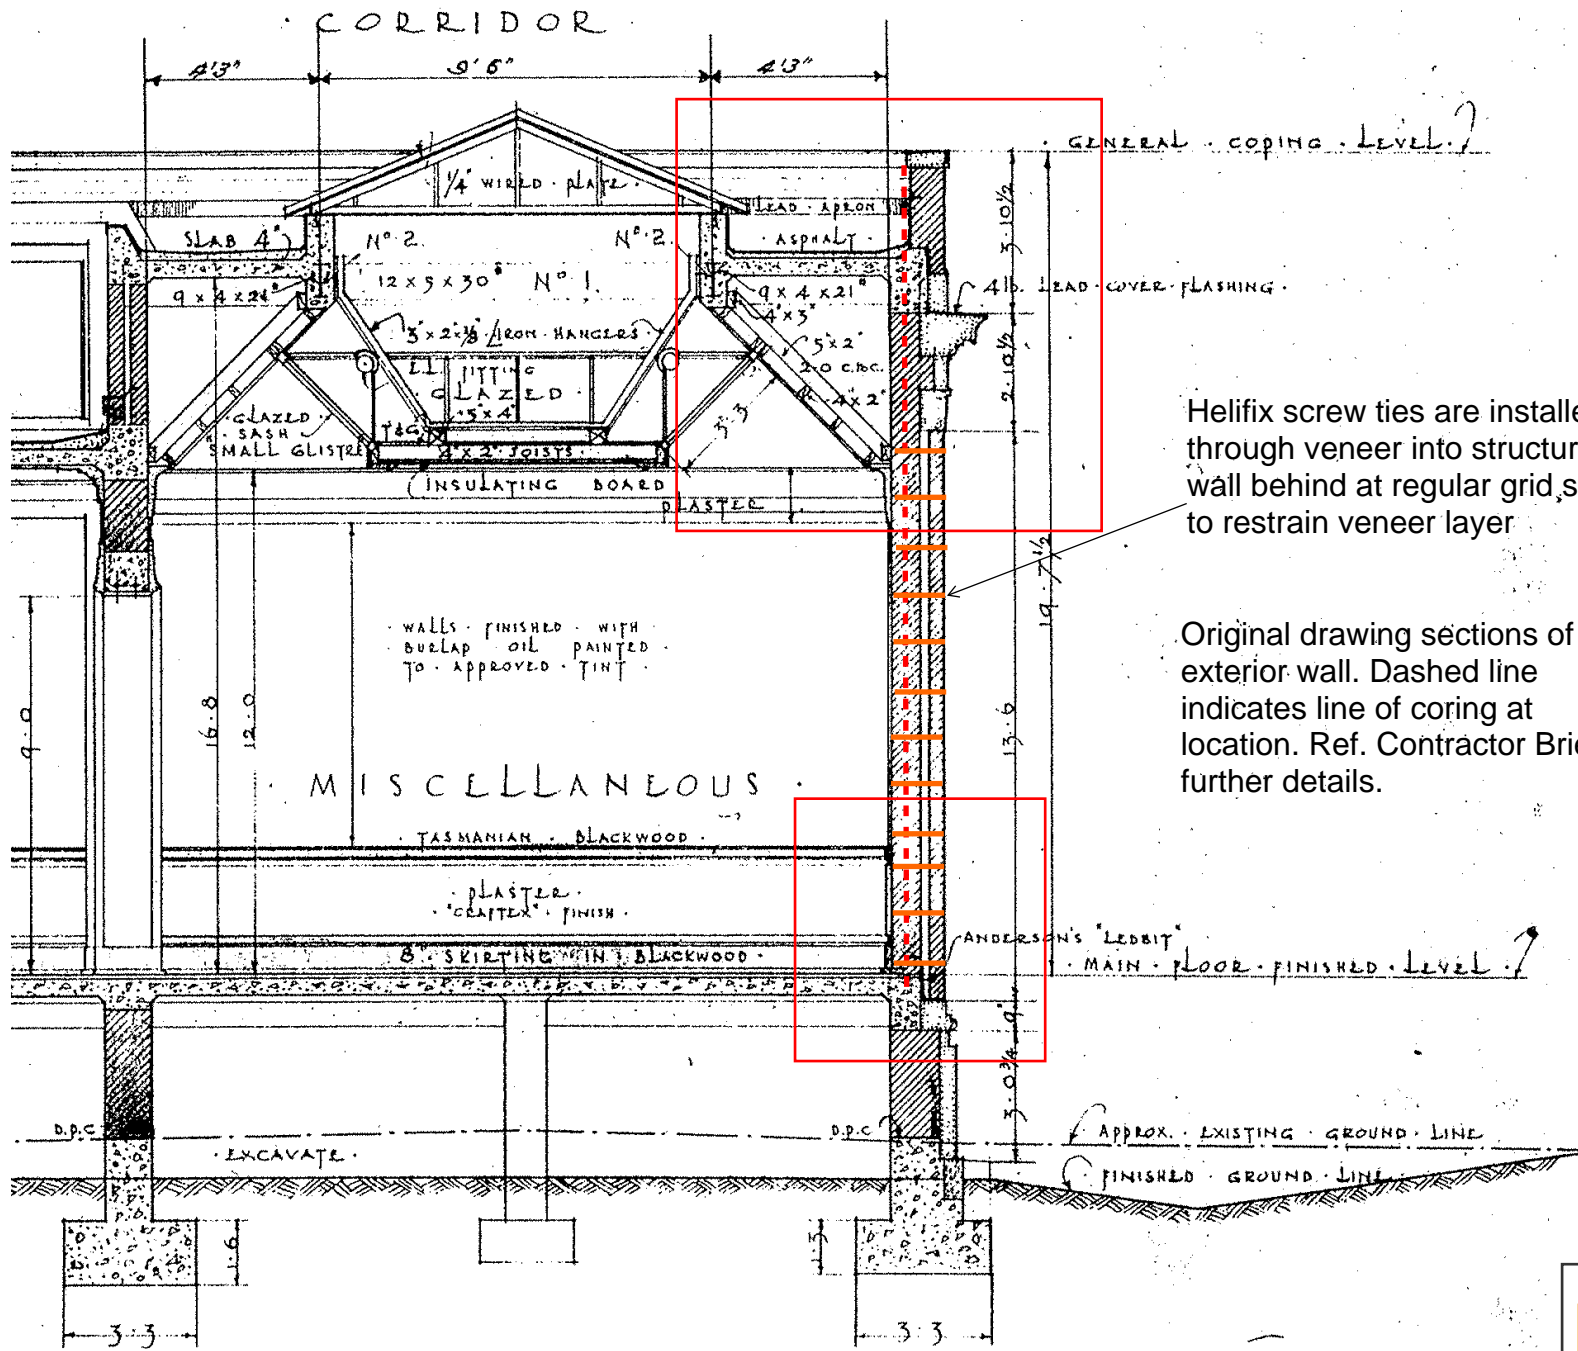
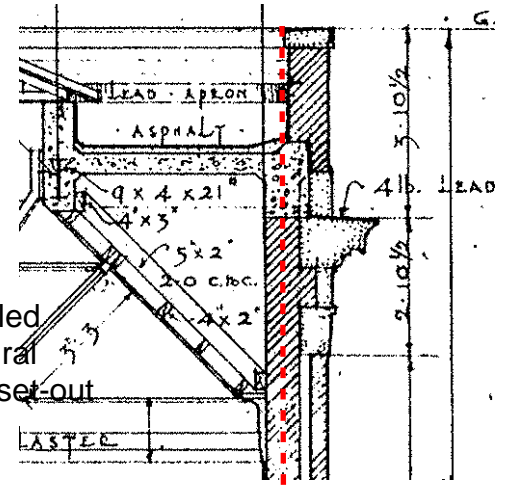
6. A review of the veneer ties on the back face of the parapet by the Heritage Architect has identified that in many areas the original ties have rusted and potentially have little remaining integrity. The remediation of the veneer ties can be achieved by various means, however a simple solution may be to introduce Helifix ties with a regular grid spacing through the veneer and into the main wall behind. Refer SSK003 in Appendix sketches.

Where the brick veneer ties are found to have corroded significantly around the parapet extent, the installation of Helifix ties (Works ID 6) may be considered as a means to re-introducing the connection between veneer and wall. The full extent of this will need to be confirmed as part of the site investigation associated to the heritage report and subsequent remediation of mortar bed scope.

Helifix screw ties are installed through veneer into structural wall behind at regular grid set-out to restrain veneer layer
