29 February 2012

EDMONDS BAND ROTUNDA: 230 CAMBRIDGE TERRACE
EARTHQUAKE DAMAGE RECOVERY

SECURING & DECONSTRUCTION METHODOLOGY & PROTECTION PLAN

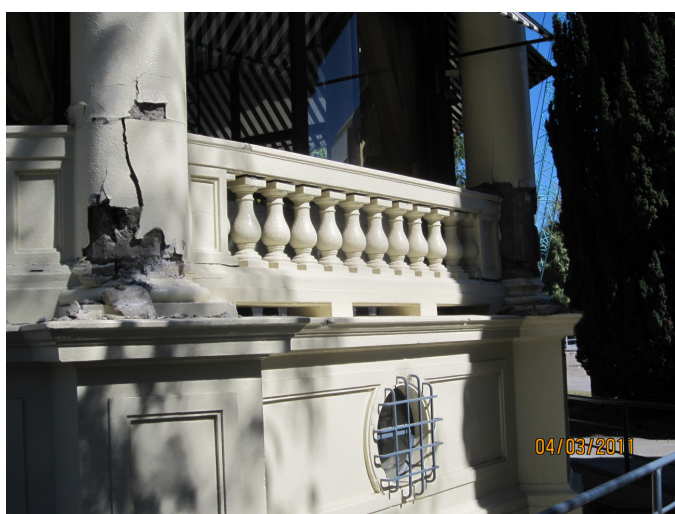
Following the 22nd February 2011 earthquake, the Band Rotunda suffered major damage to the structure. There is severe cracking and failure to the concrete at the top and bottom of all columns at the dome collar and pedestal plinth connections, and there is cracking and damage to all of the concrete balustrades. There has been appreciable ground movement and spreading in the riverbank area on which the band rotunda is located and this has caused noticeable leaning of the rotunda and the basement floor has lifted within the plinth drum. The plaster column capitals and pedestals have come away from the concrete substrate and reinforcing steel in the column connections is visible and has stretched and deformed. There are also visible cracks around the base and plinth. There is evidence of ground movement adjacent to and on the site of the rotunda and this is elaborated in separate geotechnical engineering reports. The dome and collar beam appear to be reasonably sound.

A typical column base and pedestal damage with exposed and deformed reinforcing steel. A damaged balustrade bay and a vent with grille to the plinth of the rotunda are shown.

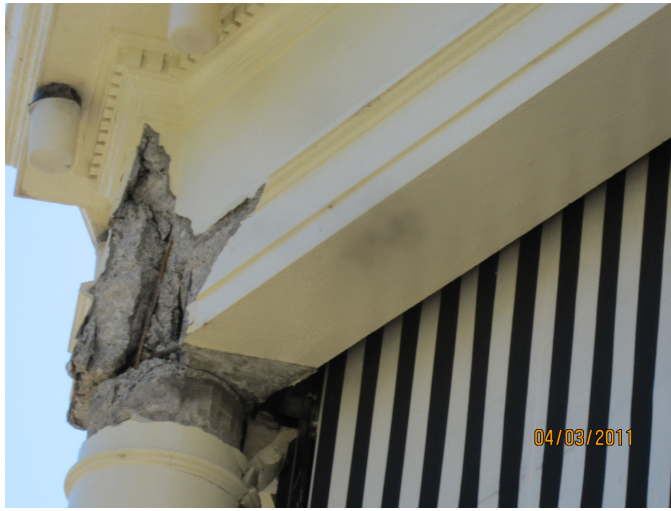
Typical damage and failure of the column capital and dome collar joint with exposed reinforcing steel. The decorative plaster moulding to the capital has collapsed.
