**Canterbury Earthquakes 2010/11 Port Hills Slope
Stability: Earth/debris flow risk assessment for
Defender Lane**

**GNS Science Consultancy Report 2014/67
August 2014 FINAL**

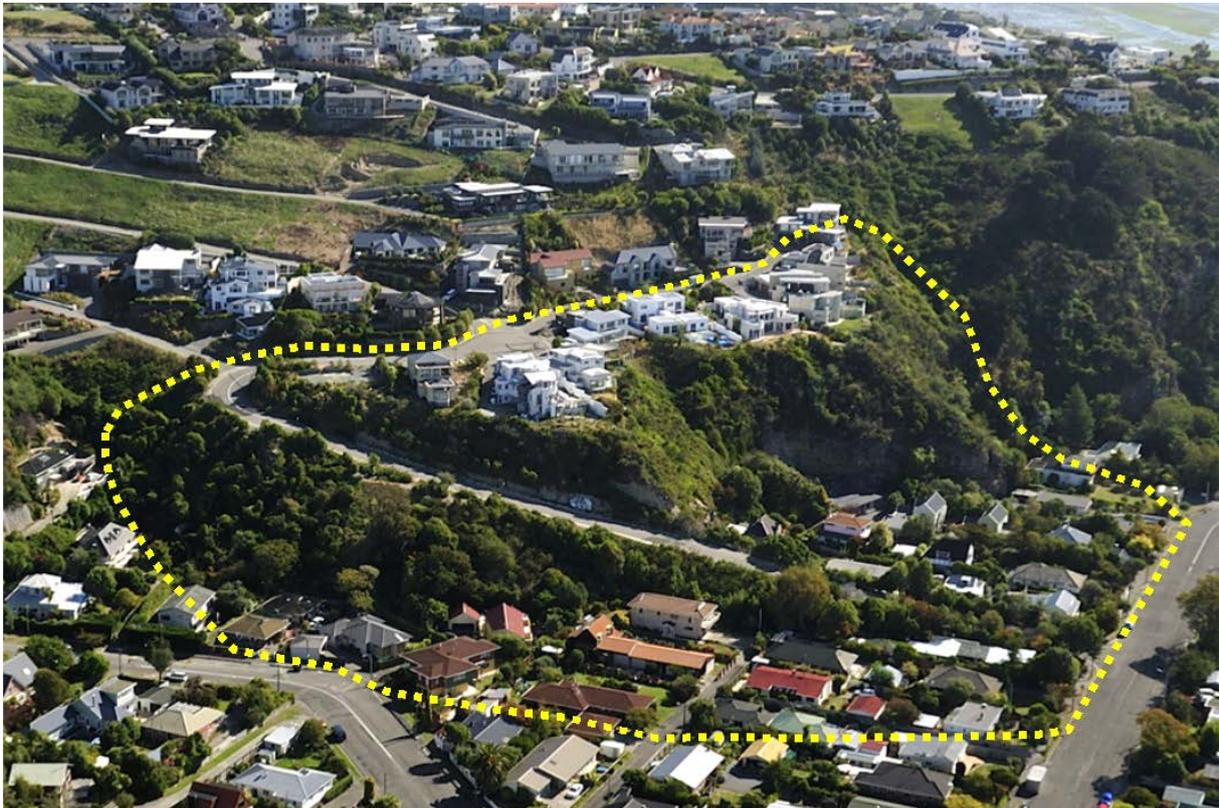
Figure 3 Aerial view of the Defender Lane mass movement study area looking west.

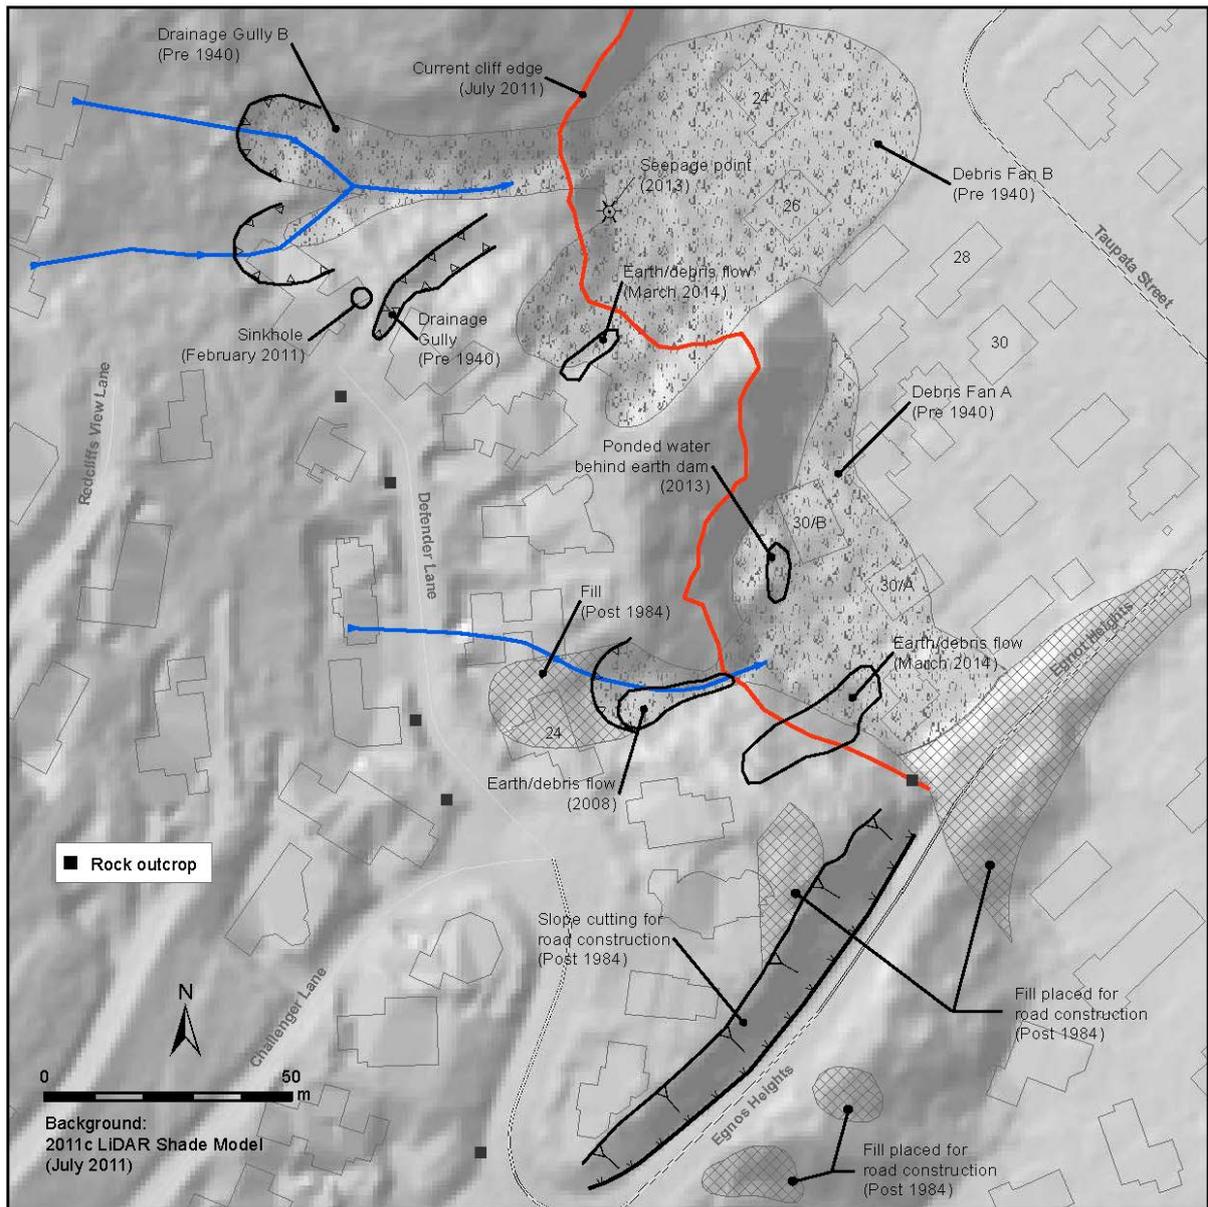
4 March 2009	Google Earth Imagery	Most housing developments along the slope crest are now completed. The head of Gully A has now been backfilled for development.
23 October 2009	Google Earth Imagery	Building works at 30B Taupata Street beneath slope. Earth dam works and excavation undercutting talus beneath slope to contain Gully A runoff.
15 February 2009	Google Earth Imagery	Bare ground exposed at slope behind 30B Taupata Street.

Figure 4 Main features identified at the site from field mapping and the interpretation of historical aerial photographs.

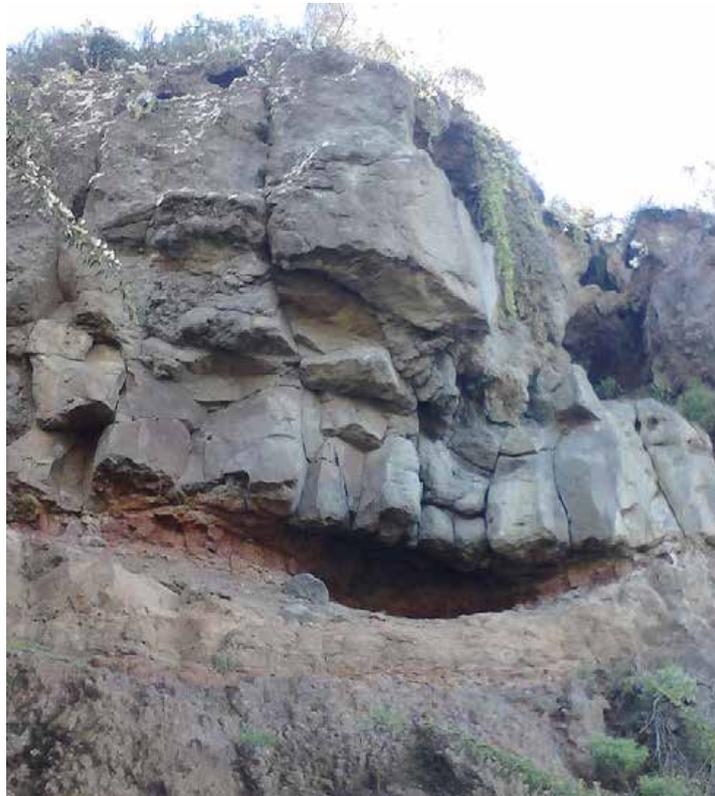
Figure 26 Columnar jointed blocks of basalt perched on the slope behind 28 Taupata Street.

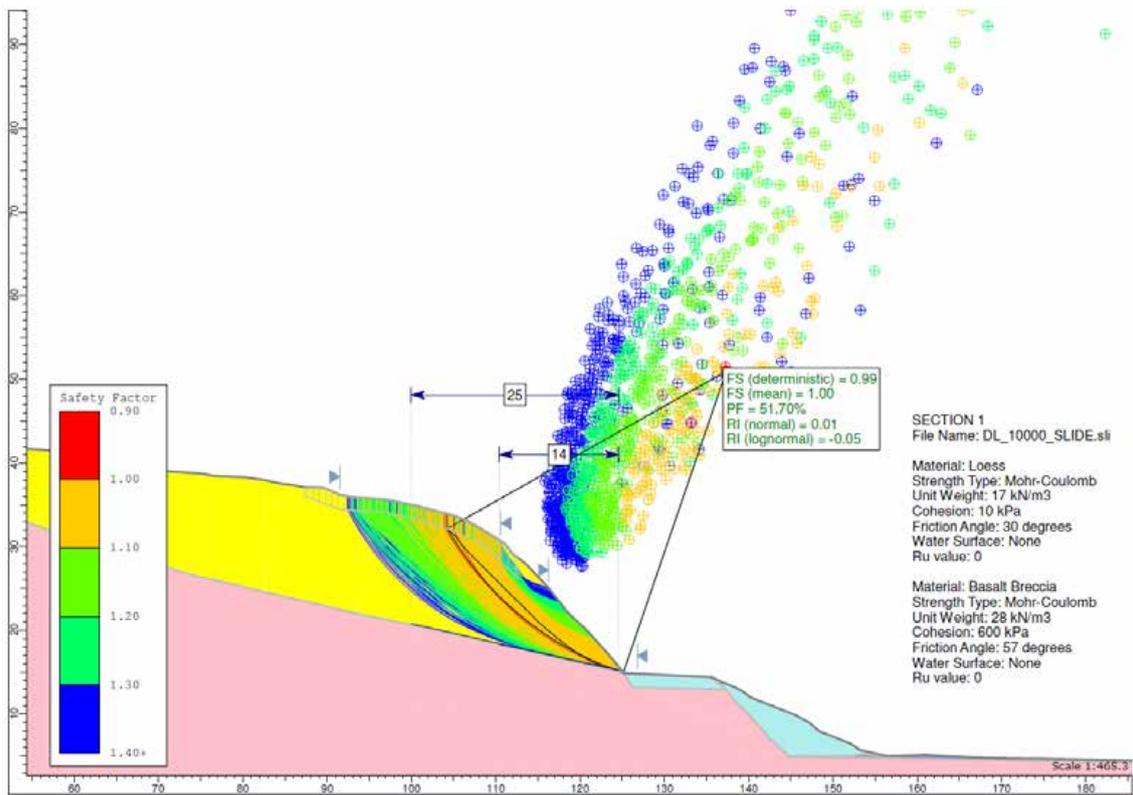
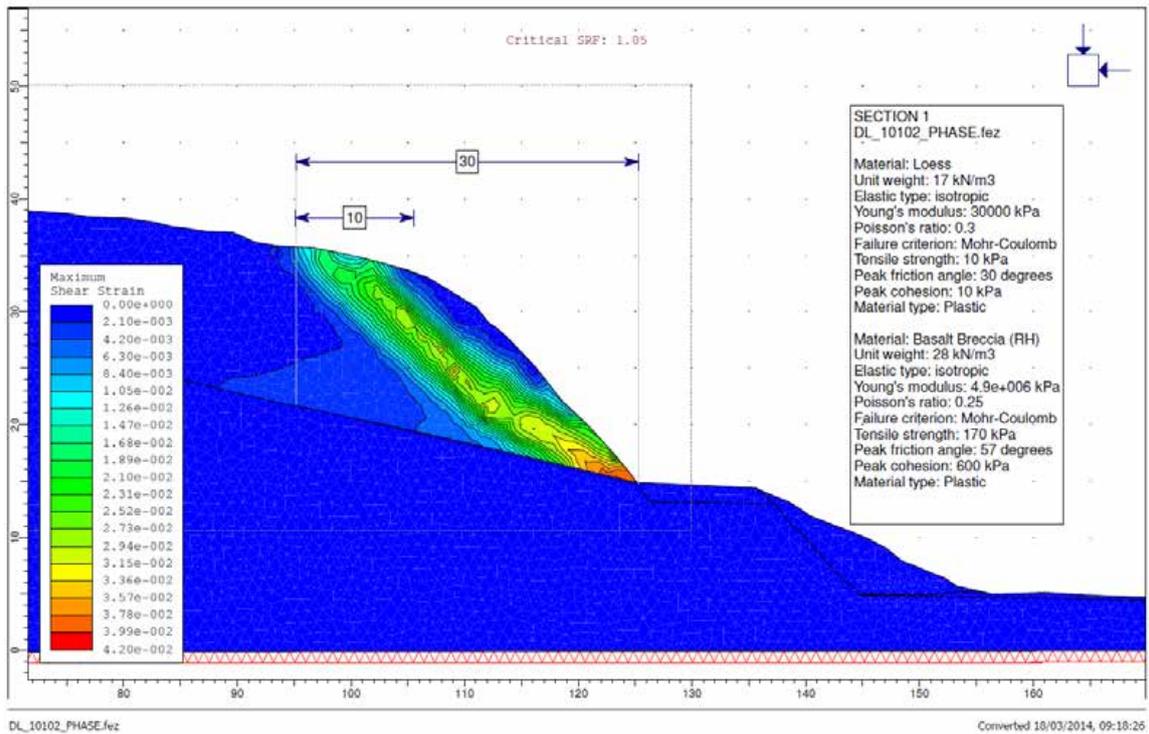
Figure 28 Mechanism 1. Limit equilibrium and finite element modelling assessment results for cross-section 1, adopting friction (ϕ) = 30°, and cohesion (c) = 10 kPa.

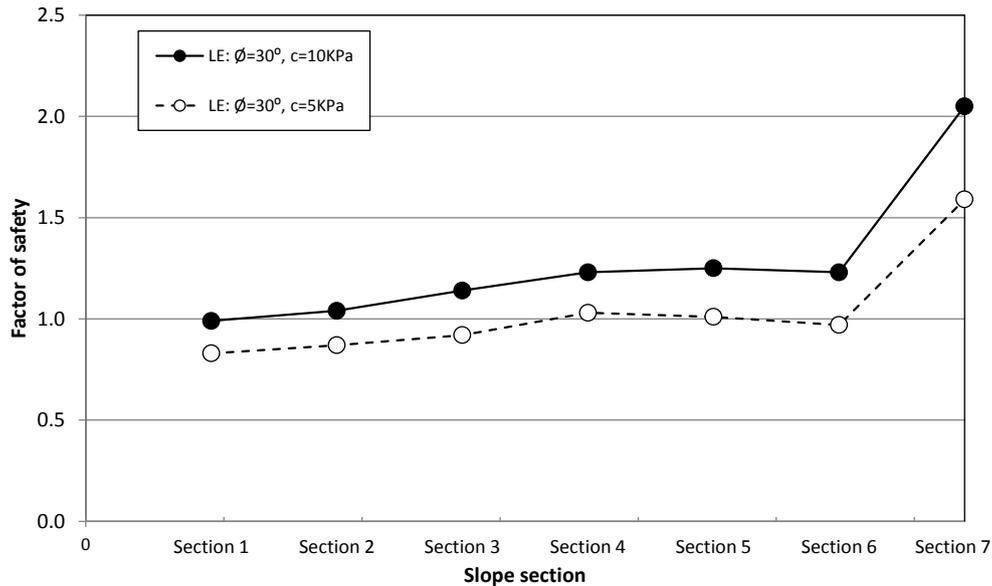
Figure 31 Effect on factor of safety output with reduction in cohesion (c) from 10 to 5 kPa (based on the limit equilibrium method for failure mechanism 1).

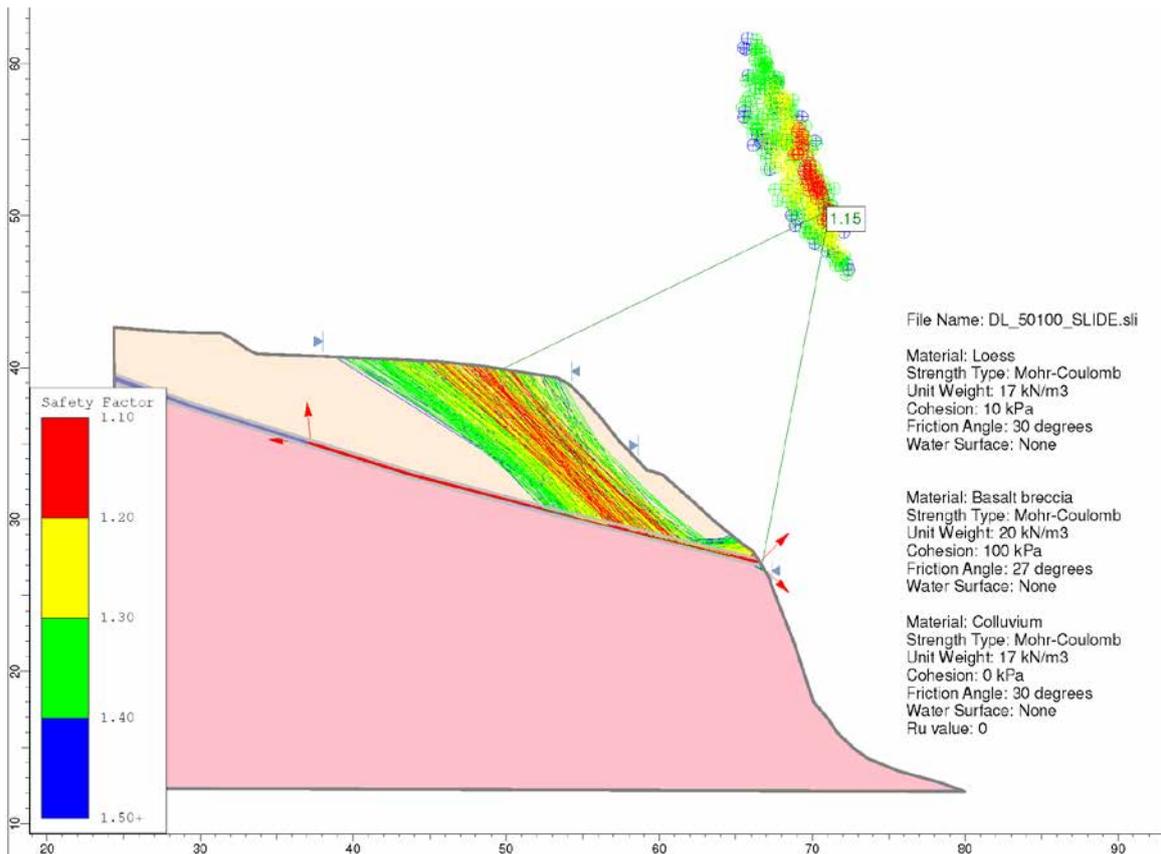
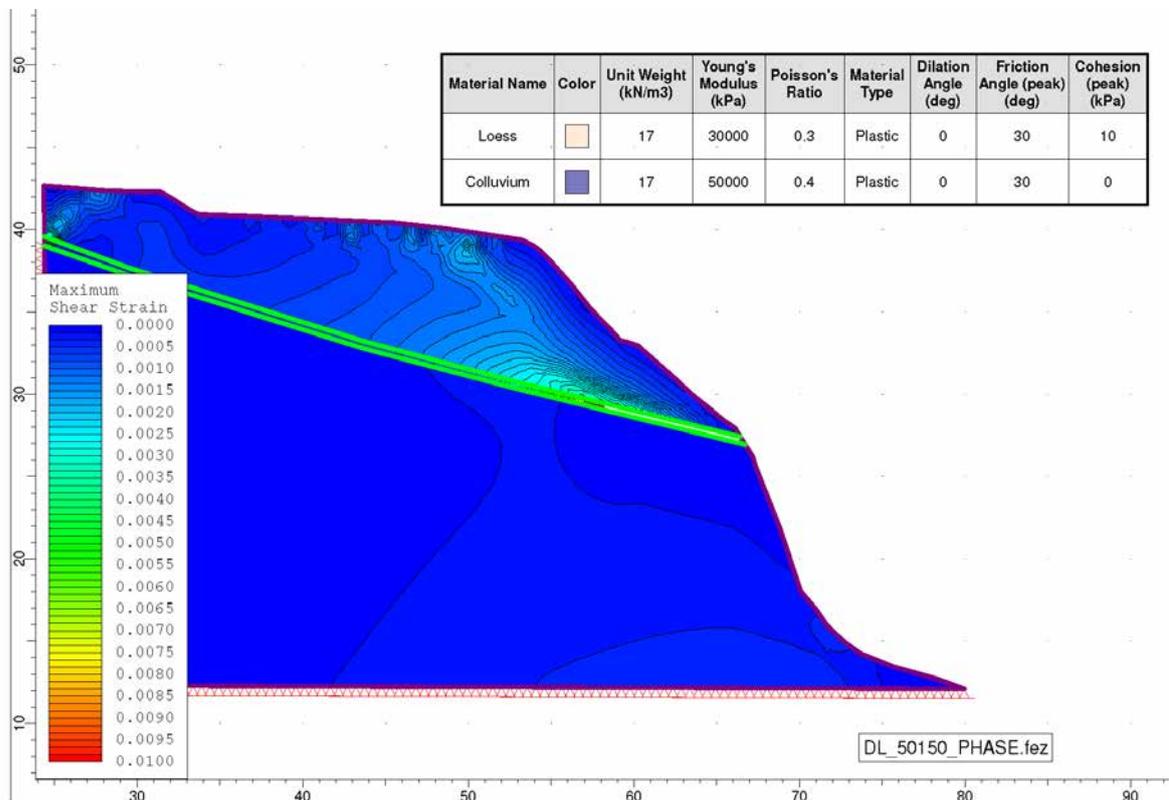
Figure 32 Mechanism 2. Limit equilibrium modelling and finite element modelling assessment results for cross-section 5, adopting friction (ϕ) = 30°, and cohesion (c) = 0 kPa for the colluvium.
