OPEN WATERWAY CONDITION ASSESSMENT

DATA SUMMARY REPORT

Land Drainage Recovery Programme

January 2017

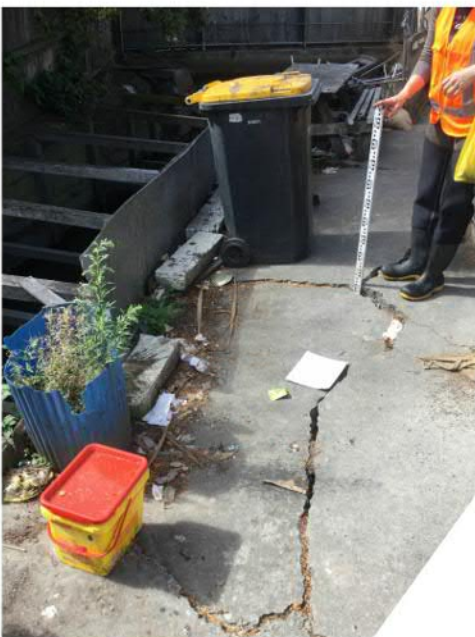
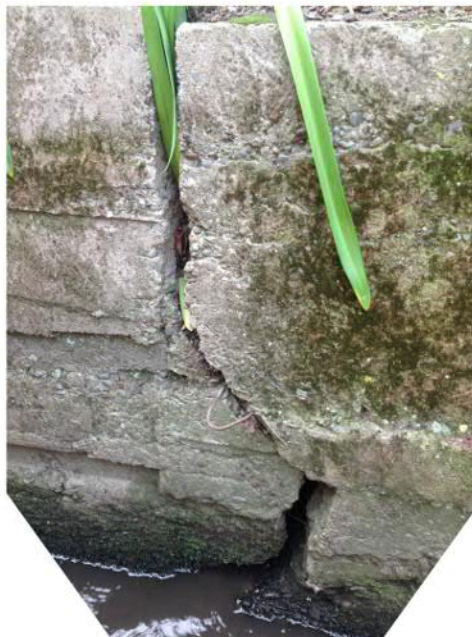
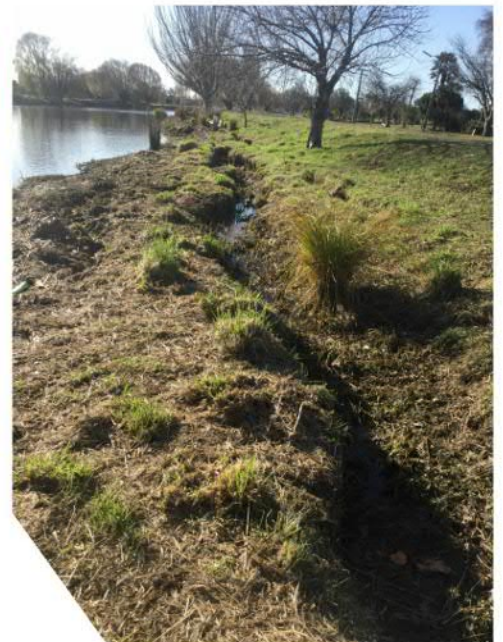
Typical earthquake effects on average channel condition included reaches where the majority of faults involved bank slumping or broken lining due to differential ground settlement or obvious lateral movement.

Some examples of characteristic earthquake effects are shown below.

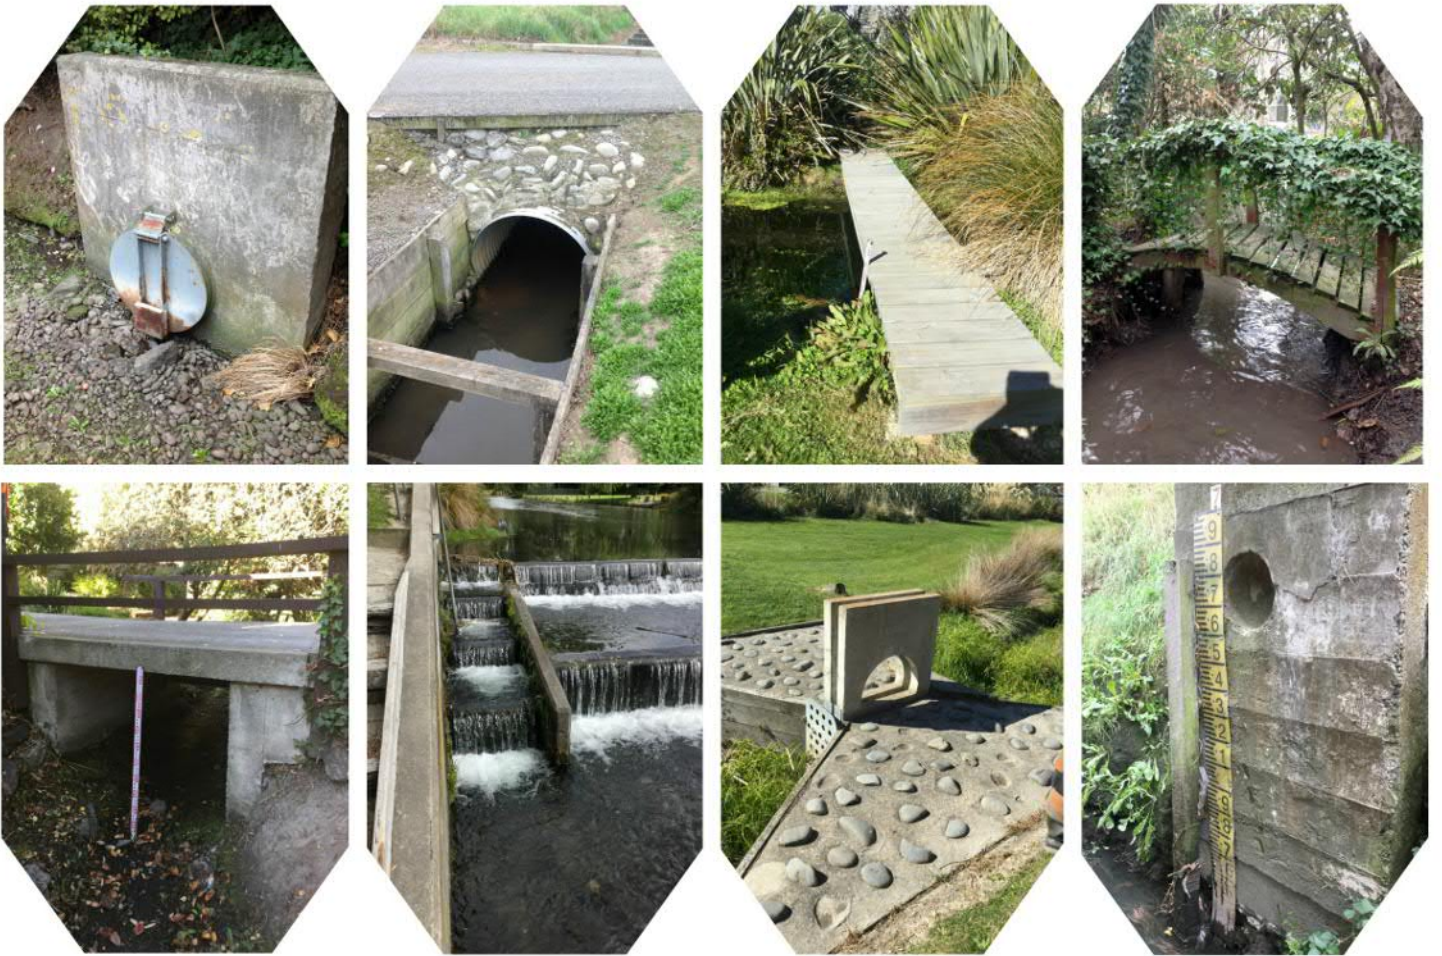
Examples of structures identified on the watercourses. Clockwise from top left: Pipe outlet with flap valve, culvert under road, pedestrian crossing in public space, pedestrian crossing on private property, culvert under vehicle driveway, fish ladder, flow dissipater, water level gauge on pipe outlet headwall.

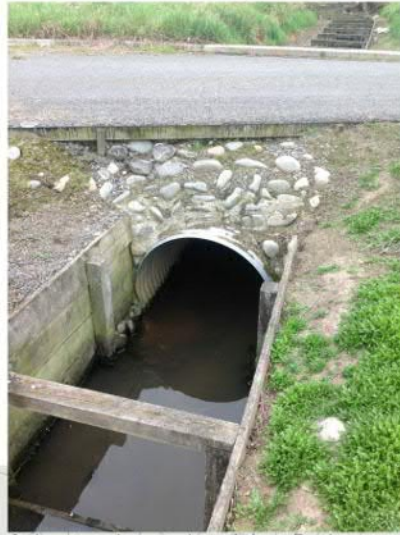
Culvert under road on Johns Drain

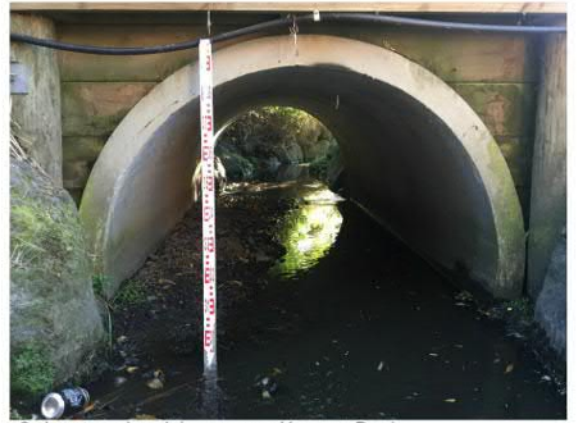
Culvert under driveway on Kruses Drain

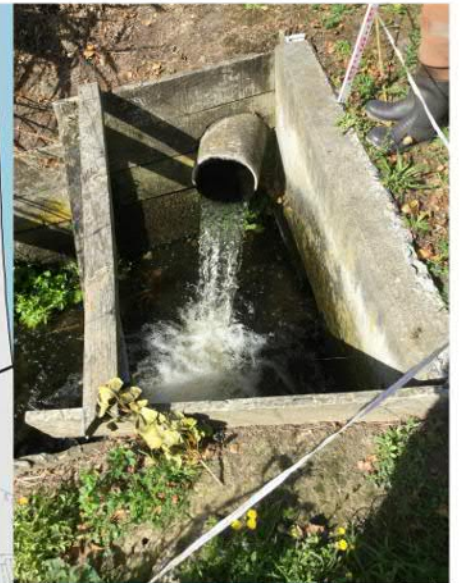
Stormwater outlet on Gibsons Drain

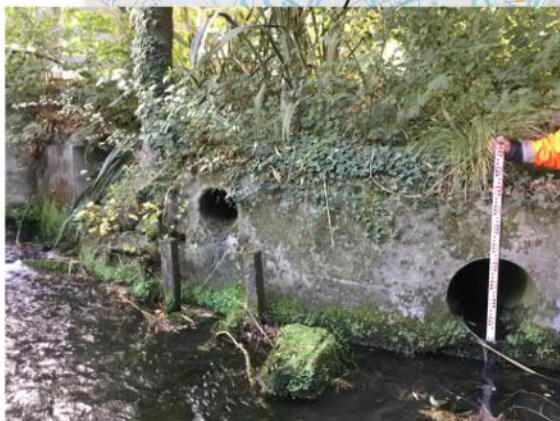
Multiple stormwater outlets on Avon River

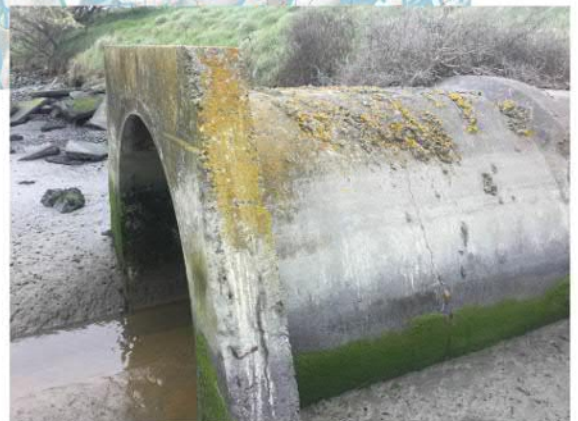
Stormwater pipe outlet on Estuary Drain
