Toilets Abberley Park
PRK 0610 BLDG 004 EQ2
Detailed Engineering Evaluation
Qualitative Report
Version Final

15 Abberley Crescent, St Albans

Christchurch City Council

Date
11 March 2013

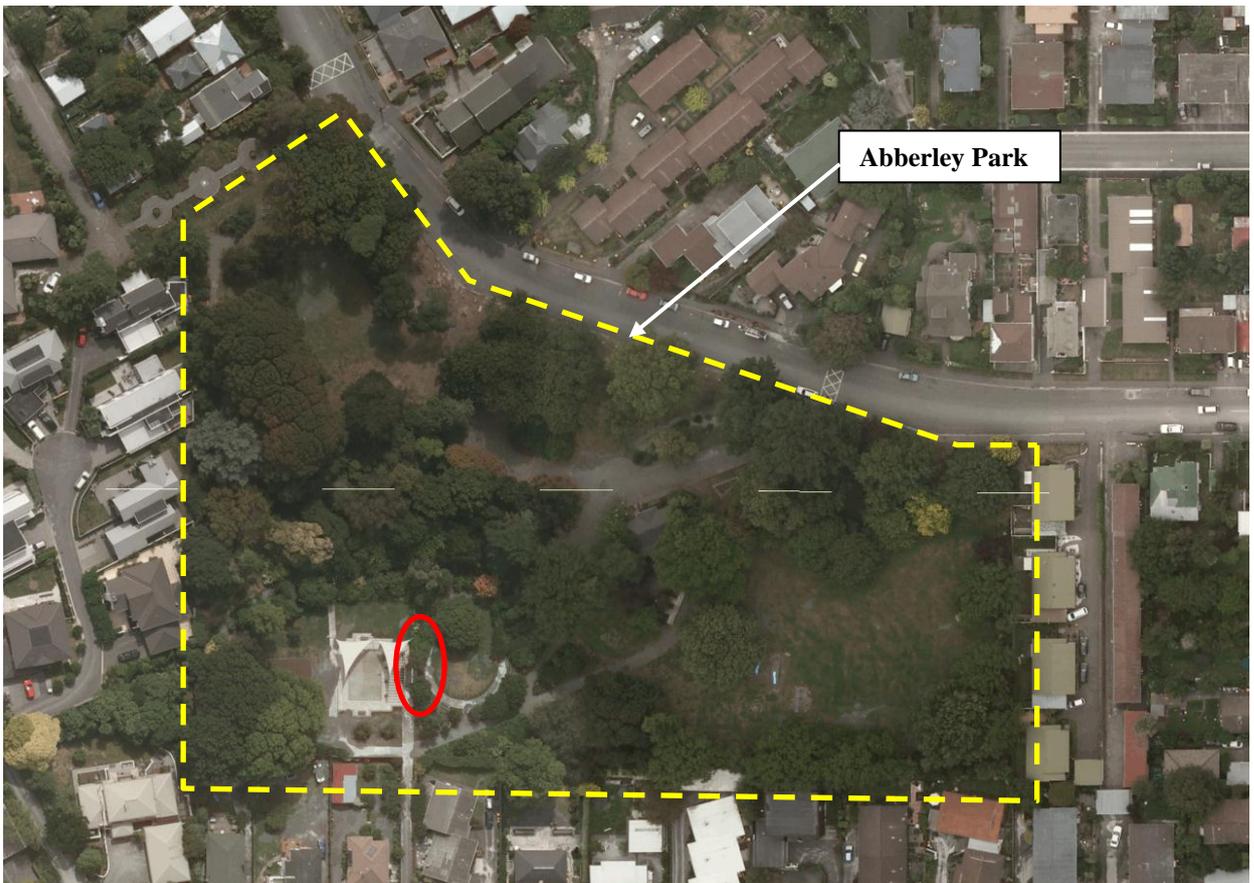
Figure 3 Post February 2011 Earthquake Aerial Photography³

Aerial photography taken following the 22 February 2011 earthquake shows evidence of minor liquefaction in the form of sand boils within the park, as shown in **Figure 3**.

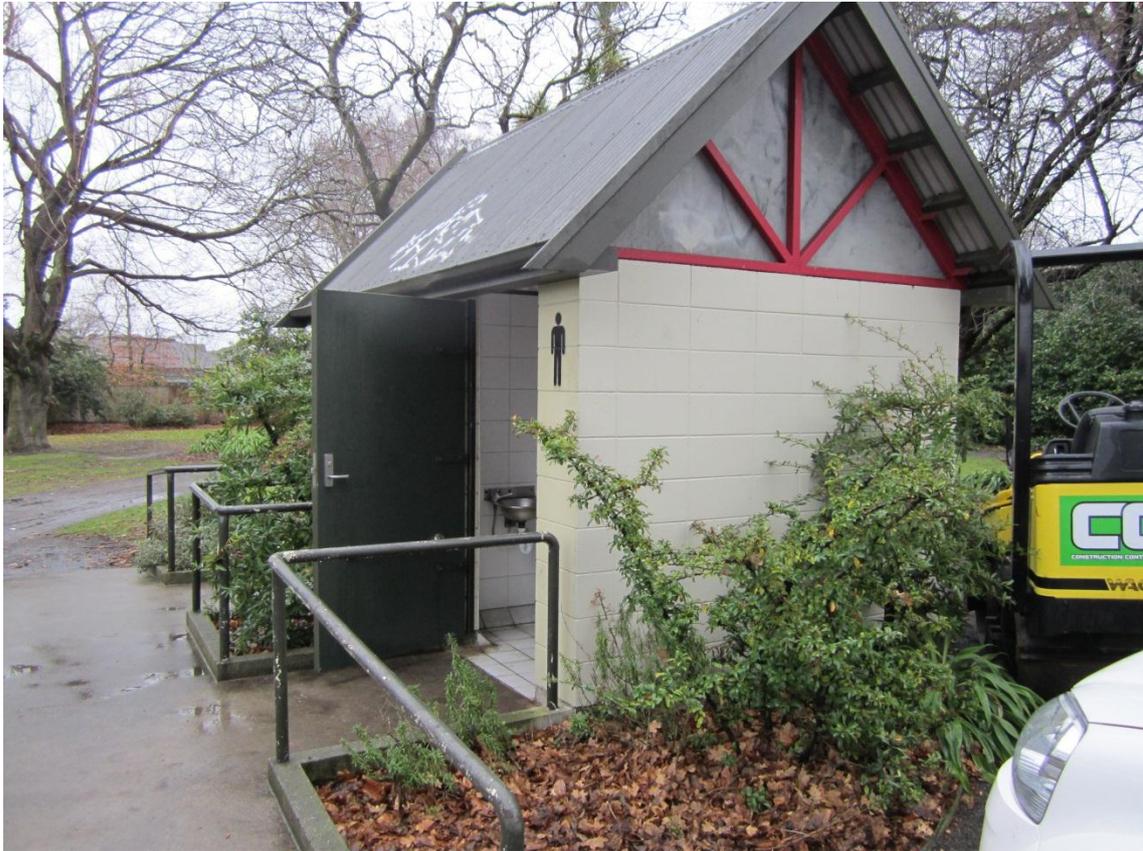
Photograph 1 North elevation.

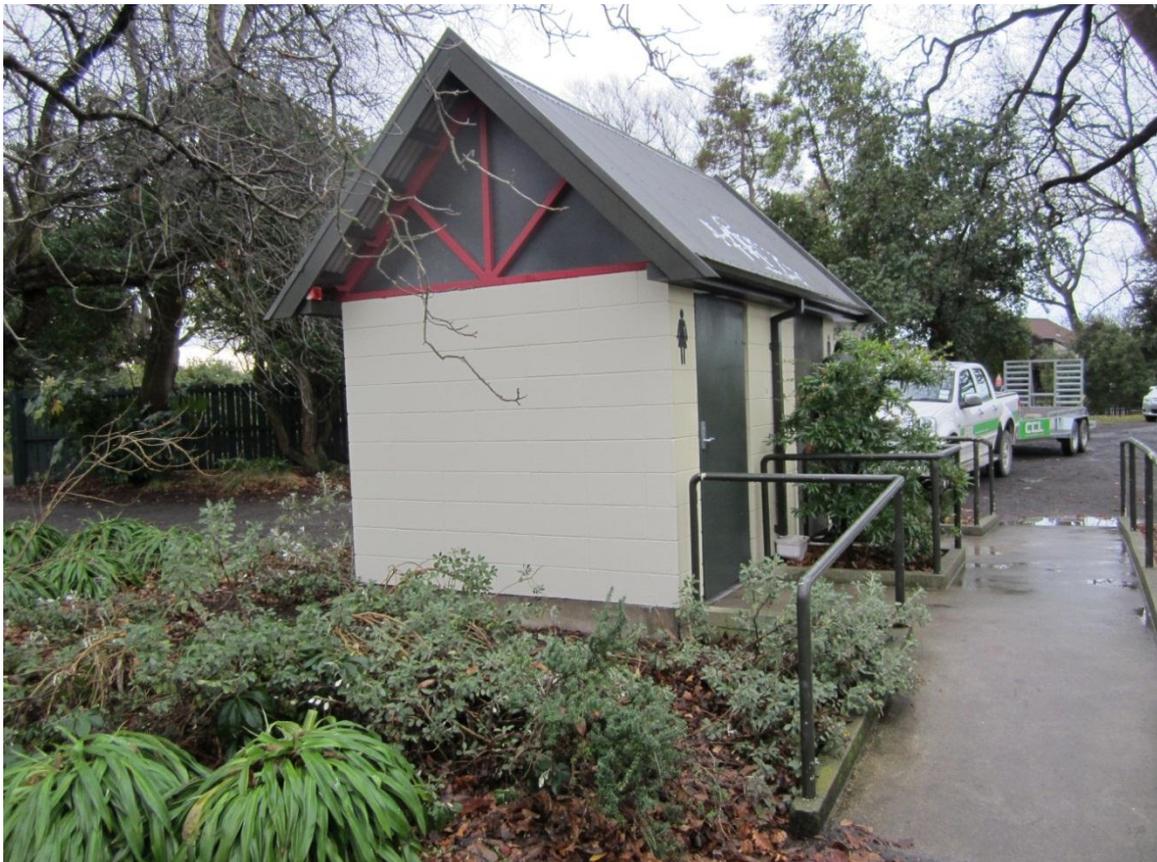
Photograph 2 South elevation

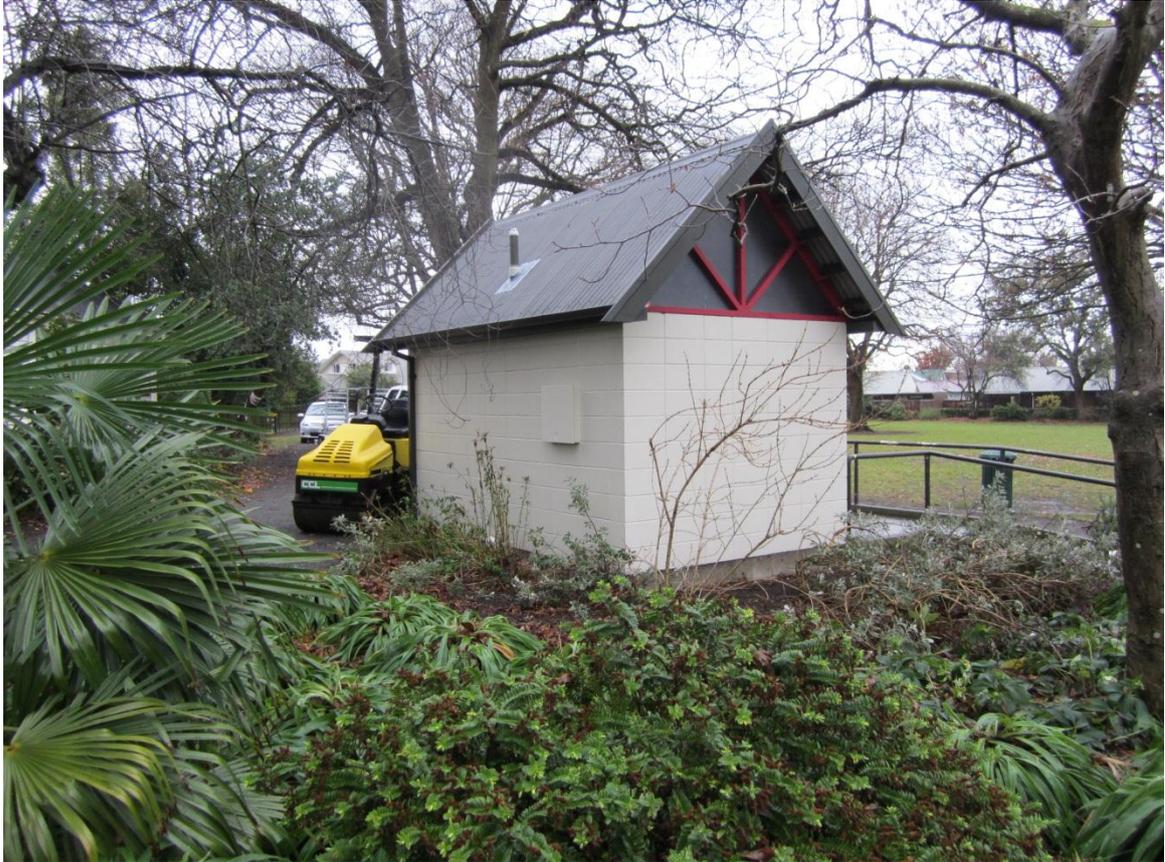
Photograph 3 West and South elevations

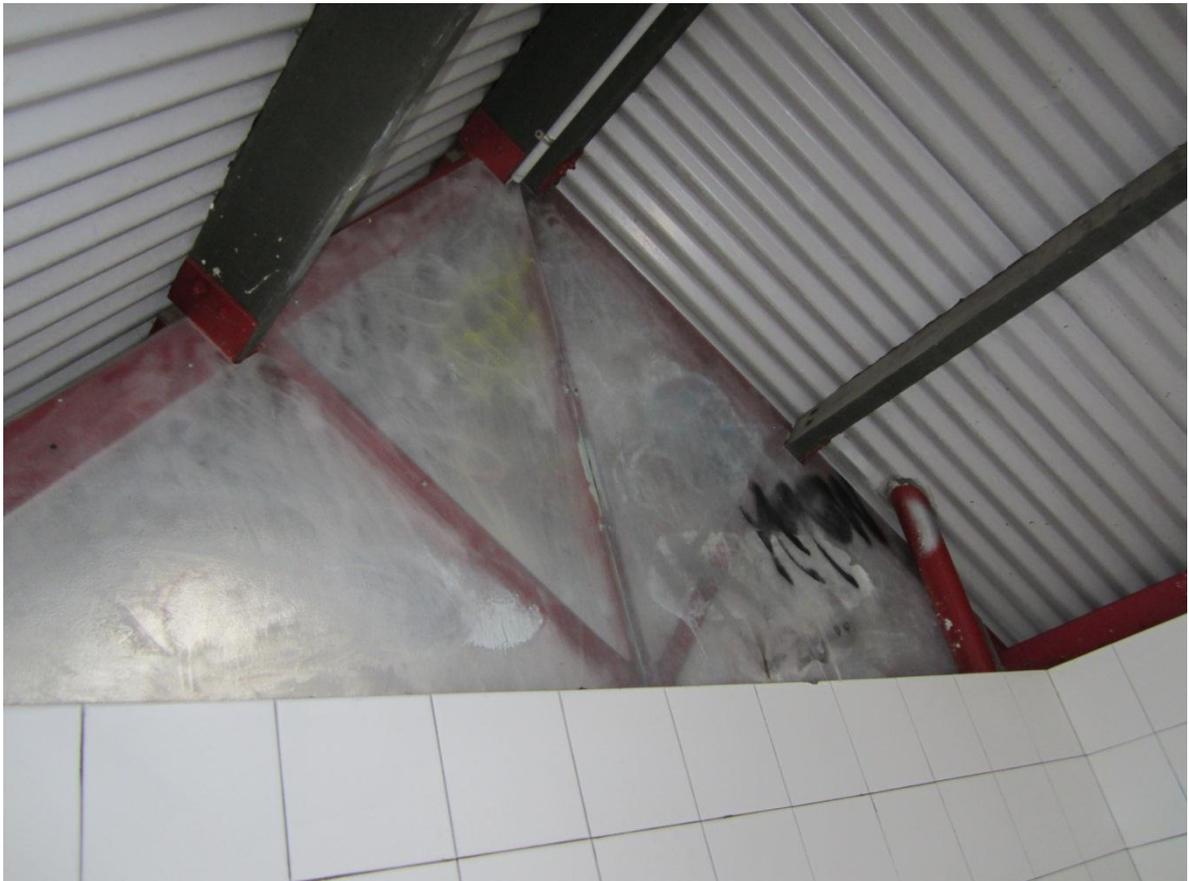
Photograph 4 Truss and Roof Interior

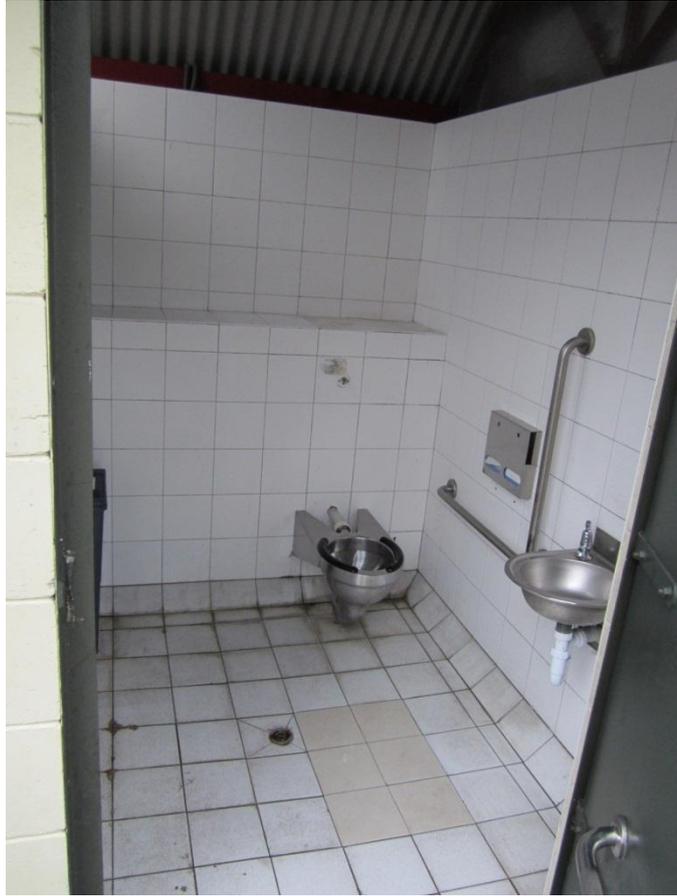
Photograph 5 Typical bathroom interior

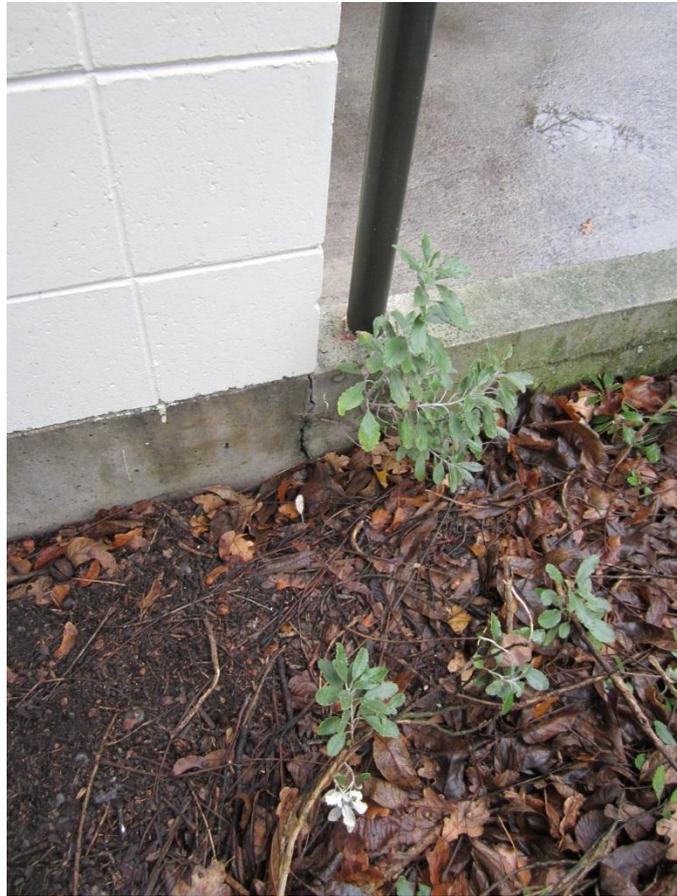
Minor cracking was noted between the foundation and footpath; this may have occurred prior to any seismic activity.

Photograph 6 Vertical cracking between foundation and kerb
